FLOODWAY INSPECTION AND MAINTENANCE FRAMEWORK

Sujeeva Setunge¹, Chun Qing Li¹, Darryn McEvoy¹, Kevin Zhang¹, Long Shi¹, Privan Mendis², Tuan Ngo², Nilupa Herath², Karu Karunasena³, Weena Lokuge³, Dilanthi Amaratunga⁴
RMIT University¹, University of Melbourne², University of Southern Queensland³, University of Huddersfield⁴

April 2018

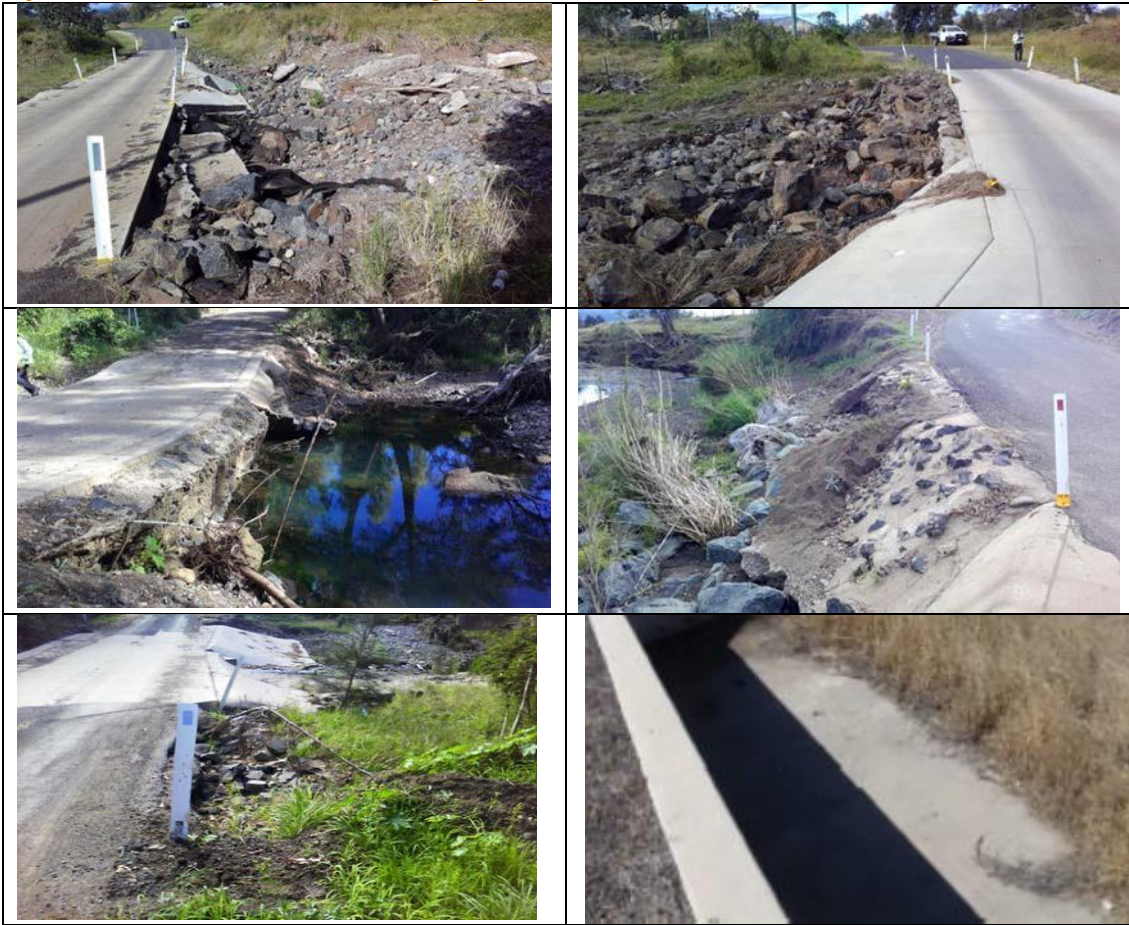
Apron and Rock Protection (US)

VicRoads - Component is in good condition with little or no deterioration.

TMR - Free of defects with little or no deterioration evident

RTA - The element shows no deterioration. There may be discolouration, efflorescence, and/or superficial cracking.

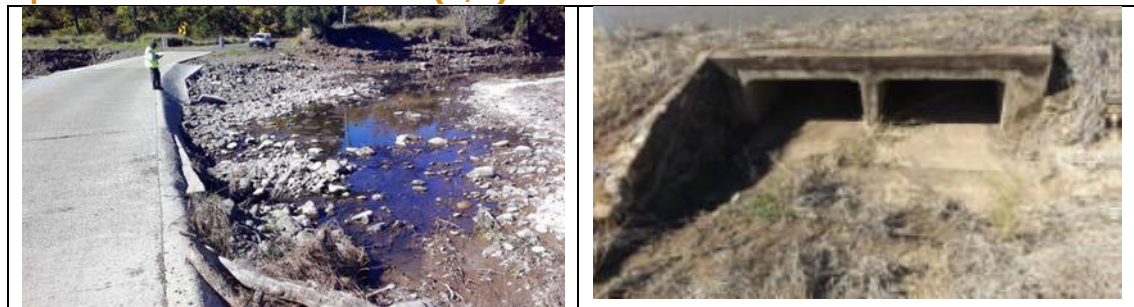
Apron and Rock Protection (U/S)

VicRoads - Component shows minor deterioration with primary supporting material showing the first signs of being affected. Intervention points for maintenance are generally as follows: Minor spalls or cracking of no real concern. Paintwork on steel components with spot rusting up to 5%.

TMR - Free of defects affecting structural performance, integrity and durability.

Deterioration of a minor nature in the protective coating and/or parent material is evident.

RTA - Minor cracks and spalls may be present but there is no exposed reinforcement or surface evidence of corrosion of reinforcement.

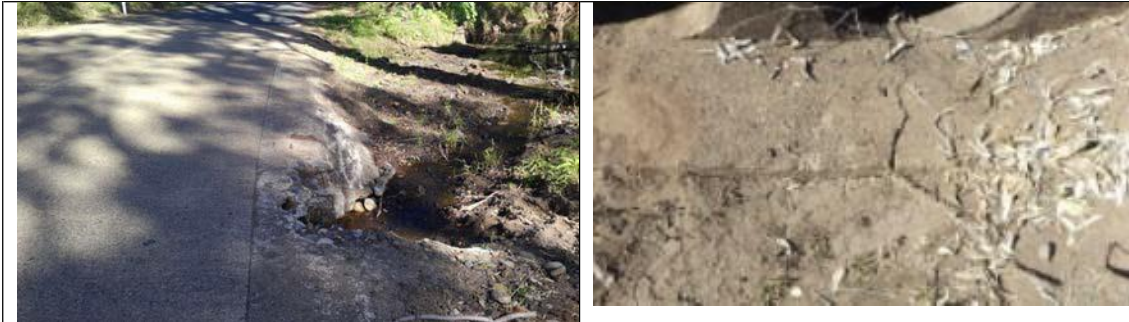
Apron and Rock Protection (U/S)

VicRoads - Component shows advancing deterioration and loss of protection to the supporting material which is showing deterioration and minor loss of section. Intervention points for maintenance are generally as follows: Large spalls, medium cracking and defects should be programmed for repair works. Paintwork has spot rusting of up to 10%, which is the approximate limit for overcoating

TMR - Defects affecting the durability/serviceability which may require monitoring and/or remedial action or inspection by a structural engineer
Component or element shows marked and advancing deterioration including loss of protective coating and minor loss of section from the parent material is evident Intervention is normally required

RTA - Some delamination's, significant cracks or spalls may be present, or some reinforcement may be exposed. Corrosion of reinforcement may be present, but loss of section is minor and is not sufficient to warrant analysis to ascertain the impact on the strength and/or serviceability of either the element or the bridge.

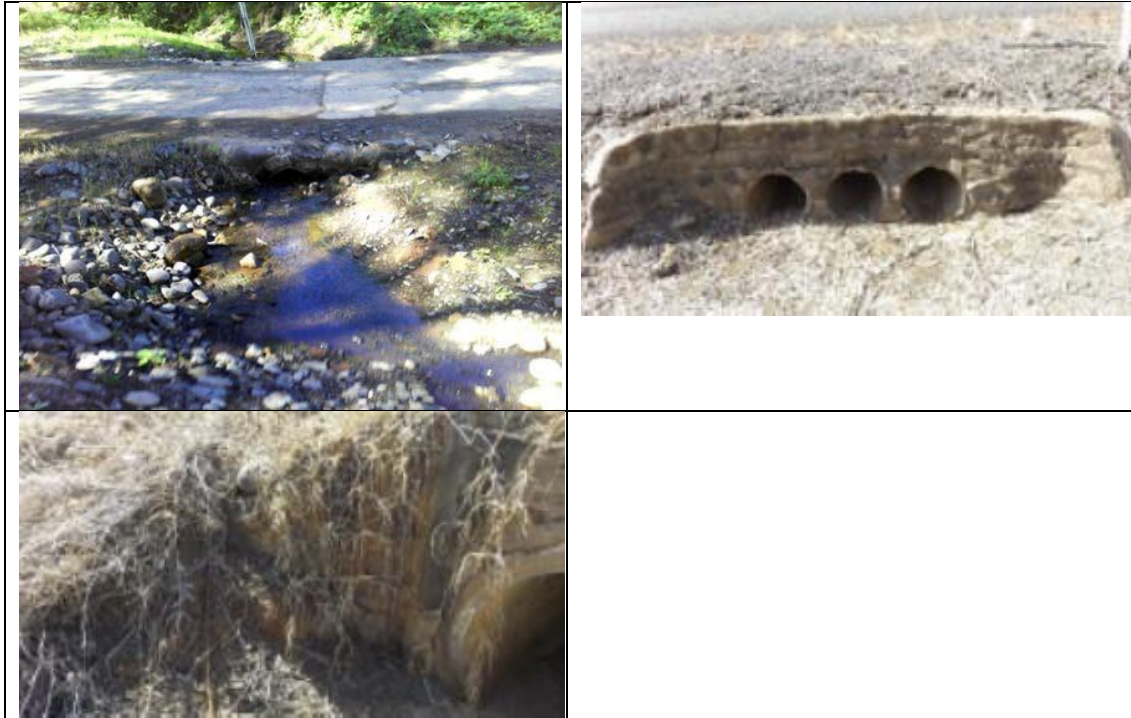
Culvert exits

VicRoads - Component shows advanced deterioration, loss of effective section to the primary supporting material, is not performing as designed or is showing signs of distress or overstress. Intervention points for maintenance are generally as follows: Very large spalls or heavy cracking and defects should be repaired within the next 12 months. Paintwork

TMR - Defects affecting the performance and structural integrity which require immediate intervention including an inspection by a structural engineer if principal components are affected. Component or element shows advanced

deterioration, loss of section from the parent material, signs of overstressing or evidence that it is acting differently to its intended design mode or function
RTA - Advanced deterioration. Corrosion of reinforcement and/or loss of concrete section is sufficient to warrant analysis to ascertain the impact on the strength and/or serviceability of either the element or the bridge.

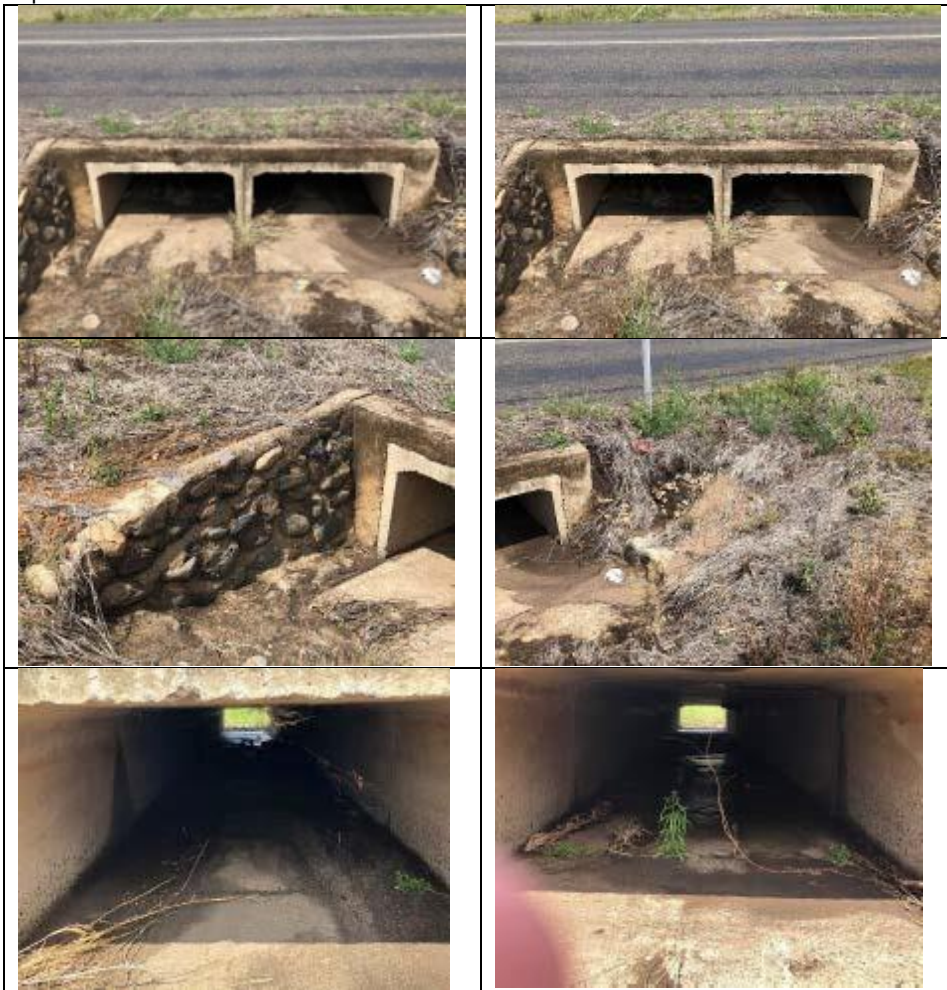
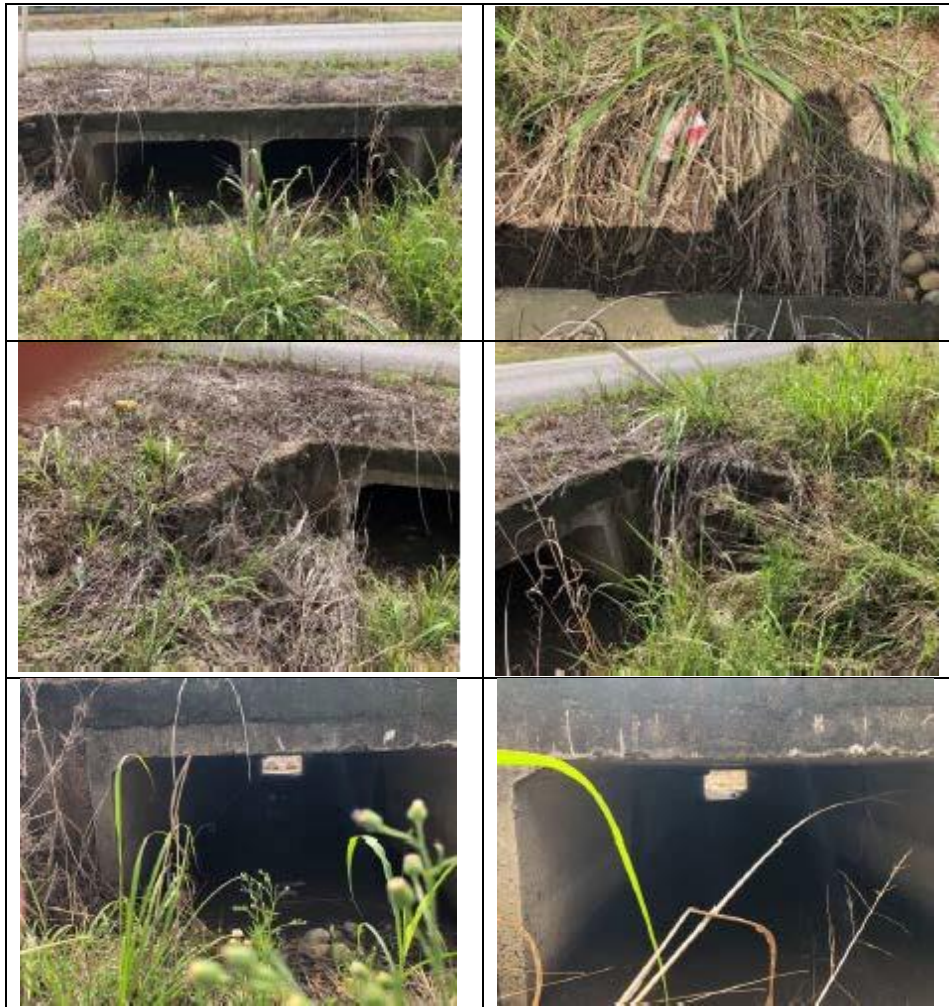
FIGURE 2: IMAGES FOR THE CASE STUDY

Inspection Record					
Upstream	Location/ Dimension	Damage Extent (%)	Condition State	Notes	
Pipe from Left to Right	In pipe note any debris, evidence of wildlife or anything noteworthy.				
1	Internal	10	1	Minor debris in pipe.	
2	Internal	25	2	Cracks in pipe. Evidence of plant life.	
Endwall	External	10	1	Needs reseal. Not covering Pipe	
Left Wingwall	External	50	2	Cracking throughout. Needs seal	
Right Wingwall	External	100	5	Missing	
Apron	External	25	2	Evidence of plant life	
Toe	External	100	5	Missing	
Riprap/Rock Protection	External	100	5	Missing	
Scour/Erosion	External	0	1	None evident	
Downstream	Location/ Dimension	Damage Extent (%)	Condition State	Notes	
Pipe from Left to Right	In pipe note any debris, evidence of wildlife or anything noteworthy.				
1	Internal	5	1	Needs reseal.	
2	Internal	10	1	Minor debris in pipe.	
Endwall	External	10	1	Needs reseal. Not covering Pipe

Left Wingwall	External	60	3	Part missing. Cracks throughout
Right Wingwall	External	60	3	Part missing. Cracks throughout
Apron	External	100	5	Missing
Toe	External	100	5	Missing
Riprap/Rock Protection	External	100	5	Missing
Scour/Erosion	External	0	1	None evident
Sundry				
Roadway	Good condition			
Upstream Vegetation	OK 1/5			
Downstream Vegetation	Fair 2/5			
Signage	OK 1/4

Structure Condition State			
Element	Damage (%)	Factor	Adjusted Damage (%)
Average damage for pipes	12.5	0.4	5
Endwall	10	0.1	1
Average damage for wingwalls	67.5	0.08	5.4
Apron	62.5	0.1	6.25
Toe	100	0.02	2
Riprap/rock protection	100	0.1	10
Scour	0	0.2	0
Condition Damaged			29.65
Condition State	Damage (%)		
Condition State 1	0 - 20		
Condition State 2	21 - 40		
Condition State 3	41 - 60		
Condition State 4	61 - 80

Damage index			
Repair Procedure	Repair needed as a fraction	Factor	Adjusted Contribution Factor
Temporary Access	0.5	0.05	0.025
Demolishing of existing structure	0	0.1	0
Reconstruction of culvert	29.65	0.5	14.825
Reconstruction of roadway	0	0.25	0
Replacing geo-textile	100	0.01	1
Reconstruction of riprap	100	0.05	5
Replacing sign posts	0	0.02	0
Cleaning and debris removal	20	0.02	0.4
DI = Σ Adjusted Contribution Factors	MUST EQUAL 1	1	21.25

The culvert featured in this case study received a condition state 2 rating from LVRC in 2015. This inspection framework also gave the culvert a condition state 2 but also gave it a damage index of 21.25. This damage index can be used to rate culverts against each other to determine maintenance priority.

Recommendations based on the damage index	Replace the structure	Perform a detailed analysis considering the design life	Critically assess components subject to	Repair activities should perform as quickly as possible	rectify the problem at the earliest
Other recommendations	Mowing of downstream not required with geotextile placement				
Asset ID	Withheld				
Date of Inspection	10-Sep-18				
Prepared by					
Name					
Id					
Signature					
Date
