Investigation of Damage: Brisbane 27 Nov 2014 Severe Storm Event

Cyclone Testing Station, James Cook University

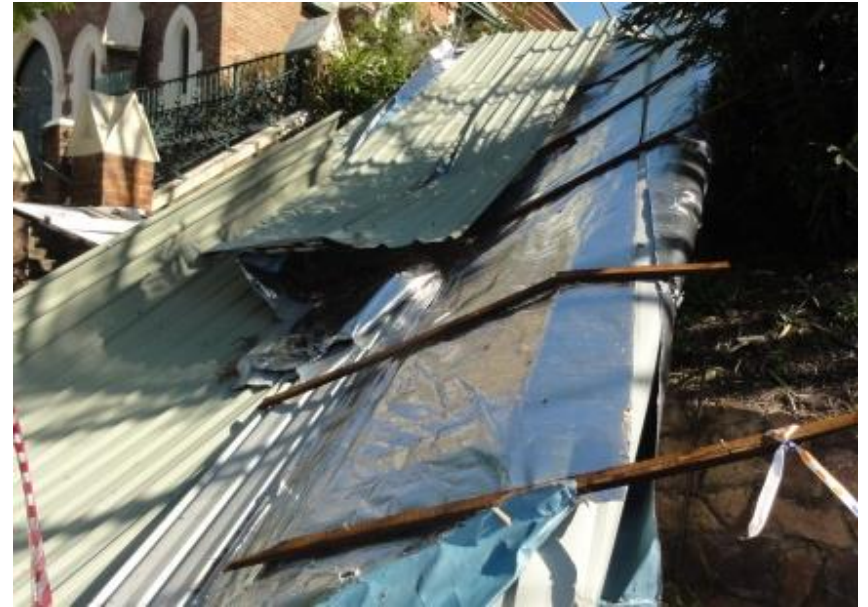
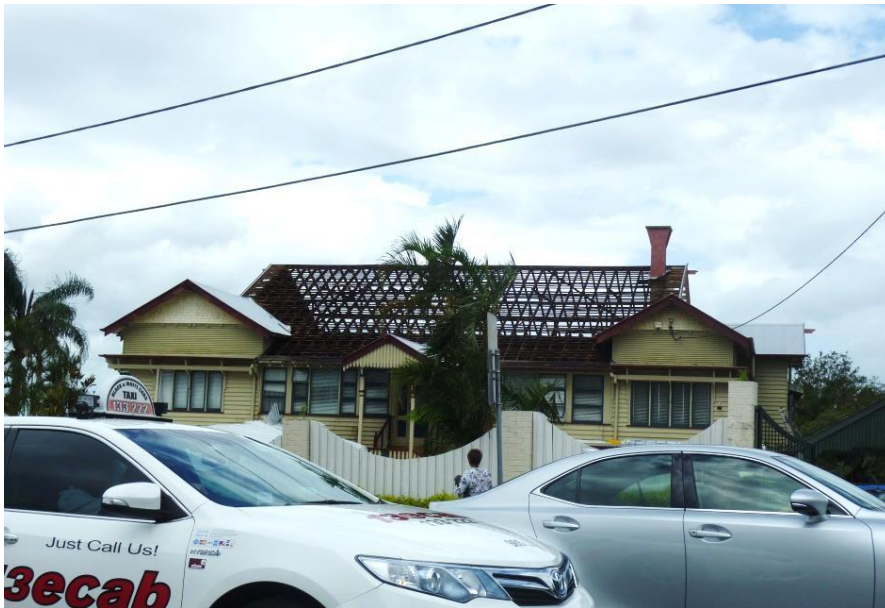
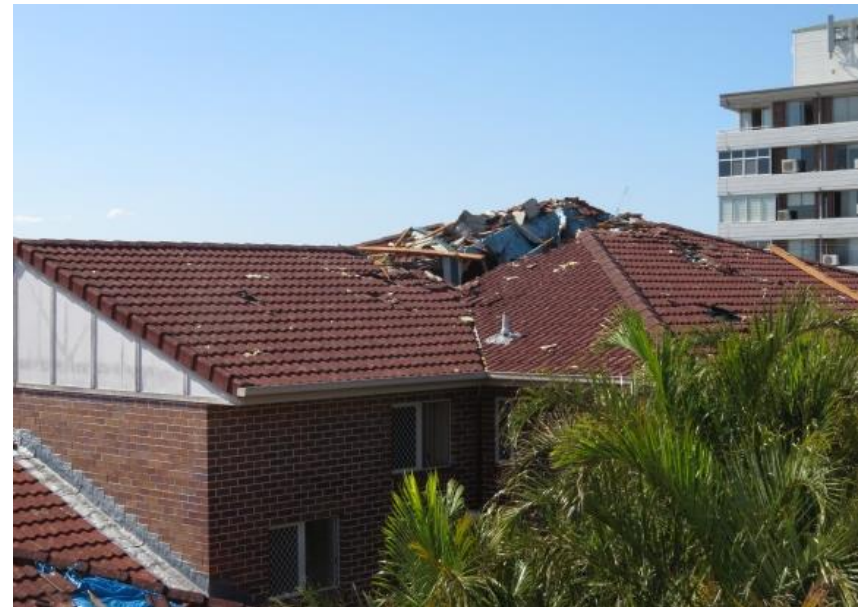
Structural Damage

- Several of these buildings had been renovated –Why did they fail?

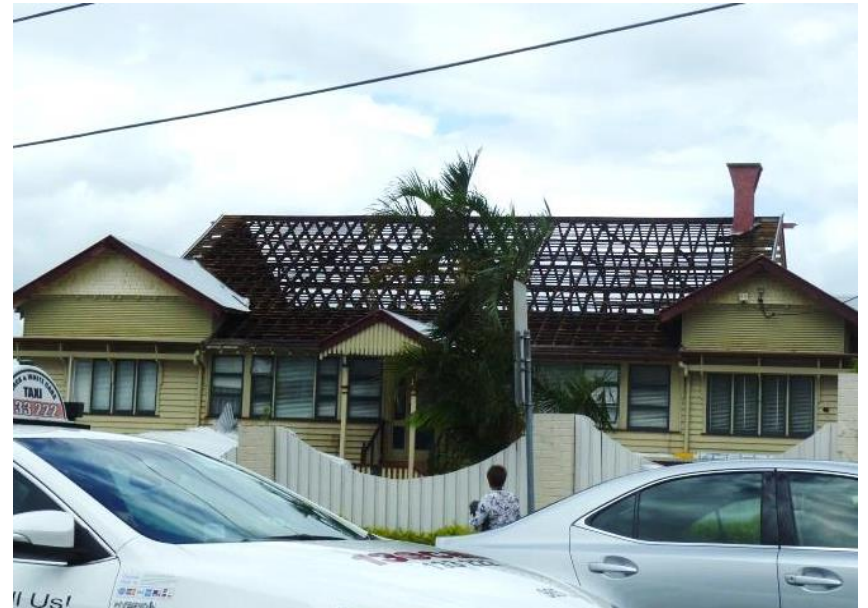
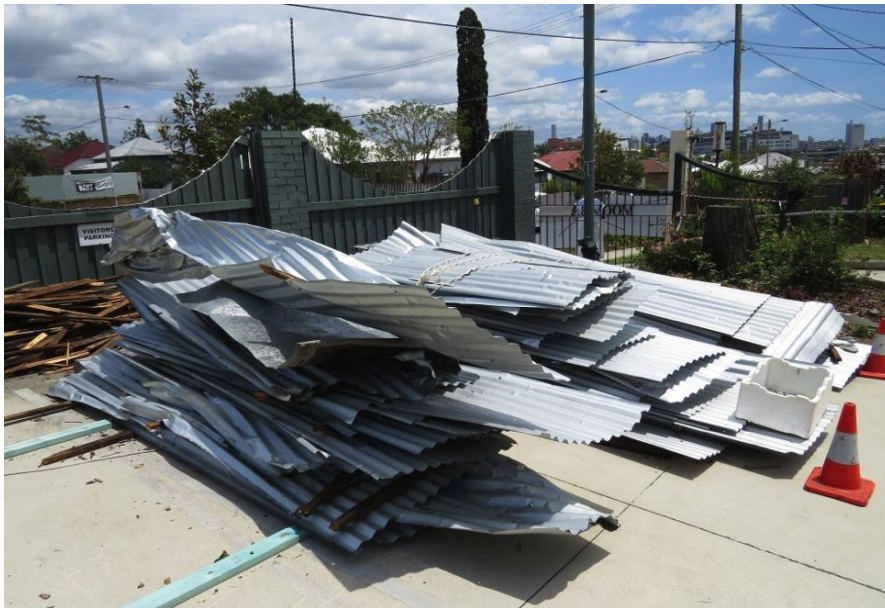
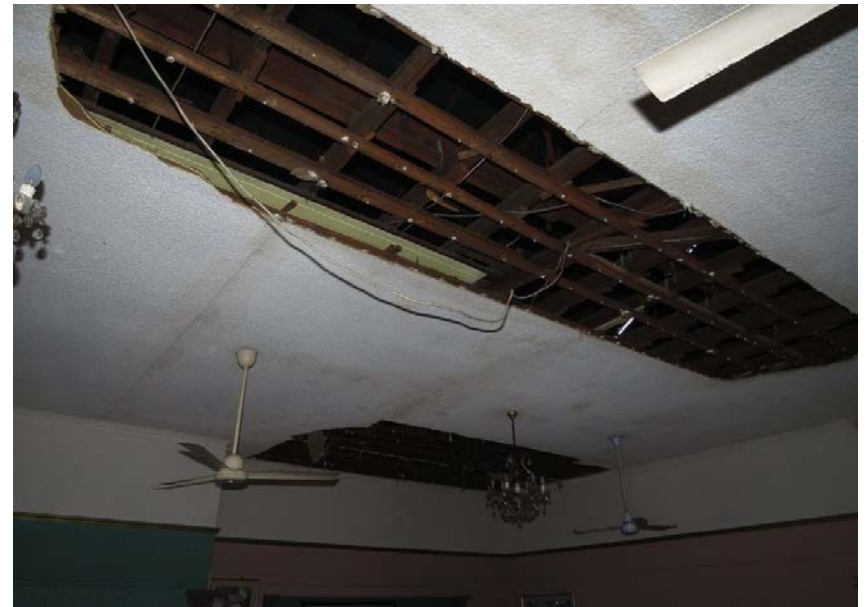
Loss of Cladding

Originally a tile roof, the new metal cladding was fastened to every 3rd batten

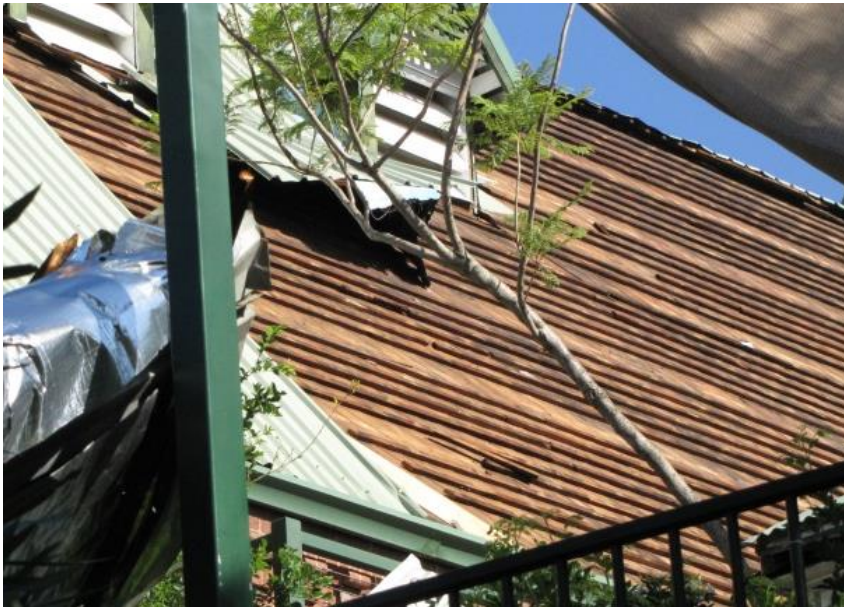
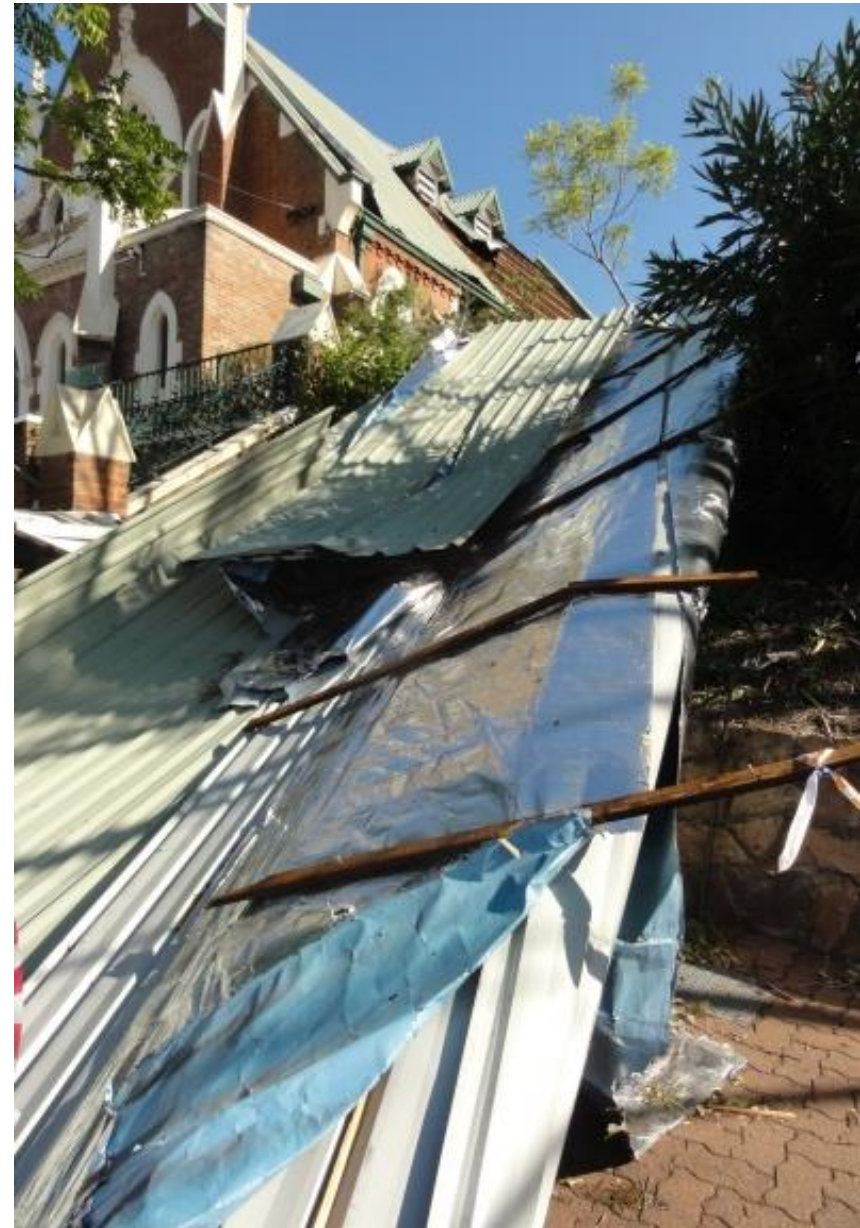
Loss of Cladding and Battens

Again, originally a tile roof. New metal cladding fastened to every 6th batten!

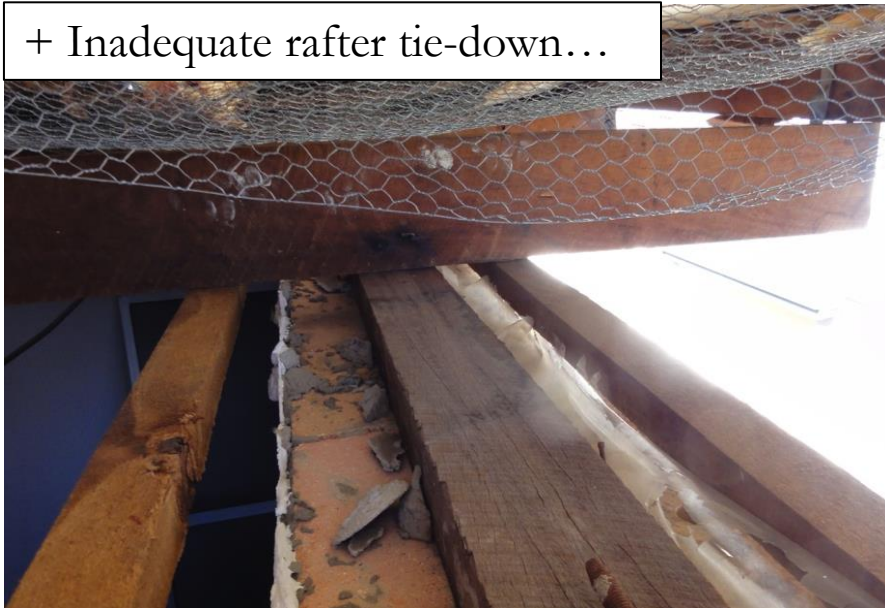
Loss of Entire Roof

Due to internal pressures and inadequate rafter tie-down

+ Inadequate rafter tie-down...

The entire 'hold-down chain' must be considered during renovation work

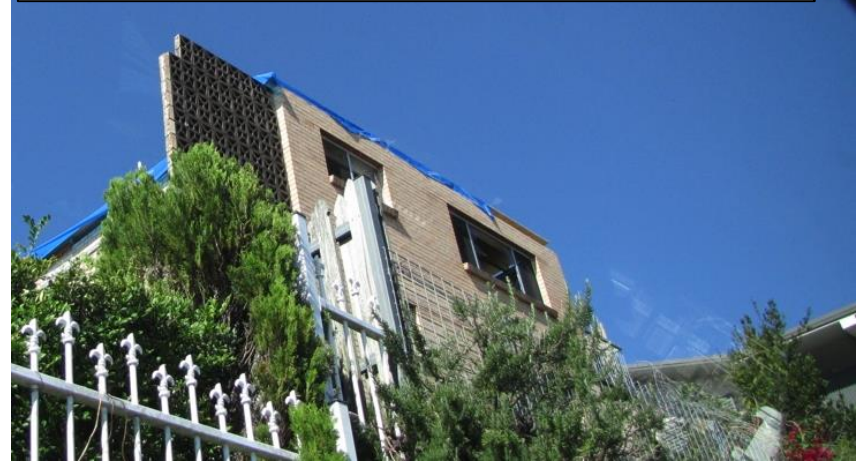
Window Broken by hail resulting in internal pressures

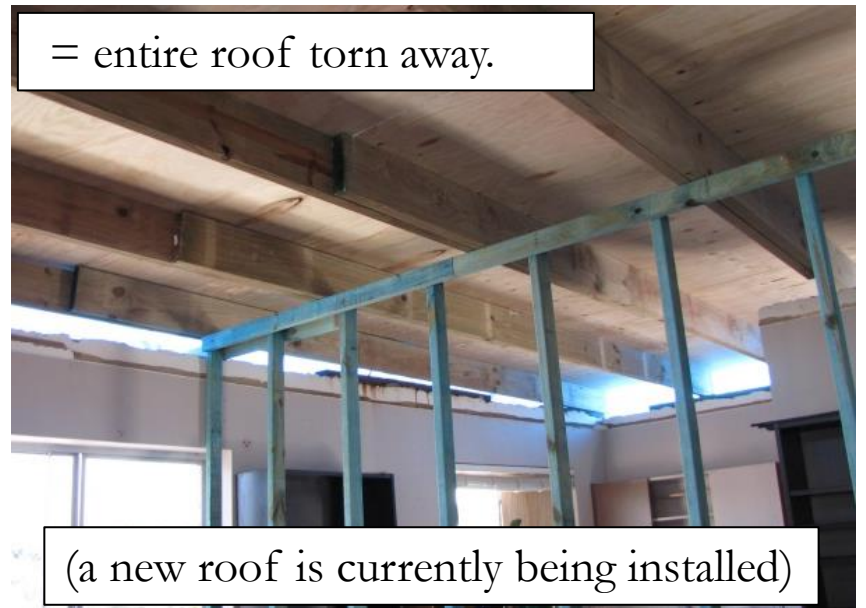
= entire roof torn away.

(a new roof is currently being installed)

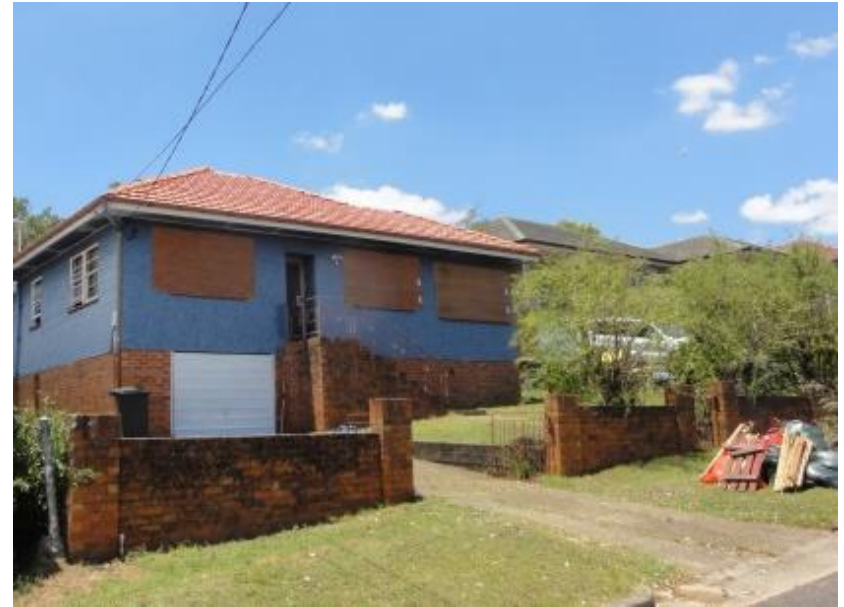
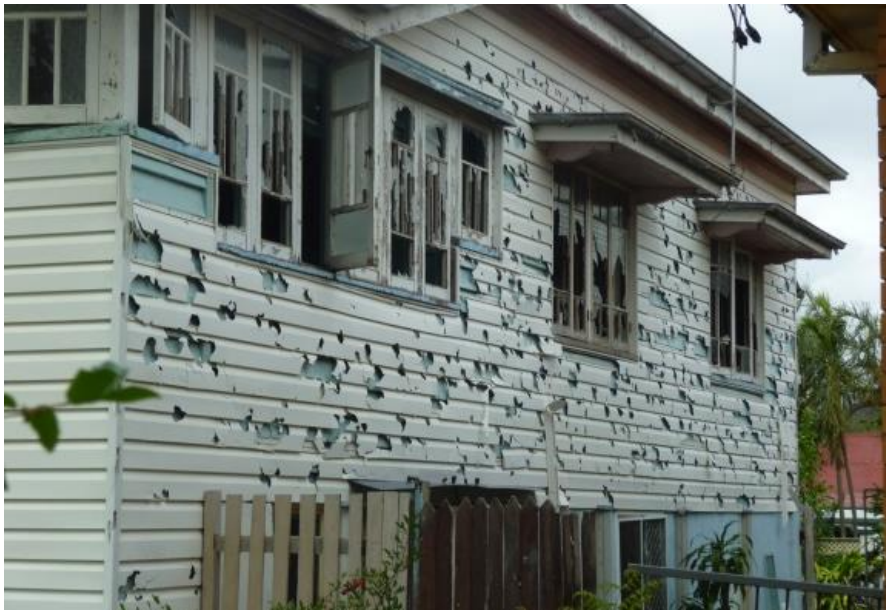
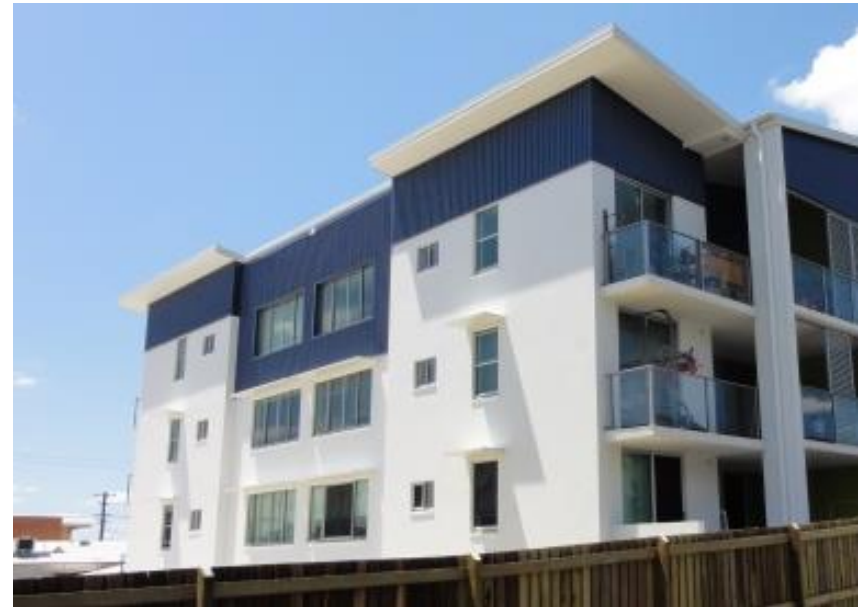
Hail Damage

- Most windows on southern side broken
- Significant horizontal component due to wind
- New windows performed better
