# From storm to study: Insights on resilience from Tropical Cyclone Alfred

Understanding damage, vulnerabilities and future risk in  
south-east Queensland and north-east New South Wales

Report number: 45.2025

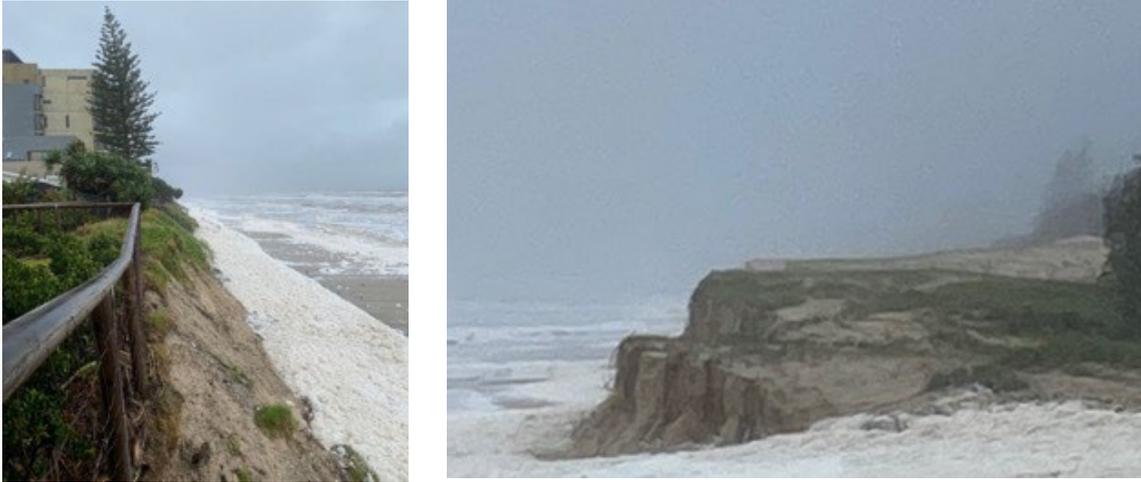
The strong winds caused significant waves, though no wave height records were broken. Beach erosion was widely reported along surf beaches in the study area.

Figure 3 - Coastal erosion from storm tide

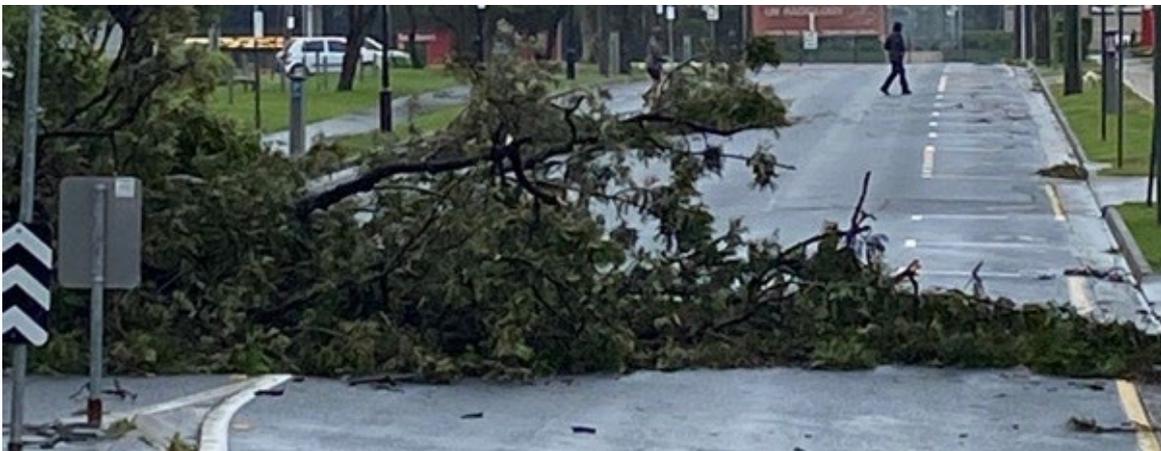
The most conspicuous damage was to trees. It ranged from loss of small branches to whole trees falling. The tree damage was similar to other events where recorded 3 sec gust wind speeds were 100 kilometres per hour or less.

- Where trees fell on powerlines, they caused power outages.
- Where trees fell on buildings, they caused damage to the building.
- Where trees fell across roads, they caused disruption to transport.

Figure 4: Fallen tree in Gold Coast

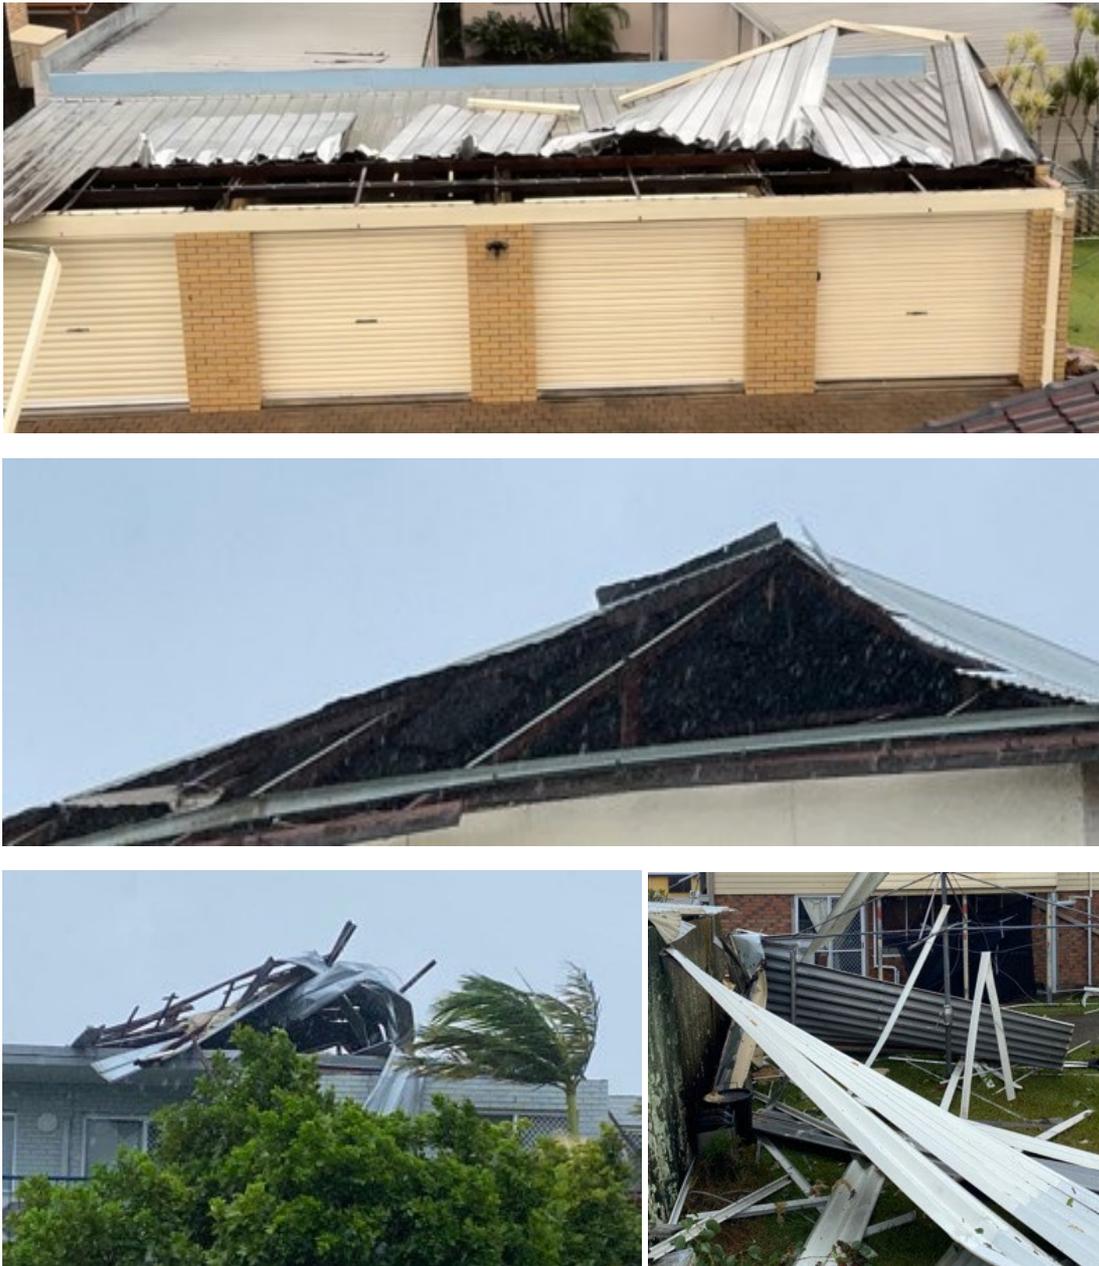
Four buildings were studied where partial roof failure had occurred. In all of these cases, deterioration had caused a loss of performance in some structural elements. This highlighted the critical role played by building maintenance. Because the peak gust wind speeds were less than 60 per cent of the design strength wind speed for the region, the general lack of wind damage was to be expected and these cases highlighted how deterioration can significantly reduce the performance of buildings.

Figure 5: Damage to buildings

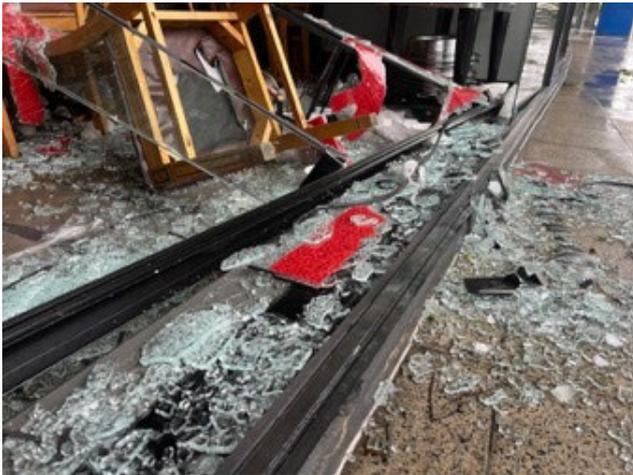
The absence of wind-borne debris meant that few windows and doors were broken. The wind speeds were also lower than the speeds at which glass should be broken by wind pressures. A few broken windows were due to high pressures at the base of tall buildings that are due to 'downwash' effects.

Figure 6: Broken shop front glazing from accelerated winds

- Some windows broke and the pressure across the windows in this event forced glass well into the building. In even stronger events, breaking glass could prove fatal, so it is important to maintain messaging about staying away from windows during strong winds.

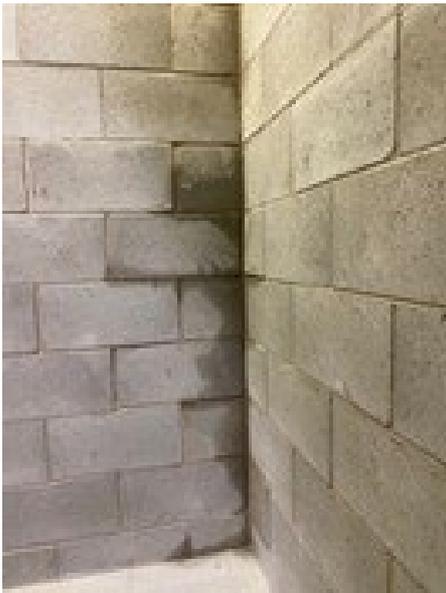
There were many instances of water entering directly through concrete block walls. This type of wall relies on weatherproofing using external membranes to stop water from soaking into the porous blocks. These membranes can include washes applied directly to the blocks, render or acrylic paints. Where these had deteriorated, water could find its way into the blocks.

Differential pressure between the outside and inside of the building drove the water through the blocks to the inside surface of the blockwork.

Once water was on the inside of the blockwork, it ran down the inside to the concrete slab, where it ponded under the floor coverings.

*Figure 7: Water ingress through masonry walls*

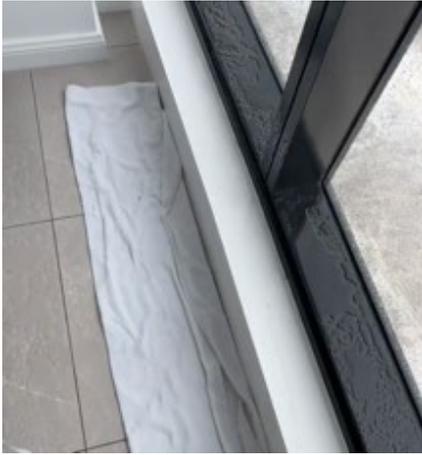
There were many social media posts during the event of water entering through closed windows and running down the inside onto floor coverings. Water can enter windows through seals, gaps around moving parts and through weep holes. Under normal operation, any water that gets to the inside of a window drops into the sill where it is drained to the outside through weepholes.

Under high winds, there is a strong pressure differential from the outside to the inside across the window. This can prevent water from draining out of the sill and drive water through the weep holes from the outside.

Figure 8: Wind driven rainwater ingress through window systems

- Water entry through closed windows was a problem in this event, even though the gust wind speeds were less than the serviceability wind speed for region B1 (wind region B1 applies to south-east Queensland and northern NSW). The glazing industry should be encouraged to incorporate simple features in the window design that control air movement through weep holes under differential pressures across windows. A method of evaluating the impact of these measures should be developed to inform purchasers of windows of the effectiveness of the windows at keeping out water at pressures above the water penetration test pressure.
- Effective sealing is vital to the watertightness of single skin structural systems such as reinforced concrete block walls. The sealing materials must be properly applied and the effectiveness of the weatherproofing maintained throughout the life of the building.

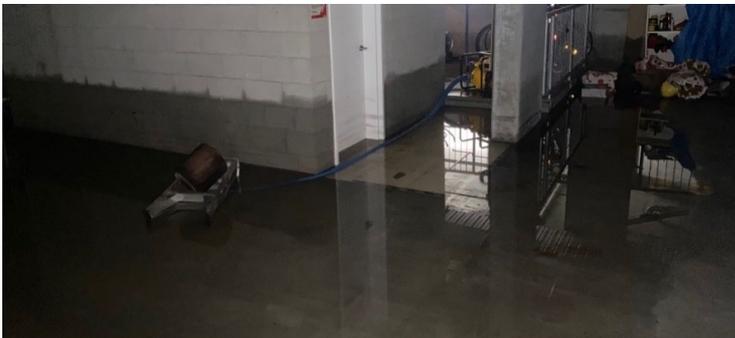
There were many cases in which basements flooded. High water tables associated with strong rain and storm surge meant that seepage was much faster than normal. In some cases, rainwater entered basements by running down the inside of walls, seeping through slabs or running through the vehicle entrance.

Water in the basement flooded the sump and, in some cases, overwhelmed the sump pumps. In other cases, power failures meant that sump pumps didn't start and basements flooded. Flooded basements led to loss of cars and items stored in the basement and damage to electrical transformers and switchboards.

Figure 9: Flooded basement

- Subterranean basements have the potential to accumulate water in extreme storms and sufficient backup power should be available to provide pump capacity even if mains power has failed during the event.

- All basements should be effectively sealed to reduce water seepage at all times and reduce the chance of corrosion of reinforcement in basement concrete. Effective sealing will also reduce inflow to basements when high rainfall has contributed to a high-water table.
