RETROFITTING OF A HIGH-SET QUEENSLAND HOUSE FOR WIND LOADING

Korah Parackal¹, John Ginger¹, Martin Wehner², David Henderson¹
James Cook University¹, Geoscience Australia²

Citation: Parackal, K, Ginger, Wehner, M & Henderson, D 2019, *Retrofitting of a high-set Queensland house for wind loading*, Melbourne, Australia, Bushfire and Natural Hazards CRC.

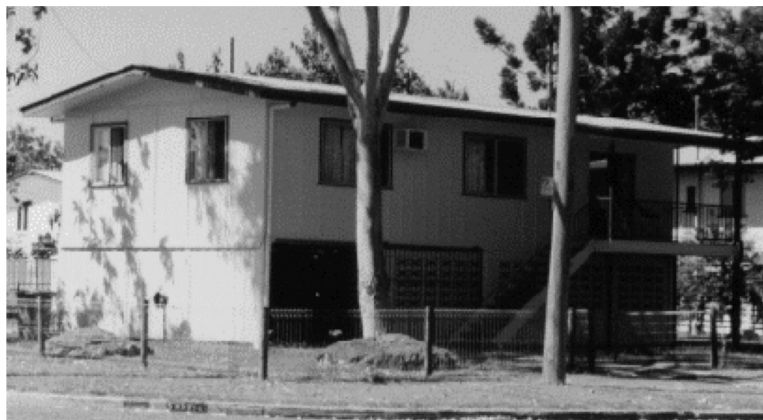
FIGURE 1 PHOTO OF GROUP 4 HOUSE

The house is a high set timber framed structure with metal roof cladding and fibre cement wall cladding, an example is shown in Figure 1. The dimensions and structural system were determined from survey data and the resulting representative house was originally described by Henderson and Harper (2003).

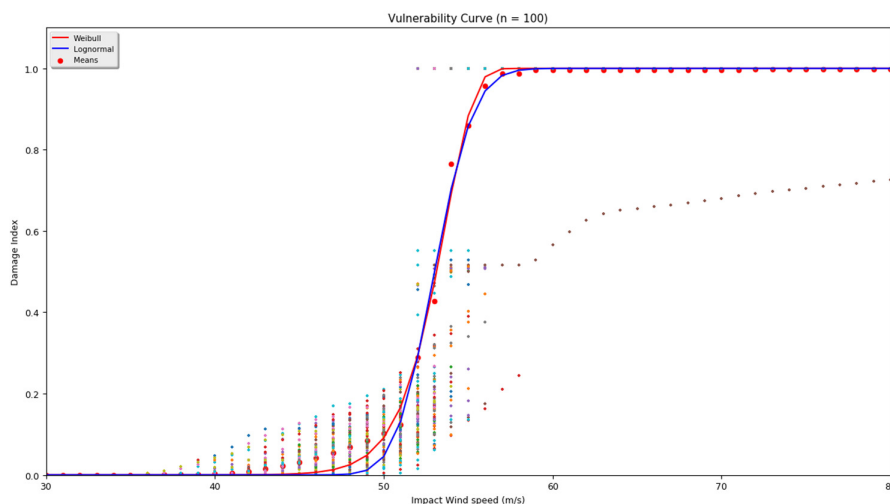
FIGURE 3 THE CONTROL CASE WITHOUT RETROFITTED CONNECTIONS

Scenario 1 where edge batten to rafter connections were strengthened showed little change in performance compared to the control case, as seen when comparing Figure 3 and Figure 4. As loads are higher on batten to rafter connections that are on the second row from the edge due to larger tributary areas it is these connections that fail first. From research by Parackal (2018), retrofitting first and second internal batten rows is recommended to delay the onset of damage and a progressive failure of batten-rafter connections. However, due to the one-way load redistribution process used in VAWS failure propagation may not be arrested by the strengthened connections once failure initiates in other batten rows and further investigation is required.

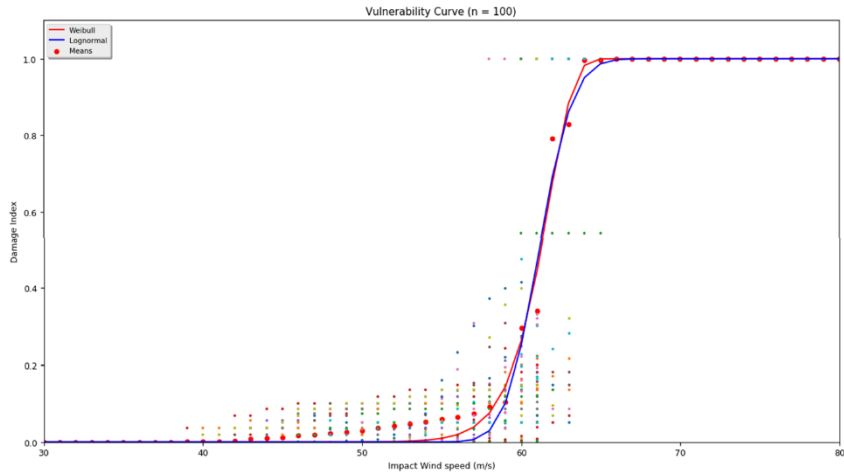
FIGURE 6: SCENARIO 3 - ALL BATTENS TO RAFTER CONNECTIONS RETROFITTED WITH 3KN SCREW CONNECTION + 10KN STRAP FOR END RAFTER TO WALL CONNECTIONS

Scenario 3 involved retrofitting only end rafters (roof to wall connections and ridge connections) with strapping in addition to retrofitting all batten to rafter connections. No significant change in performance was noted as shown in Figure 6.

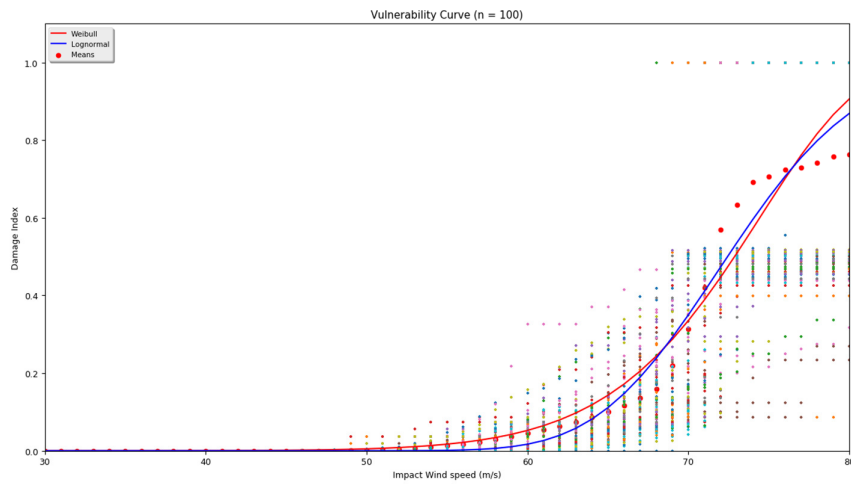
FIGURE 7: SCENARIO 4 - ALL BATTENS TO RAFTER CONNECTIONS RETROFITTED WITH 3KN SCREW CONNECTION + 10KN STRAP FOR ALL RAFTER TO WALL CONNECTIONS

Scenario 4 includes the retrofit of all battens and all rafters, a significant improvement in performance is made as shown in Figure 7.
