RAINWATER INGRESS THROUGH RESIDENTIAL SLIDING WINDOWS

Korah Parackal, John Ginger, Alexis Leblais, David Henderson
James Cook University, Bushfire and Natural Hazards CRC

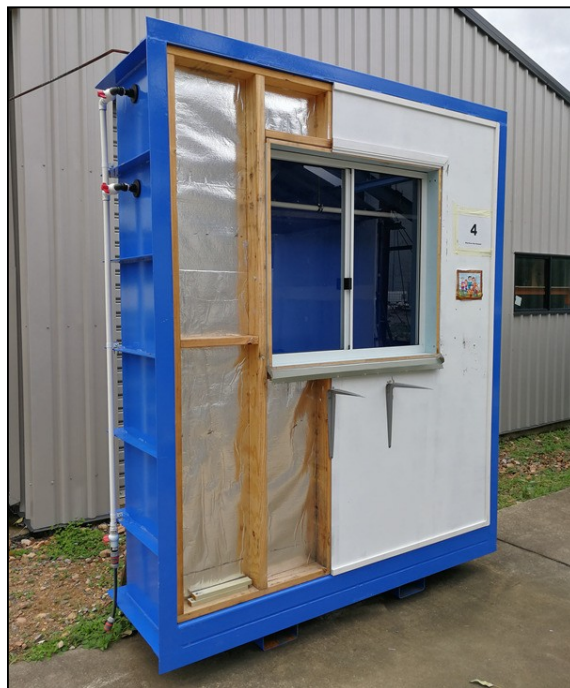
FIGURE 1. WDRS WITH WALL AND WINDOW TEST SAMPLE

A stud wall with a residential sliding window was attached to the open face of the air-pressure-chamber to simulate 'real-life' conditions for the window, as shown in Figure 1. A single glass sliding window comprising of one fixed glass panel and one slider glass panel was tested in this study. The overall window size was approximately 1 m × 1 m hence the surface area of the window was approximately 1 m². The window was specified as C2 cyclone rated. The window was set up in the WDRS with its outdoor side facing the inside of the WDRS. This simulates 'real life' conditions since the rain and pressure are applied inside the chamber of the WDRS. A 'water-collecting tray' was fixed under the windowsill to collect water leaking through the window during the tests.

A wind driven rain simulator (WDRS) was constructed at the CTS. The WDRS is an open face air-pressure-chamber equipped with two 'spray bars' to simulate rain and is connected to a Pressure Loading Actuator (PLA) to simulate the net pressure on the window. The spray bars were made of PVC pipes and attached to water sprinklers orientated towards the open face of the air-pressure-chamber. The spray bars were connected to the water supply through a flow valve and flow meter to control the water flow rate.

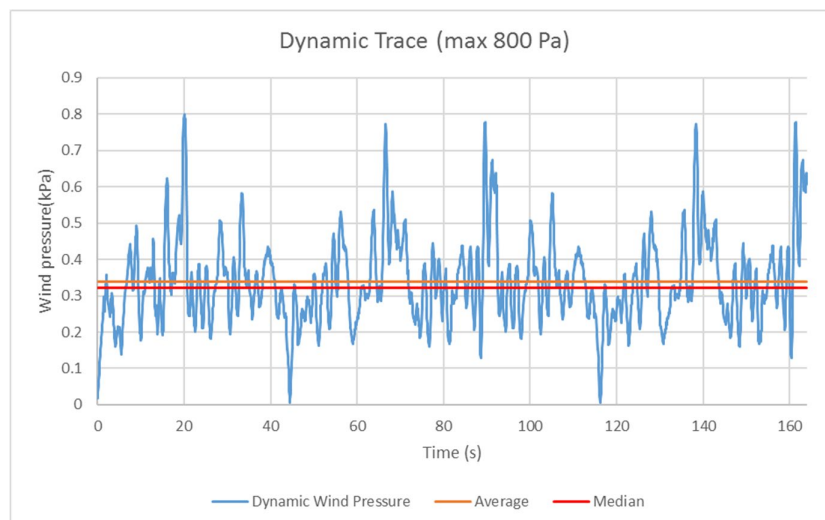
FIGURE 2. DYNAMIC TRACE WITH MAXIMUM 800 PA PRESSURE

For the fluctuating tests, the PLA was run in automatic mode, allowing for dynamic pressure traces to be applied. Two dynamic traces were used, both generated from a wind tunnel study determining the pressure fluctuations on a windward wall of a building. The dynamic traces were scaled in intensity to allow for their peaks to reach 800 Pa and 1200 Pa respectively. Both traces run for approximately 2 minutes and 45 seconds. Figures 2 and 3 show the dynamic traces as a function of time with peaks at 800 Pa and 1200 Pa respectively.

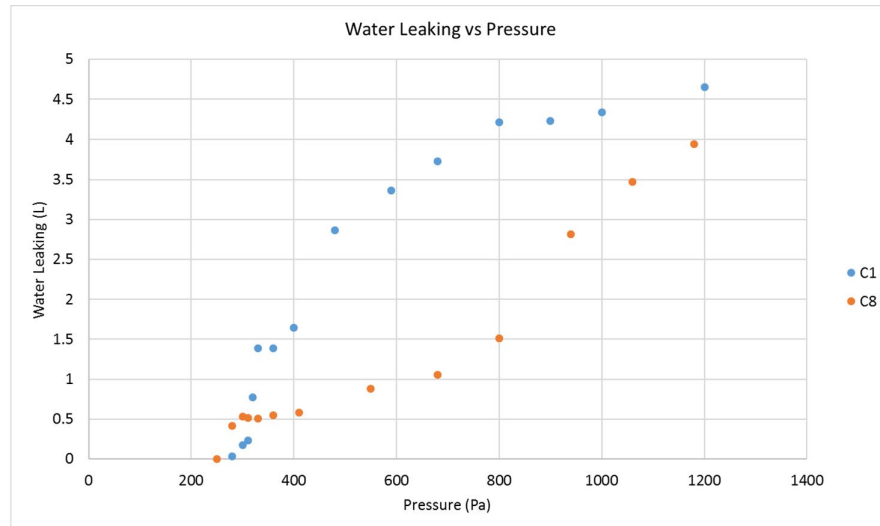
FIGURE 4. WATER INGRESS AS A FUNCTION OF STATIC PRESSURE

The water ingress through the window as a function of the net pressure differential between the outdoor in indoor sides of the window for configurations C1 and C8 is shown in Figure 4.

The results of the static tests show that obstructing the possible water pathways in the window with tape and blu-tack can reduce the amount of water ingress, mainly when the net pressure differential between the outdoor in indoor sides are between 400 Pa and 1000 Pa. However, it must be noted that blocking the window's weep holes prevents the water accumulated in the track from returning to the outdoor side. This contributed to the water ingress being higher for the C8 configuration than the C1 configuration at less than 300 Pa. Since the water trapped in the track was not able to return to the outdoor side, it was collected and measured as water that had leaked through the window.

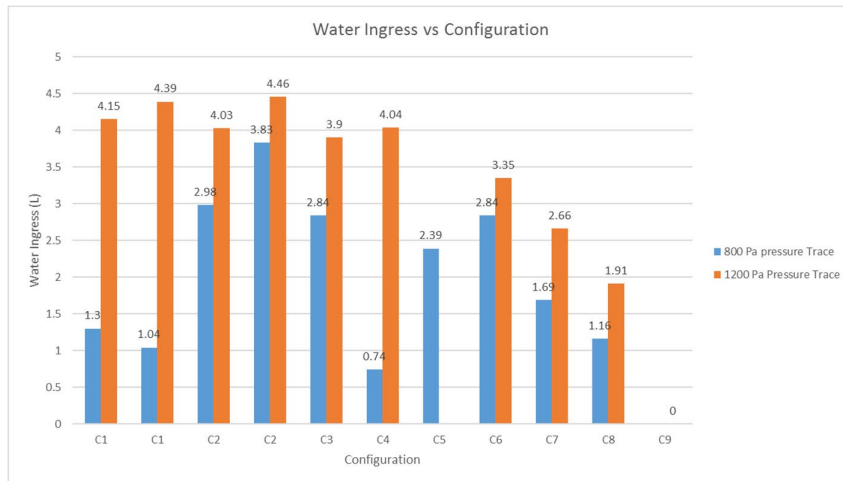
FIGURE 5. WATER INGRESS AS A FUNCTION OF CONFIGURATION

The water ingress through the window for each configuration and pressure traces is given in Figure 5.

The results of the fluctuating tests show that the only effective method we found to prevent water ingress was by using the C9 configuration.

These tests also confirmed the observation previously made that blocking the weep holes could actually worsen the water ingress. This is particularly true for the less intense pressure peaks. It was observed that when the pressure decreased between the peaks, the amount of water in the window track reduced by leaving through the weep holes. Obstructing the weep holes therefore prevents this phenomenon and the track does not empty, contributing to increased water ingress. This observation is highlighted in configurations C1 and C4 with the 800 Pa trace. The amount of water ingress is significantly less than for all other configurations where the weep holes are obstructed.

However, obstructing water pathways as much as possible like in configuration C8 is effective to reduce the amount of ingress water at higher pressure (1200 Pa trace). This configuration saw a reduction of ingress water by about 50% in comparison with the C1 configuration and 1200 Pa trace. Although this is an interesting result to take into consideration for future studies, where the implementation of the C9 configuration might not be possible, it must be noted that setting up the C8 configuration is much more time consuming and tedious than the C9 configuration.

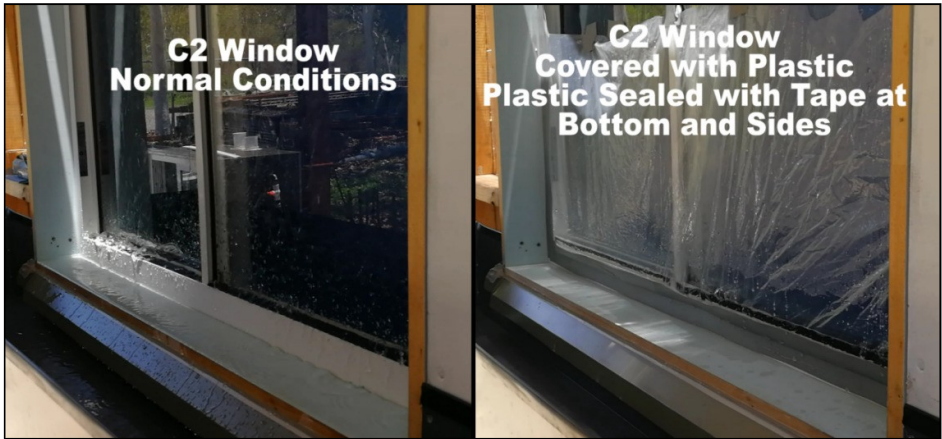
FIGURE 6. SIDE BY SIDE VIEWS OF CONFIGURATIONS C1 AND C9 DURING PRESSURE PEAK AT 1200 PA

The only configuration that produced an insignificant amount of water ingress was C9. Figure 6 shows configurations C1 and C9 side by side during a pressure peak of the 1200 Pa dynamic trace. We can observe a significant amount of water leaking out of the window on the left side, while the water is constrained by the plastic lining on the right side. The amount of water that leaked through the tape and plastic of configuration C9 was so small that no water was able to reach the water collecting tray.

However, a final configuration of using a plastic sheet placed over the bottom of the window with the sides taped securely to the window frame was effective in holding water that did enter through the window. It is recommended that further testing be performed on other styles of windows and details and new, more water resistant detailing of windows designs be developed.
