Severe Wind Hazard Preliminary Assessment
Tropical Cyclone Nathan, Far North QLD, Australia
March 20th, 2015

*Daniel J. Smith, Ph.D., David Henderson, Ph.D., Korah Packaral (James Cook University)
David B. Roueche, Austin Thompson, David O. Prevatt, Ph.D. (University of Florida)
Matthew Mason, Ph.D. (University of Queensland)

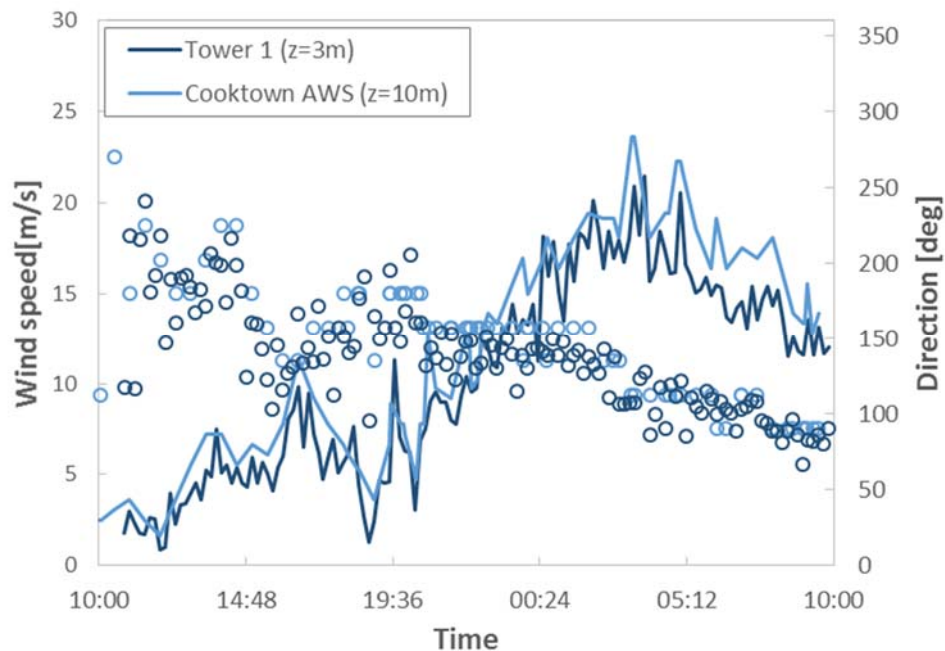
Figure 6. SWIRLnet anemometer Tower 1 (3 m height) and Cooktown Bureau of Meteorology (10 m height) automatic weather station maximum 3-second gust ($V_{3,600}$) wind speed (solid line) and direction (open dots) from 10 AM (AEST) Thursday 19 2015 to 10 AM Friday 19 2015 during TC Nathan. (Note: these weather stations were located within ~20 m of each other at the Cooktown Airport)

- Very similar direction recorded at both heights during maximum intensity of storm. This is expected.
- Predominantly the 10 m V3,600 is larger than at 3 m, but there are times when it is not. This is probably not unexpected simply due to the randomness of the wind. This may warrant further investigation to determine the possible cause of these lower level excursions.
- Ratio of max V3,600 between 3 m and 10 m ($V@3/V@10$) is 0.91. $M_{z,cat}$ (terrain category/height multiplier per AS/NZS 1170.2) for Terrain Category 2 at 3 m is also 0.91. (Note: AS/NZS 1170.2 uses $V_{0.2,600}$)

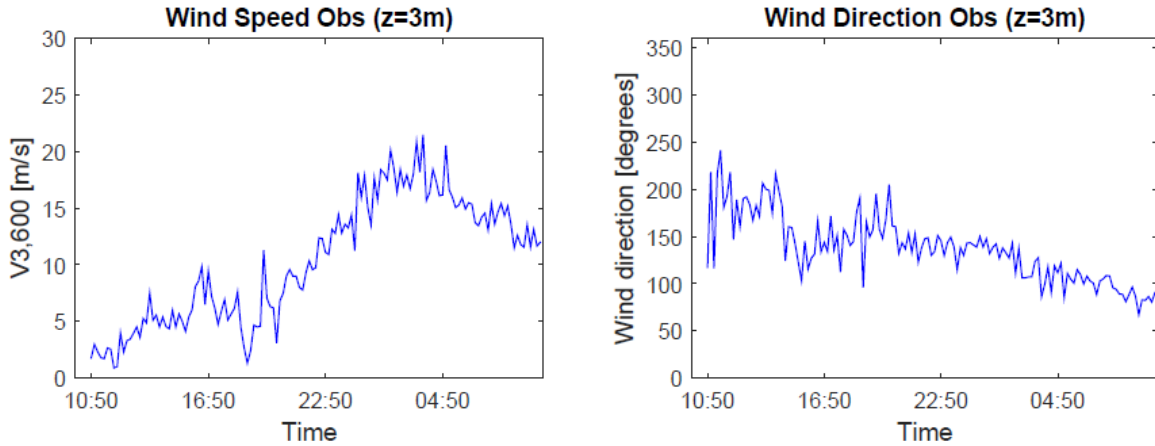
Figure 8. Wind speed (V3,600) and direction measurements from SWIRLnet Tower 1 (located at the Cooktown Airport) beginning 10 AM (AEST) Thursday 19 March and ending at 10 AM (AEST) Friday 20 March.

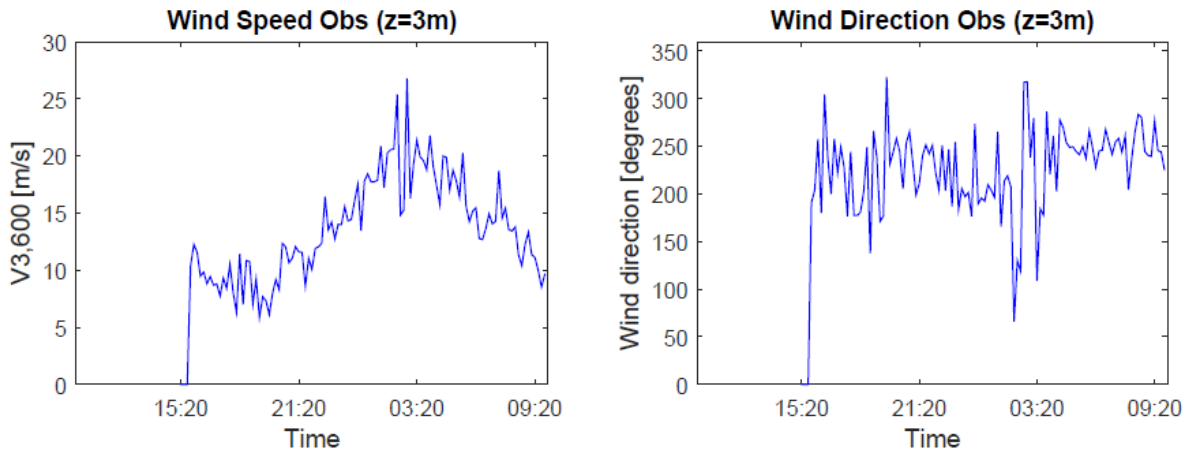
Figure 9. Wind speed (V3,600) and direction measurements from SWIRLnet Tower 2 (located near the Cooktown Community Center) beginning 10 AM (AEST) Thursday 19 March and ending at 10 AM (AEST) Friday 20 March.

- It is interesting that the maximum recorded velocity was observed at Tower 2 given that it is located in more suburban terrain than Towers 3 or 5, but the timing and direction of gust indicate that the maximum at this location has occurred more towards the backside of the storm (i.e. the storm has moved West of Cooktown) than either Towers 3 or 5.
- The wind speed trace for Tower 2 is interesting in that the maximum has occurred during quite a large excursion from what would be typical (i.e. it probably has a large gust factor). It will be interesting to see if there has been significant rainfall during this period and whether this could be a convective gust.

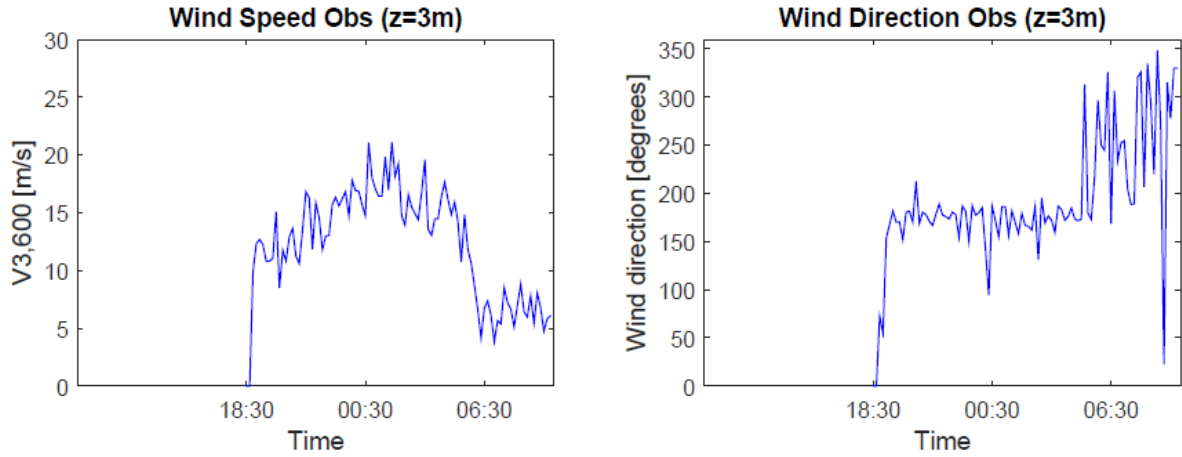
Figure 10. Wind speed (V3,600) and direction measurements from SWIRLnet Tower 3 (located on Charlotte Street near the Cooktown jetty) beginning 10 AM (AEST) Thursday 19 March and ending at 10 AM (AEST) Friday 20 March.

- Tower 3 gusts may have been affected by the hill to its Southeast. This is roughly where the direction the maximum gust has come from. The wind direction is pretty consistently around SE to S until the wind speed rapidly dies off and the directions begin to fluctuate. This may be caused by the influence of the hill.
- Tower 4, recording the lowest maximum gust, is in line with what would be expected as the storm moves on land and both the storm itself decays and friction possibly starts slowing winds down more than in Cooktown itself.
- Measured atmospheric pressure was similar for all towers. Tower 1 and the Cooktown AWS also match well.
- Note that the AIMS Lizard Island anemometer was offline. This station would have seen the eye passage just prior to landfall and measured the highest gust during TC ITA.

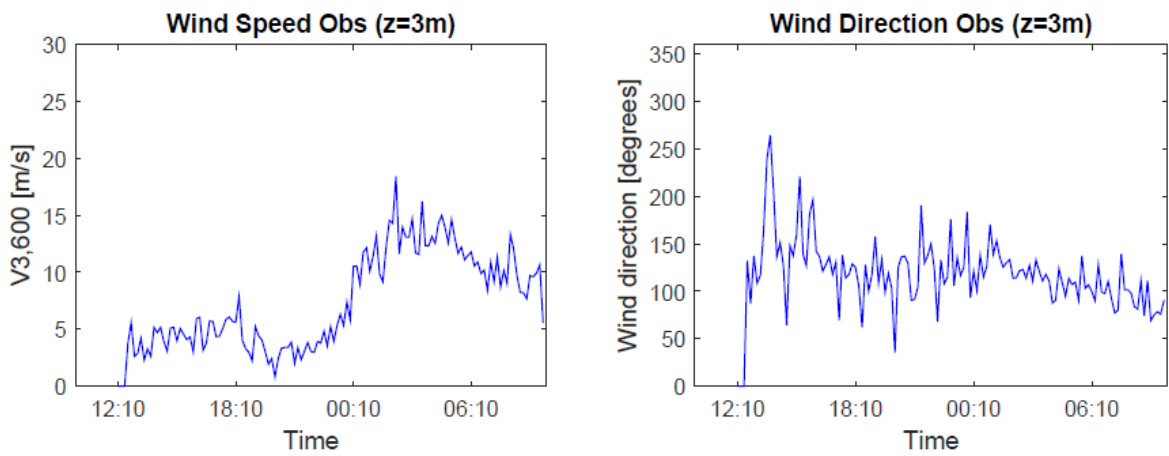
Figure 11. Wind speed (V3,600) and direction measurements from SWIRLnet Tower 4 (located West of Cooktown on private land) beginning 10 AM (AEST) Thursday 19 March and ending at 10 AM (AEST) Friday 20 March.

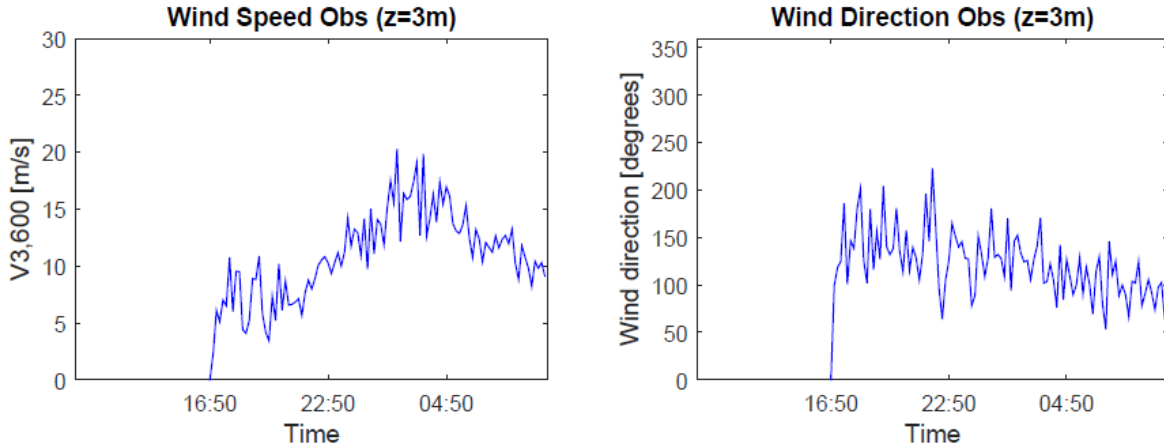
Figure 12. Wind speed (V3,600) and direction measurements from SWIRLnet Tower 5 (located adjacent to Cooktown racetrack) beginning 10 AM (AEST) Thursday 19 March and ending at 10 AM (AEST) Friday 20 March.

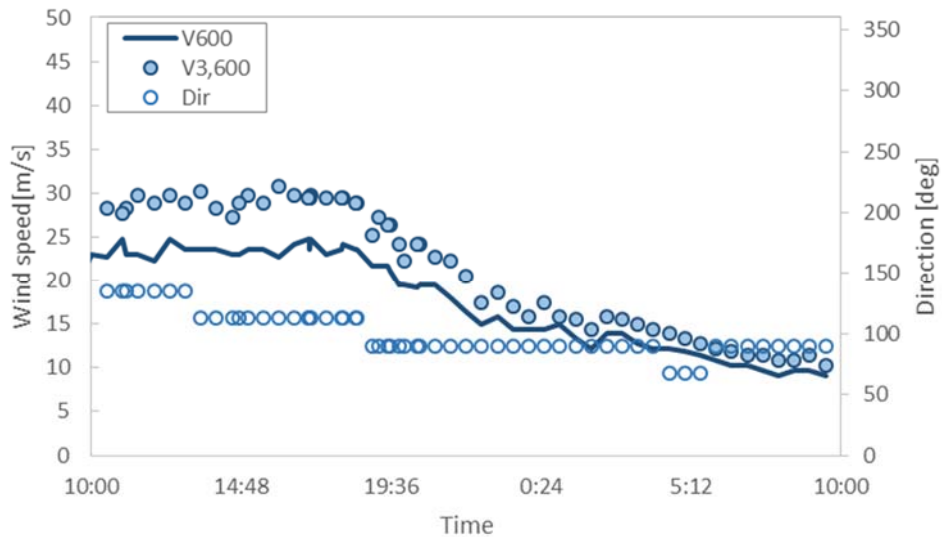
Figure 13. Wind speed and direction measurements from the Bougainville Reef automatic weather station beginning 10 AM (AEST) Thursday 19 March and ending at 10 AM (AEST) Friday 20 March.

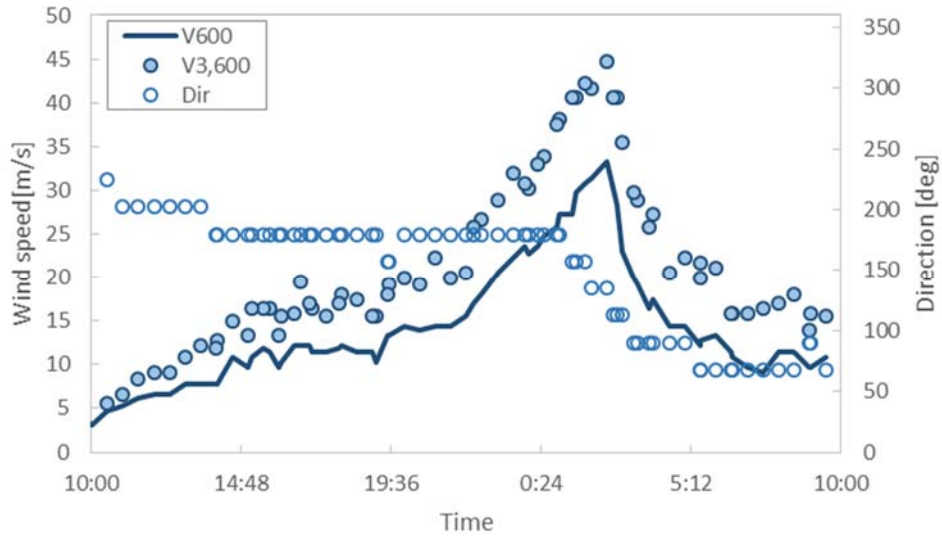
Figure 14. Wind speed and direction measurements from the Cape Flattery automatic weather station beginning 10 AM (AEST) Thursday 19 March and ending at 10 AM (AEST) Friday 20 March.

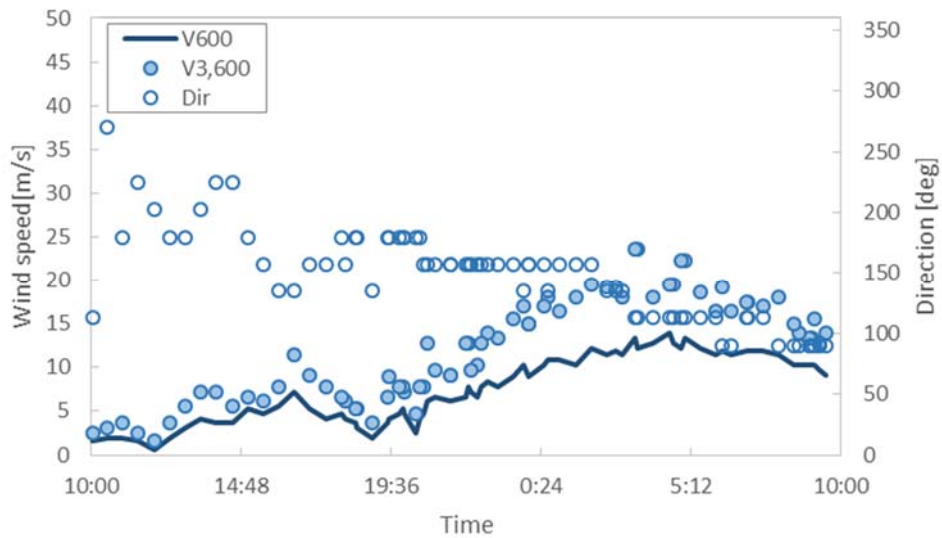
Figure 15. Wind speed and direction measurements from the Cooktown automatic weather station beginning 10 AM (AEST) Thursday 19 March and ending at 10 AM (AEST) Friday 20 March.

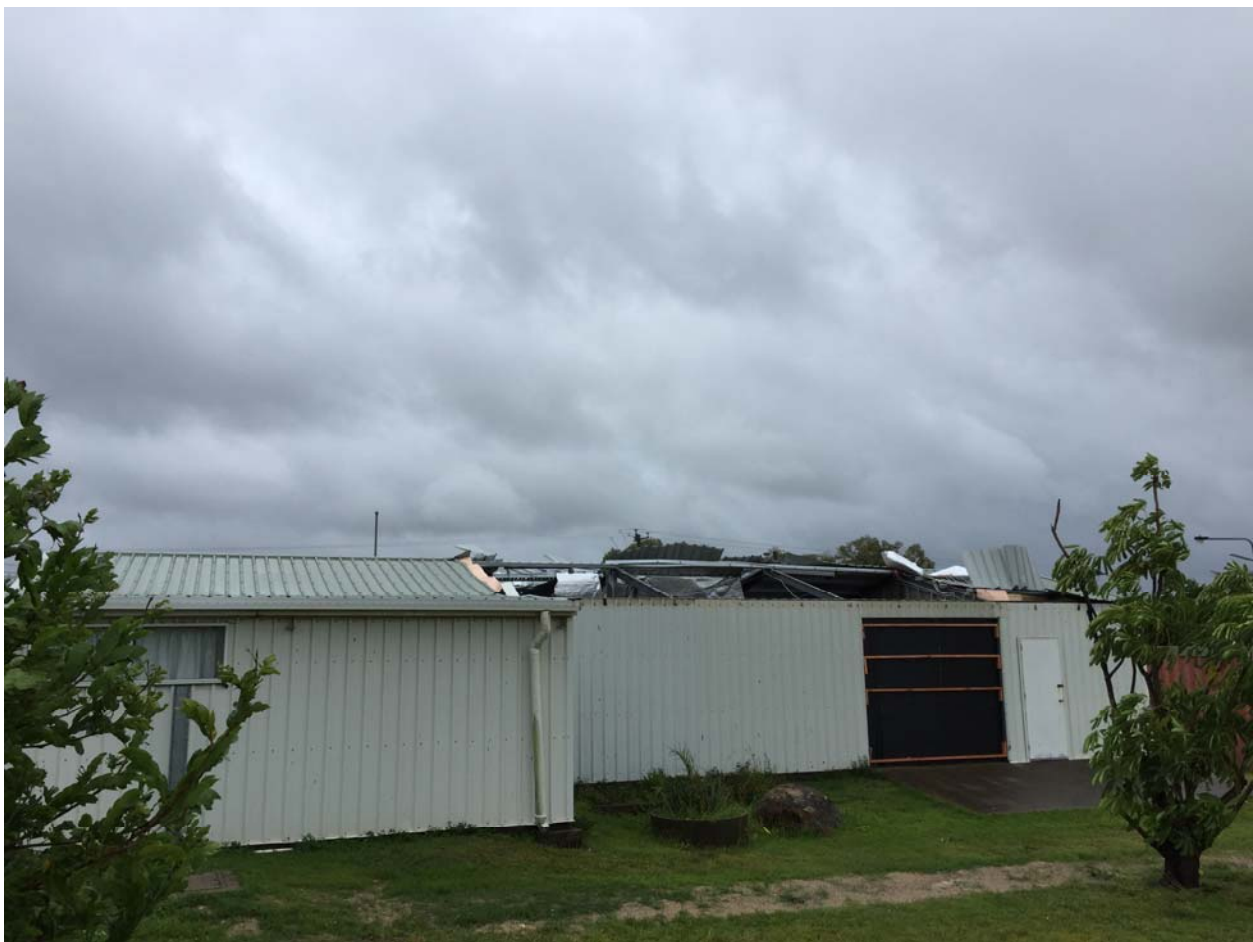
The only observed severely damaged from wind loads building was a work/storage shed that failed. Wind speeds measured in the area were well below the anticipated design wind speed for this location. This building also experienced a roofing failure in Cyclone Ita and there was evidence of re-roofing. Initial indications suggest that aspects of the current roofing system may not have conformed to manufacturer's recommendations.

Figure 16. Wind damage to metal roof cladding and battens in Cooktown (Note: roller door was damaged during TC Nathan approach to coast in previous week)

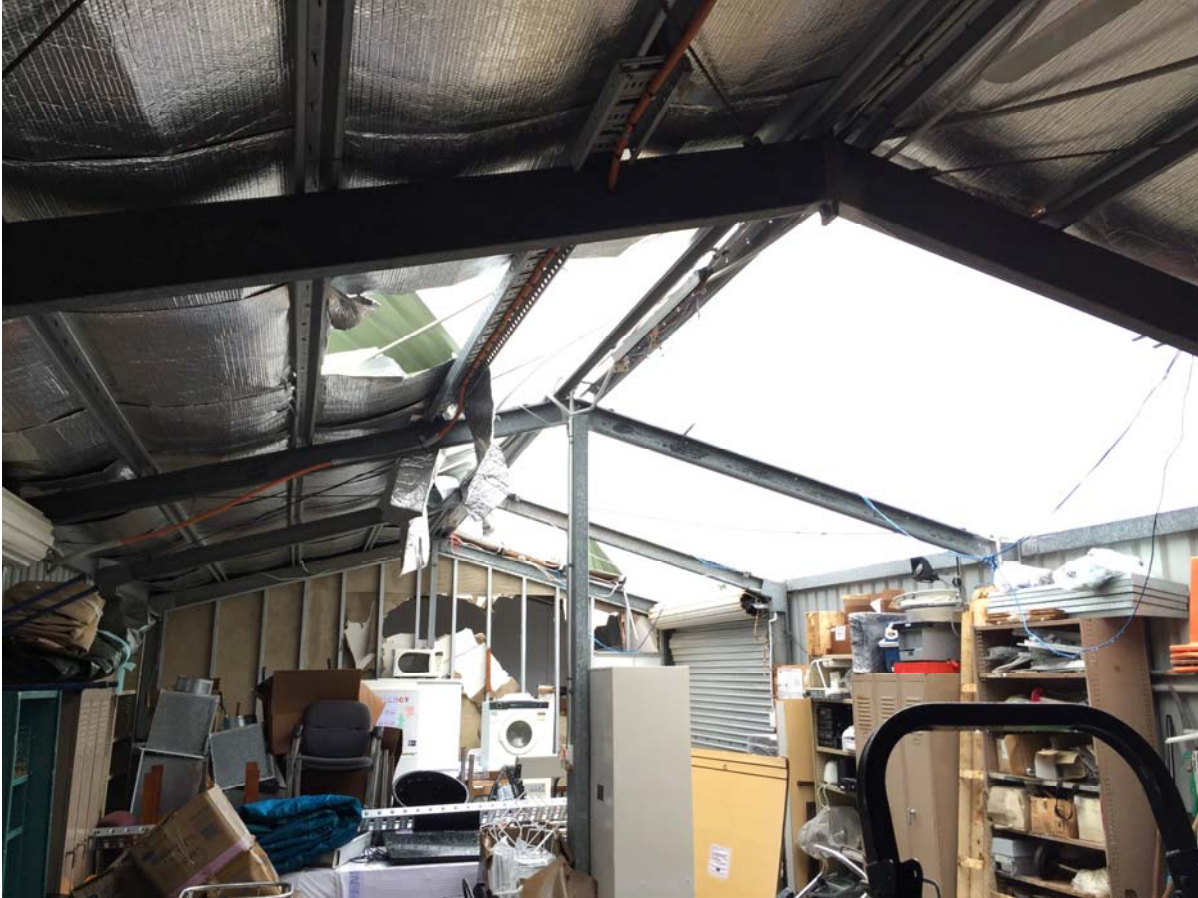
Figure 17. Interior view of metal roof cladding damage to portal structure (see Figure 16)

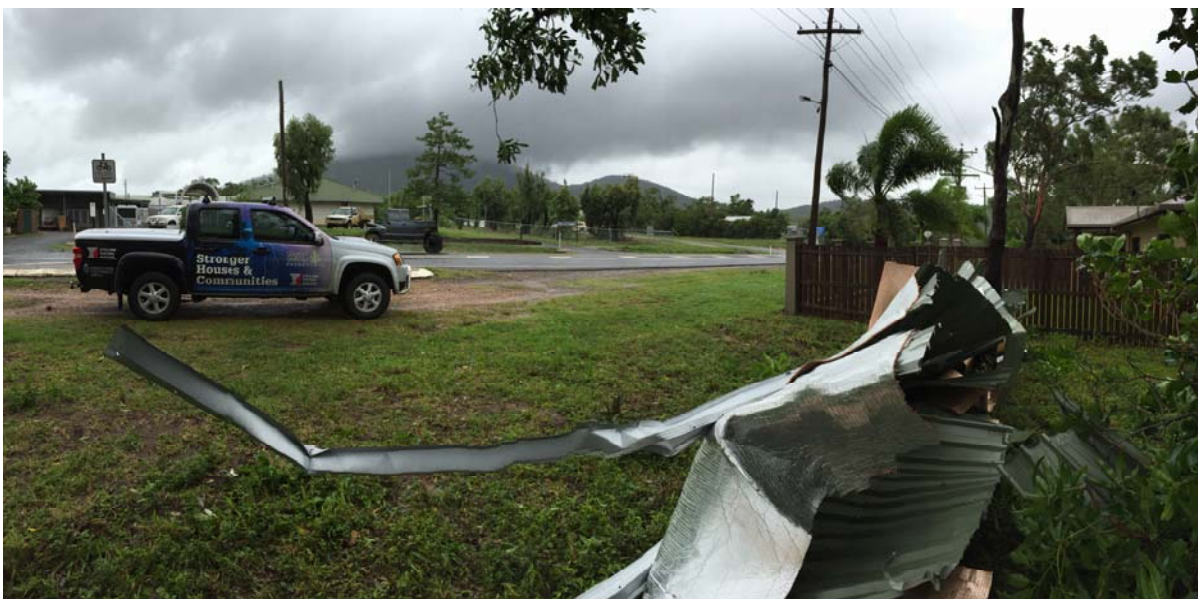
Figure 18. Metal roof cladding removed from wind uplift and blown across street (Note: cladding from the structure in the previous figure)
