FINAL REPORT ON PUSHOVER ANALYSIS OF CLASSES OF URM BUILDINGS TO CHARACTERISE DRIFT RATIOS FOR DIFFERENT DAMAGE LEVELS

Hossein Derakhshan, University of Adelaide, SA
Michael Griffith, University of Adelaide, SA

December 2018

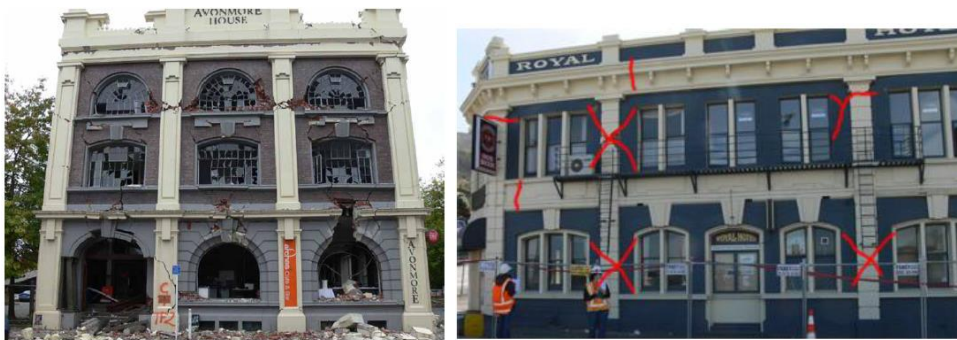
Figure 3: AH and RH building damage

Similar to the other study (Cattari et al. 2015), this study did not identify wall or storey drifts. The reported drift ratios are building drift ratios and can translate to trifold storey drifts if damage is concentrated on a certain storey. Although this could not be verified using building damage photos (Figure 3), the photos do suggest some uneven

distribution of the damage with building height, e.g. see visible shear damage in all of the 4 top-storey piers in AH building vs. shear damage to only one pier in ground storey and no pier in the first storey.

Although both buildings were demolished, the damage level in the two-storey RH building was significantly less extensive than that in the 3-storey AH building. Based on the reported damage patterns, one can assess the building states after the earthquakes to be Damage Control and Collapse Prevention limits, respectively for RH and AH buildings. The DC drift limit of ~ 0.08% (average of 0.07% and 0.09% from two pushover analyses) is comparable to that for building LH (0.06%), with both drift ratios being considerably smaller than ASCE suggested value of between 0.3% and 0.6%. Similarly, the CP drift limit of between 0.14% and 0.33% appear to be significantly smaller than the ASCE suggested value of upwards of 1%.

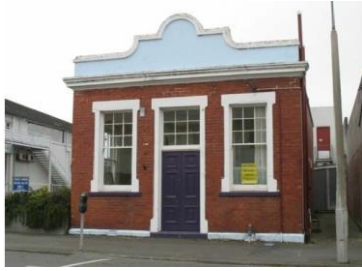
Figure 4: Building 1

(a) Example building (Russle 2010)

(b) Building plan

(c) Front elevation

(d) Front wall model in Tremuri

Four building models (Figure 4 to Figure 7) were created in TREMURI and pushover analyses were conducted. The buildings are symmetrical in Direction 2, for which analyses were performed. TREMURI is capable of modelling failure mechanism of in-plane loaded URM walls but the stiffness of the out-of-plane loaded walls are ignored. The out-of-plane wall mass is directly applied to in-plane loaded walls. Another limitation is that a standard analysis does not allow for proper modelling of in-plane diaphragm displacements. However, an approach was suggested by Nakamura et al. (2017) to overcome this limitation by still using the same software.

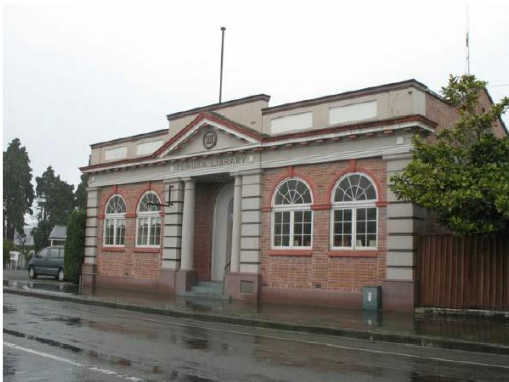
Figure 5: Building 2 (Russle 2010)

(a) Example building

(b) Building plan

(c) Front elevation

(d) Front wall model in Tremuri

(e) Side wall elevation

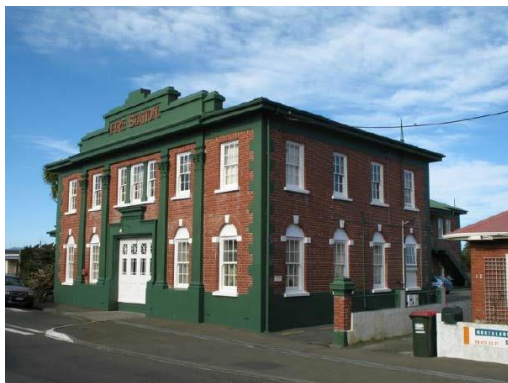
Figure 6: Building 3

(a) Example building (Russle 2010)

(b) Building plan

(c) Front and interior wall elevation

(d) Front and interior wall model in Tremuri

(e) Side wall elevation

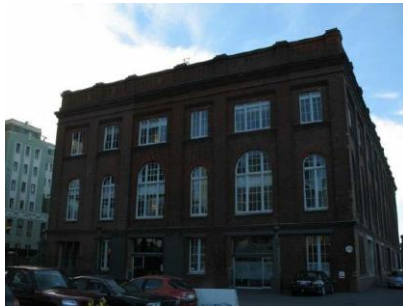
Figure 7: Building 4

(a) Example building (Russle 2010)

(b) Building plan

(c) Front and interior wall elevation

(d) Front and interior wall model in Tremuri

(e) Side wall elevation

(f) Side wall model in Tremuri
