SIMULATED WIND LOAD STRENGTH TESTING OF SOFFITS

Alexis Leblais, David Henderson
Cyclone Testing Station, James Cook University, QLD

Citation: Leblais, A. & Henderson, D. (2018) Simulated wind load testing of soffits. Melbourne: Bushfire and Natural Hazards CRC.

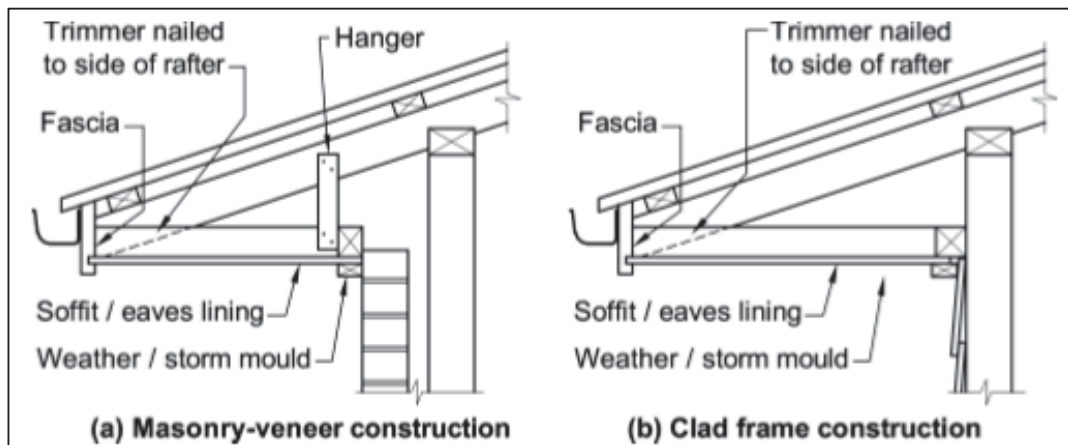
Figure 1: Eave Cross-Section, Source: Australian Building Codes Board, 2016

Figure 1 shows cross section views of typical boxed eave constructions.

Note: As seen on Figure 1, gutters are often fastened to the fascia board. Wind and water can create additional stress to the fascia board through the gutter. Therefore, the failure observed in Test 3 would potentially occur earlier in a 'real world' installation since the test was conducted without gutter.

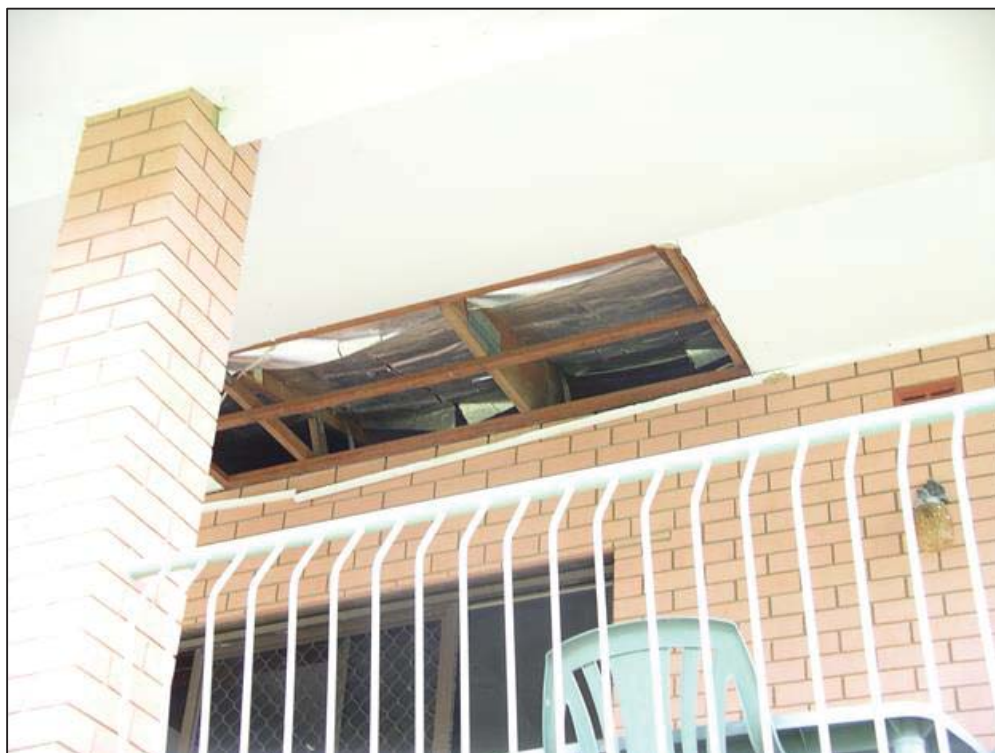
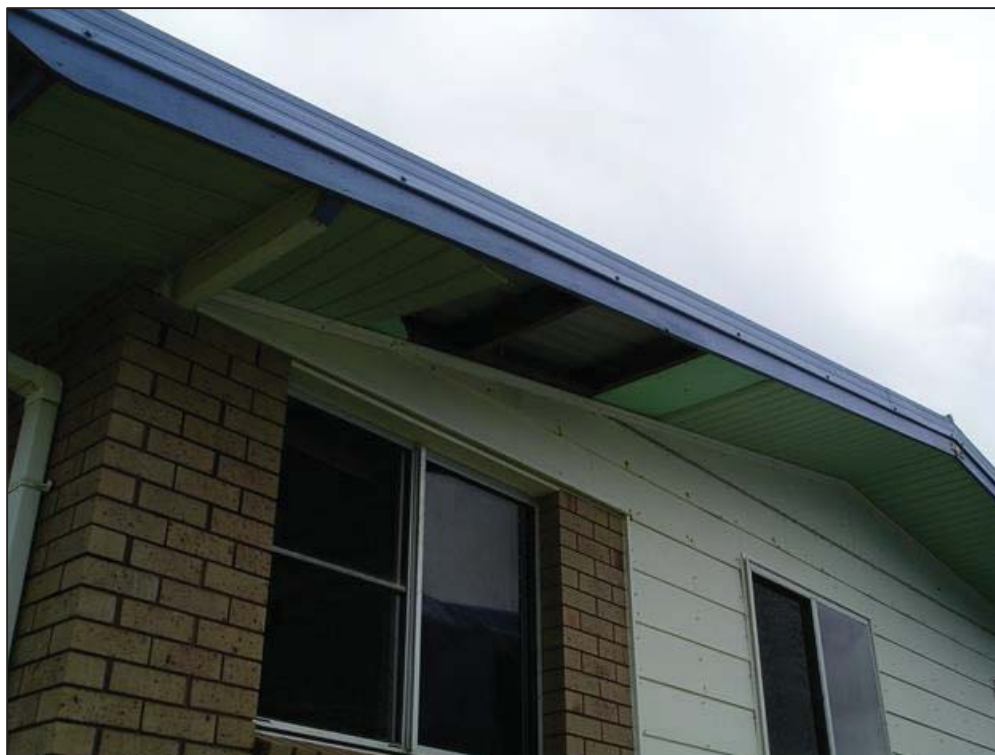
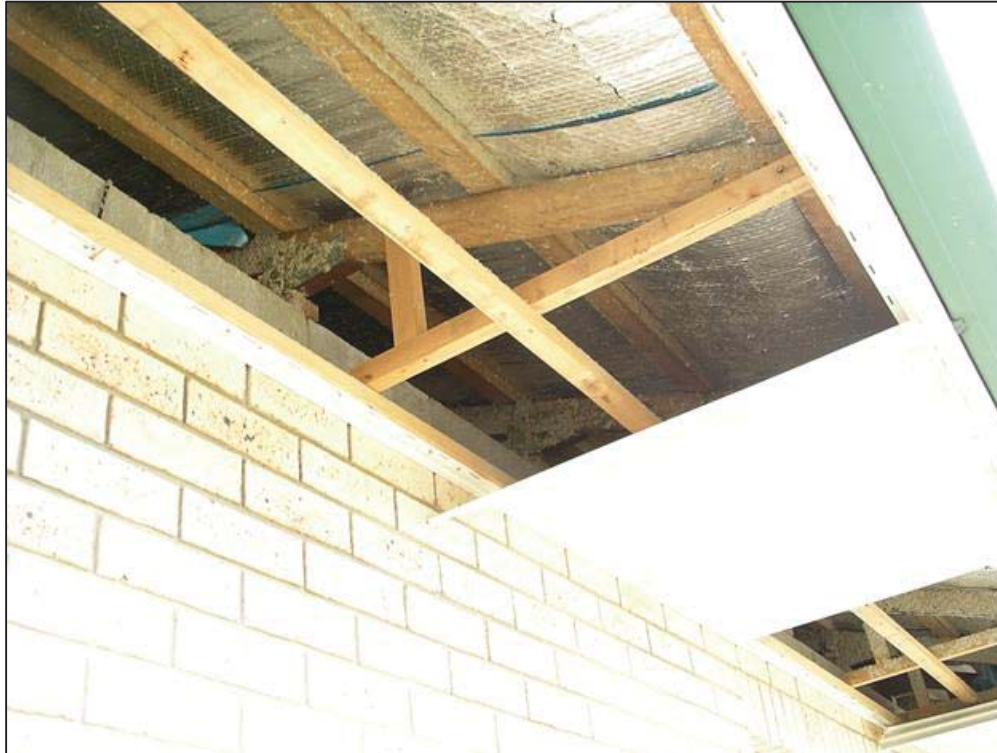
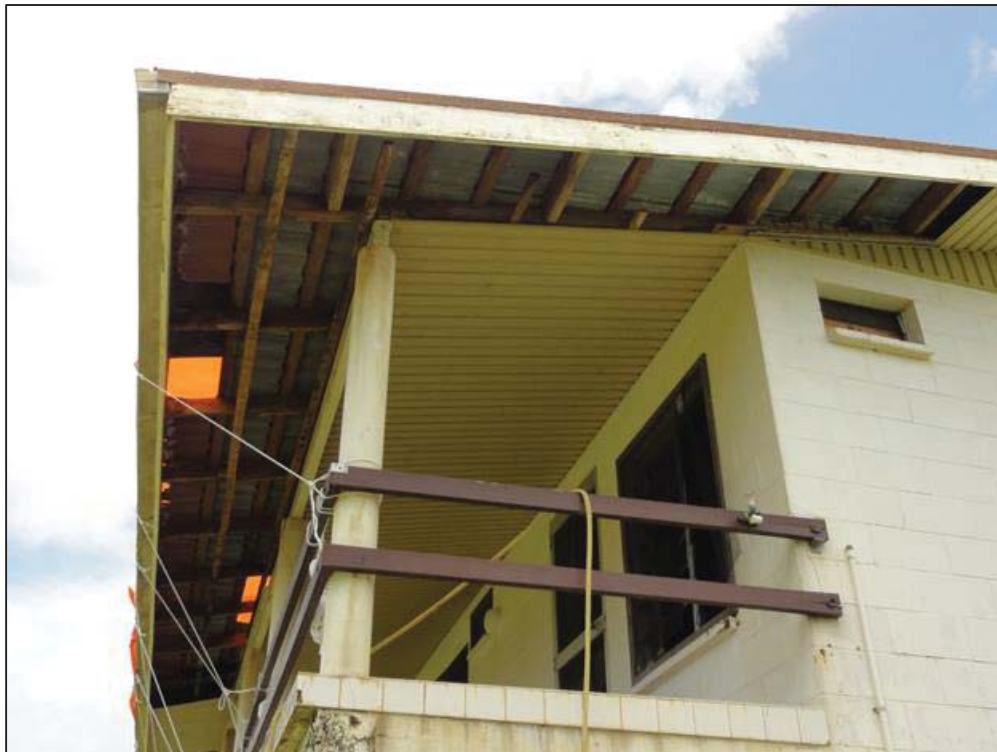
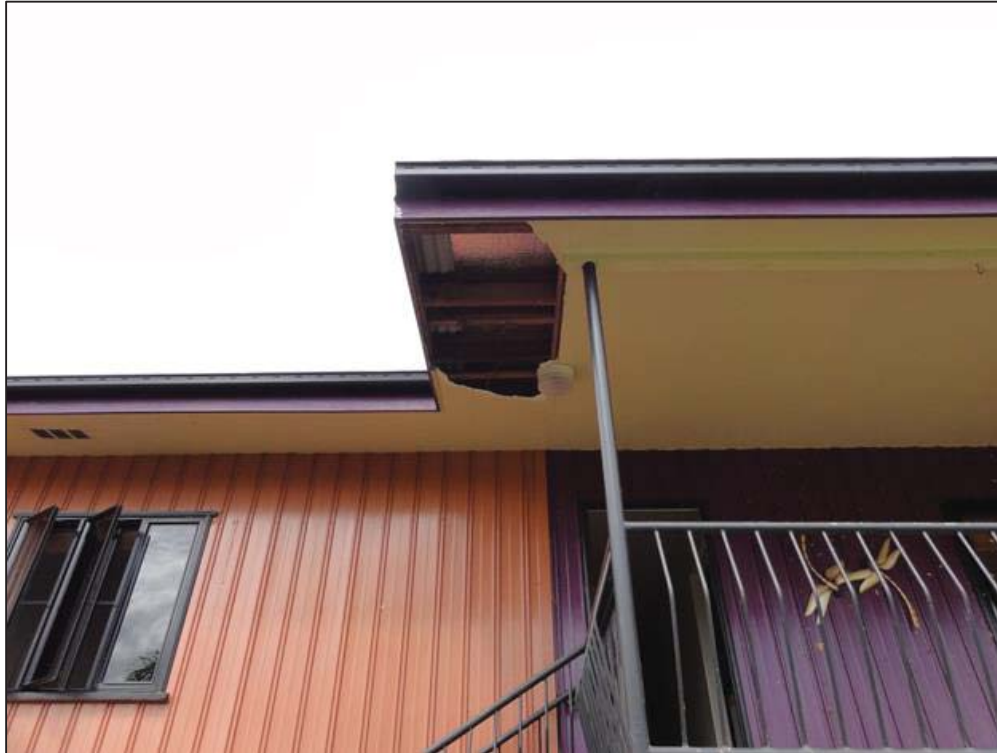
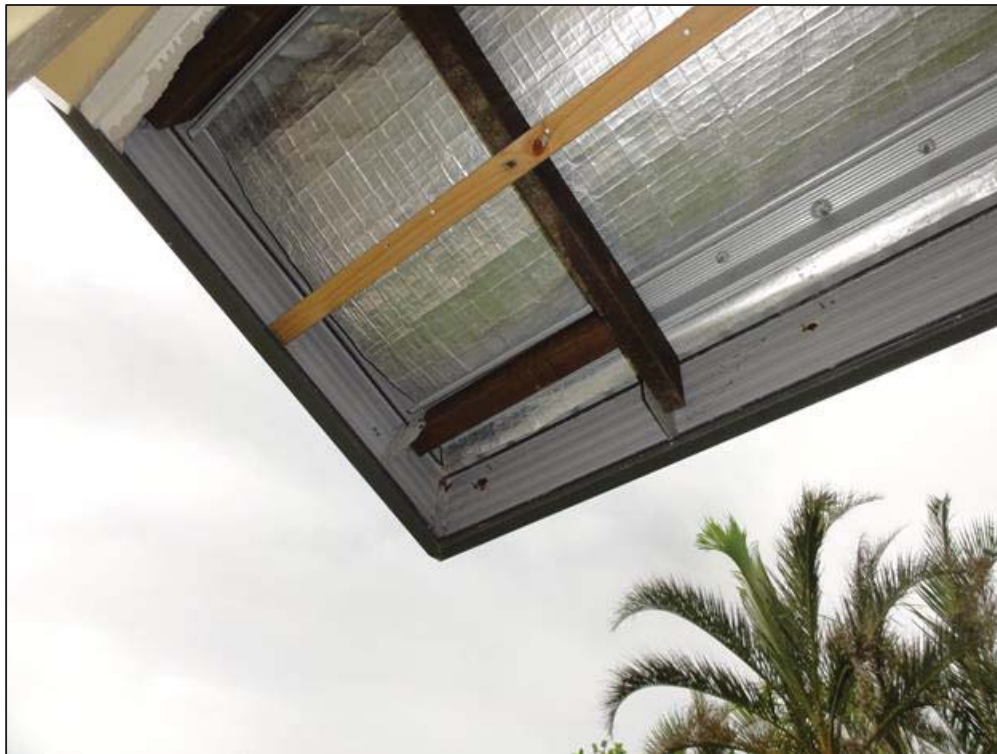
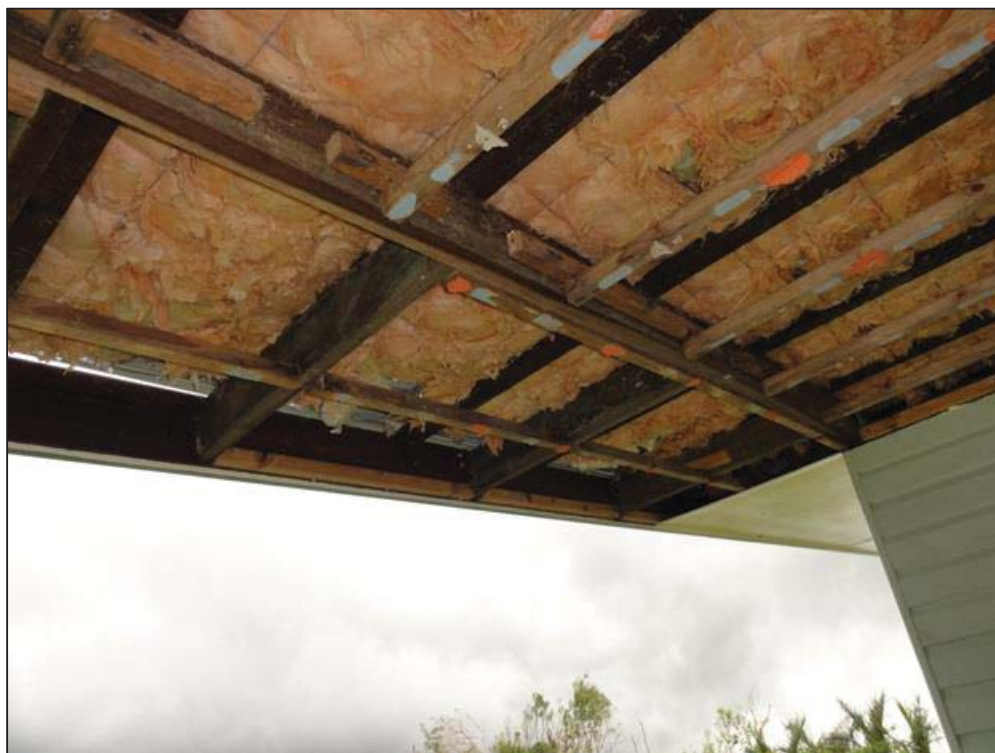
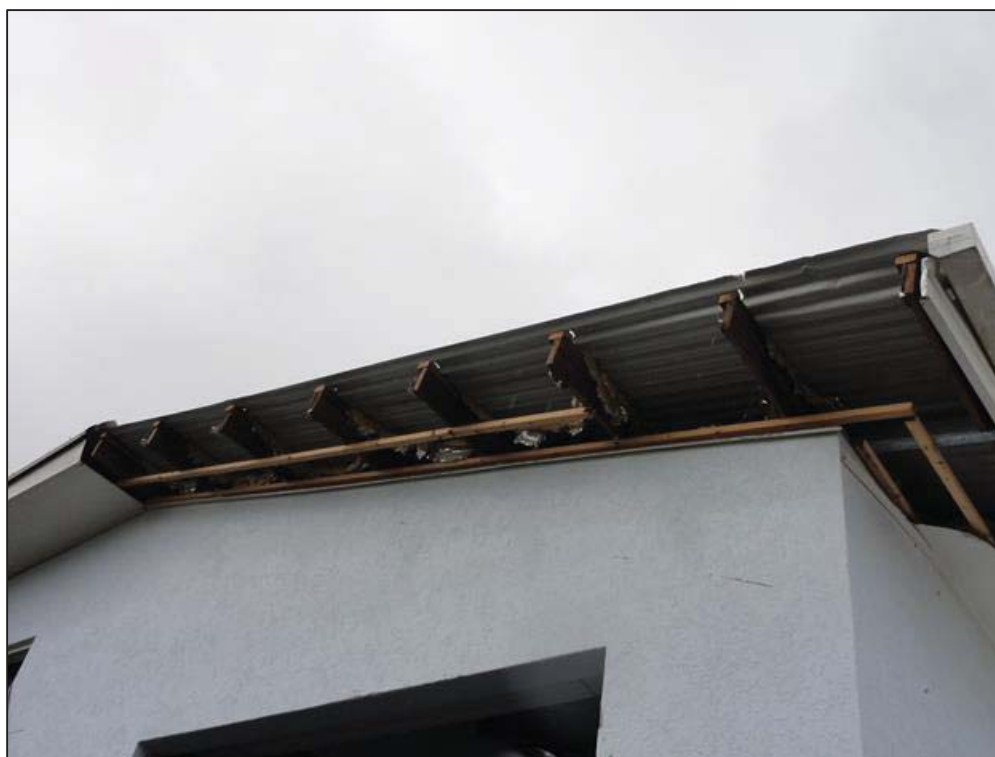
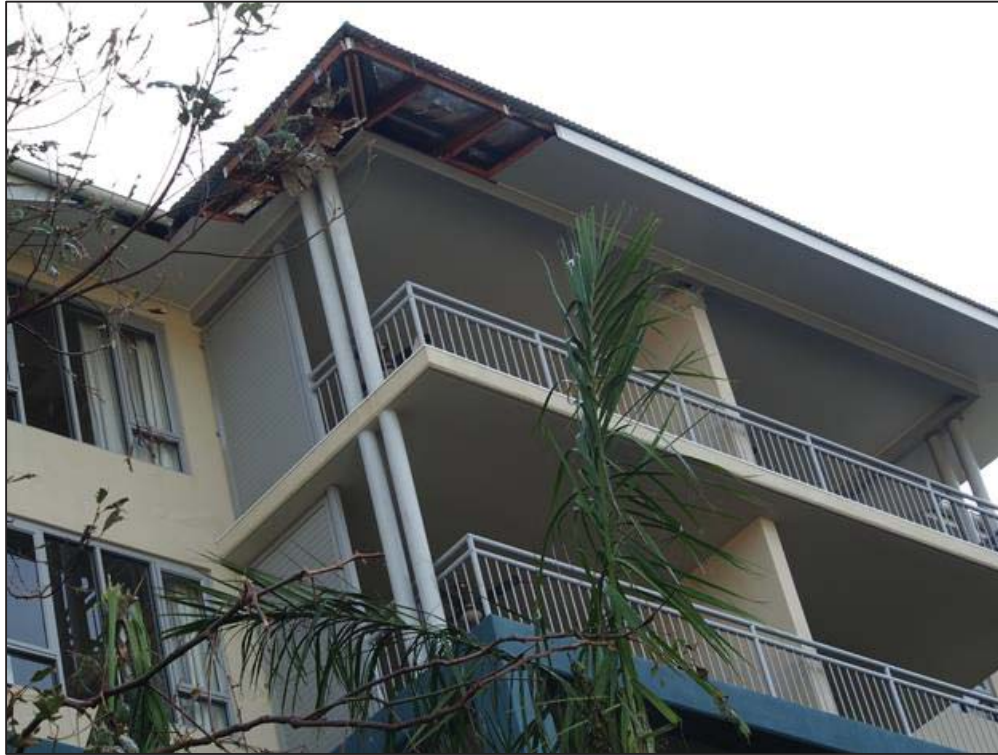
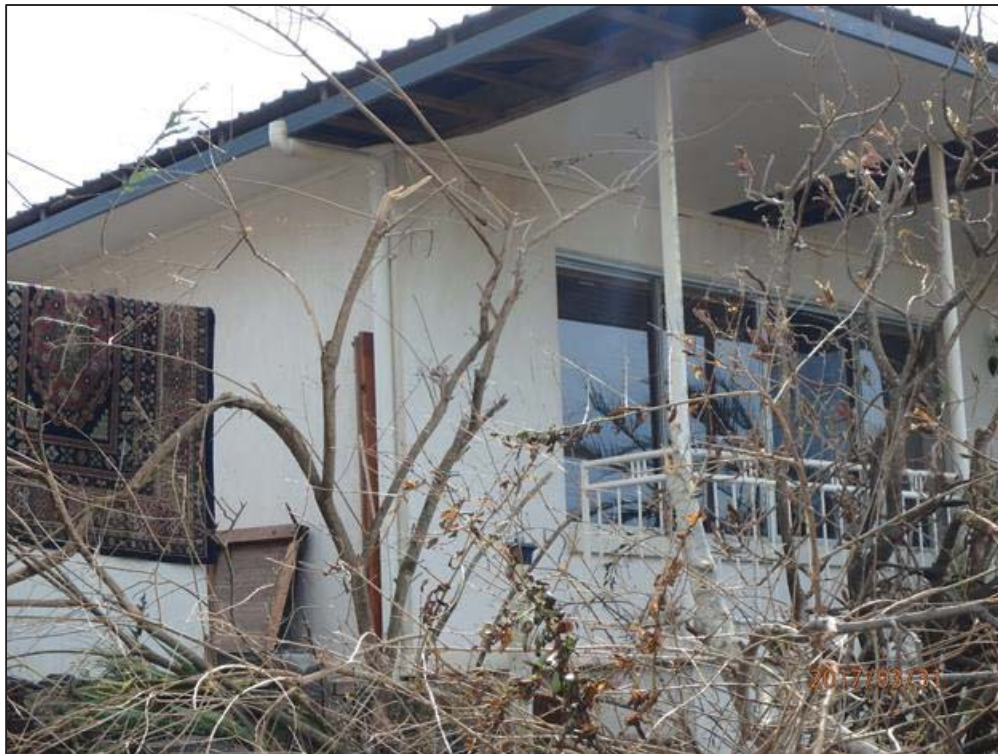
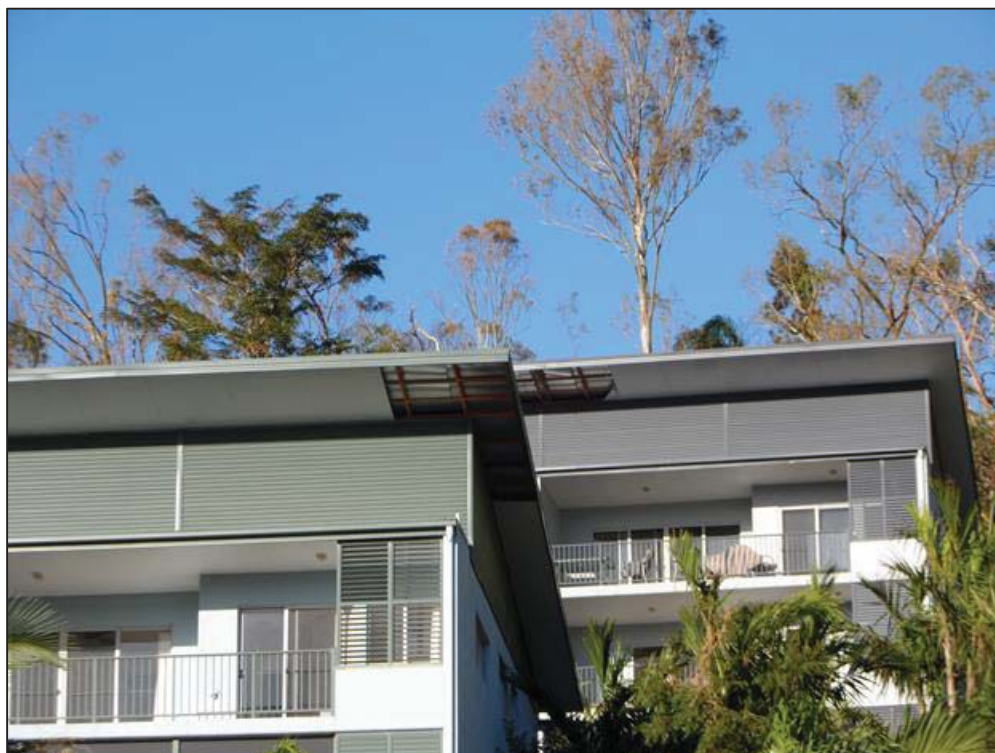
Figure 2: Failure of Soffit, Cyclone Larry, 2006

Figure 3: Failure of Soffit, Cyclone Larry, 2006

Figure 4: Failure of Soffit, Cyclone Larry, 2006

Figure 5: Failure of Soffit, Cyclone Yasi, 2011

Figure 6: Failure of Soffit, Cyclone Yasi, 2011

Figure 7: Failure of Soffit, Cyclone Yasi, 2011

Figure 8: Failure of Soffit, Cyclone Yasi, 2011

Figure 9: Failure of Soffit, Cyclone Yasi, 2011

Figure 10: Failure of Soffit, Cyclone Debbie, 2017

Figure 11: Failure of Soffit, Cyclone Debbie, 2017

Figure 12: Failure of Soffit, Cyclone Debbie, 2017

Damage investigations following cyclonic events have shown failure of soffit lining, including on contemporary buildings, as illustrated in Figure 2 to Figure 12. Failure of soffit lining can lead to further major damage to the building by allowing wind driven rain to enter the ceiling attic, causing the ceilings to collapse and further water damage. In addition to water damage to contents and internals, soffit lining failure creates increased stress to the building envelope due to the increased internal pressure caused by wind entering the roof cavity through the eaves, which can lead to further failure such as roof failure.

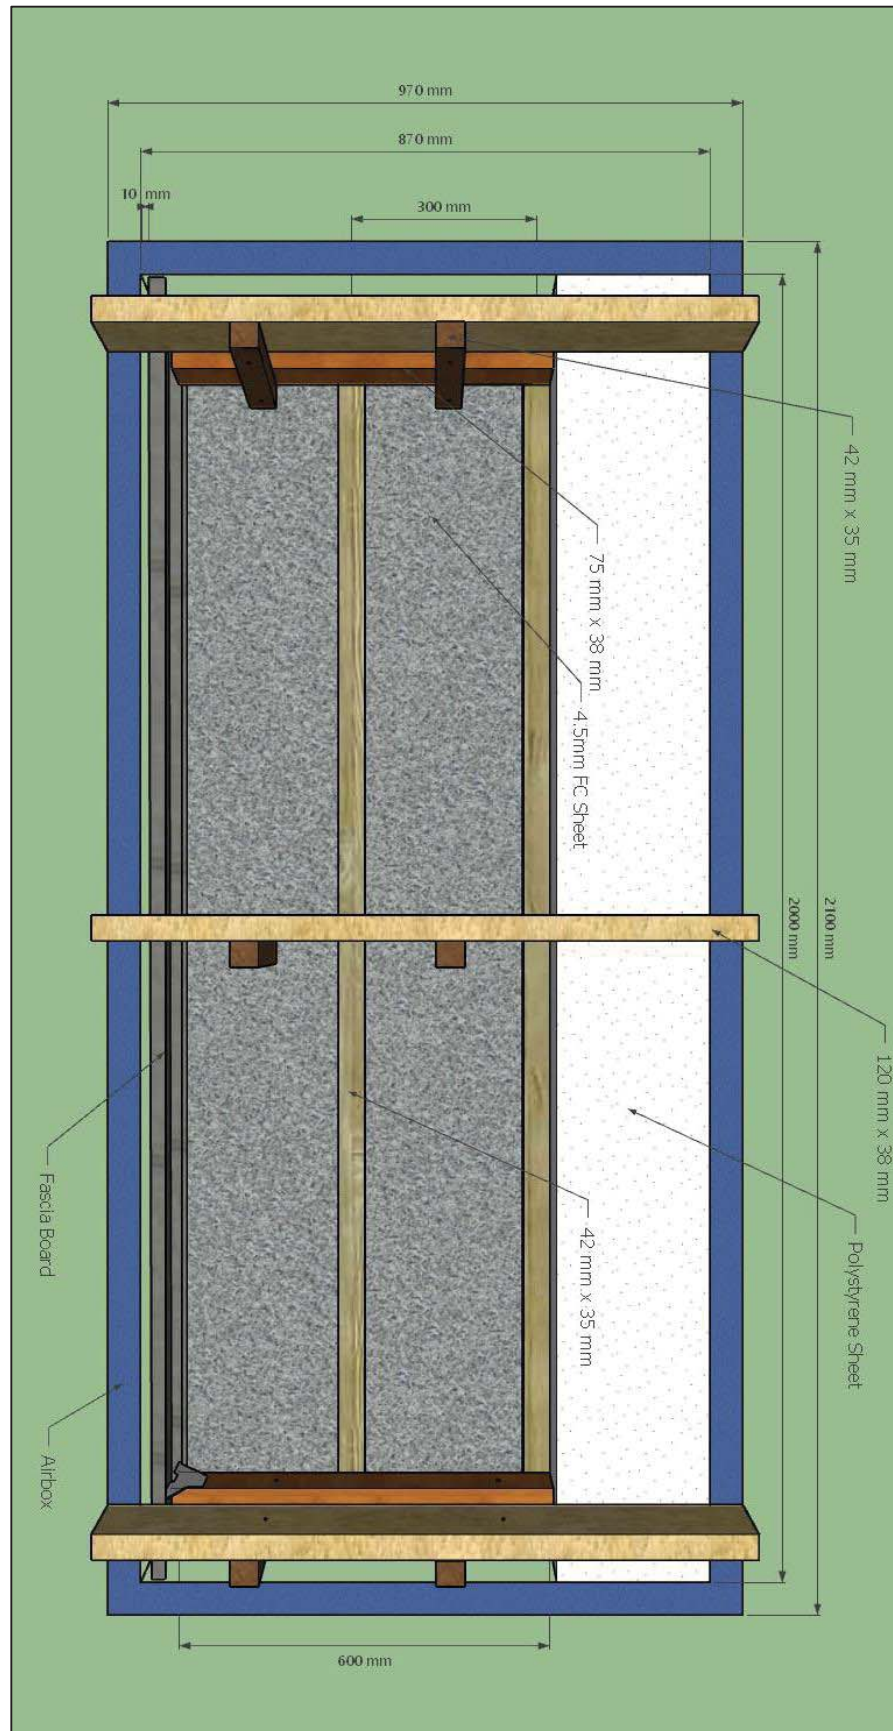
Figure 13: Test Specimen Set Up in Airbox (Top View) – Drawing by Lalin Chhoeuk

Figure 13 and Figure 14 show the eave test specimen set up in the airbox testing rig. In order to account for potential failure mode of the fascia board, a 10 mm gap was left to allow for its rotation during testing. A polystyrene sheet was placed inside the airbox, both to prevent air leakage and to permit structural movement. Prior to commencement of the experiment, builders tape was used to seal the gaps between the airbox and the specimen to ensure airtightness throughout the testing phase.

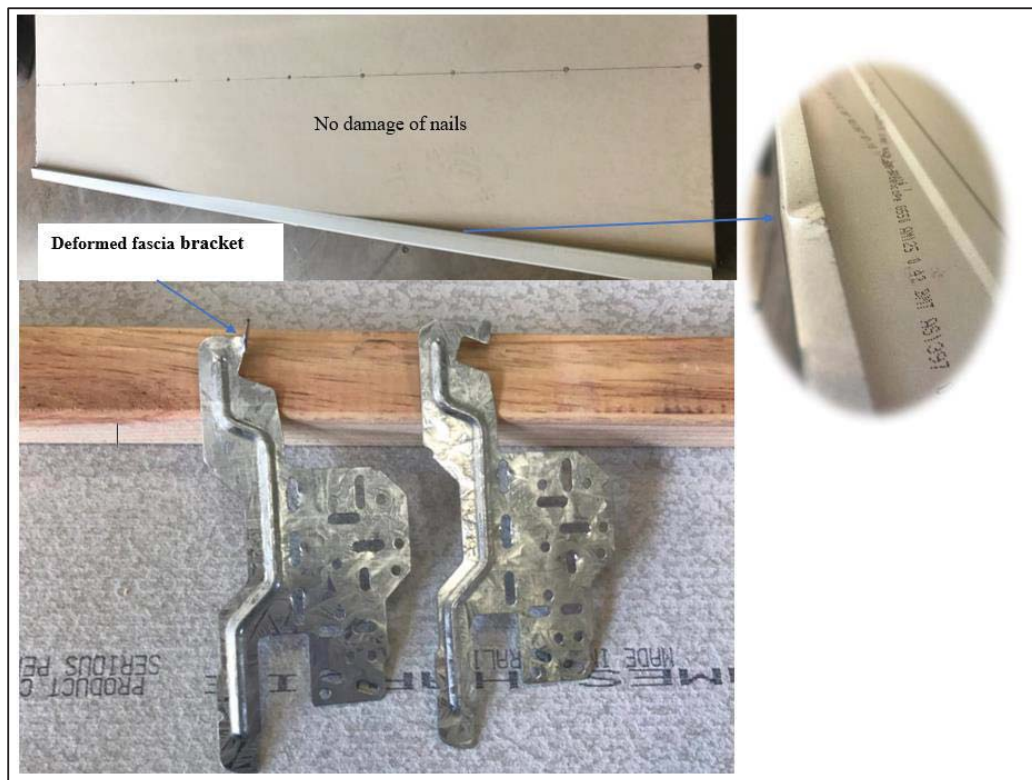
For Test 3, failure mode of fibre-cement nail connection was not at the nails. One of the fascia brackets deformed but the clouts showed no sign of deformation. The failure of the fascia bracket can be explained as the clouts had adequate capacity to withstand the suction pressure at which the connection failed. Failure of the bracket led to deformation of fascia as shown in Figure 16.

Figure 16: Failure mode for Test 3 – Photograph by Lalin Chhoeuk
