# TOWNSVILLE 2019 FLOOD: INSIGHTS FROM THE FIELD

Andrew Gissing, James O'Brien, Salomé Hussein, Jacob Evans and Thomas Mortlock.

Risk Frontiers & Bushfire and Natural Hazards CRC

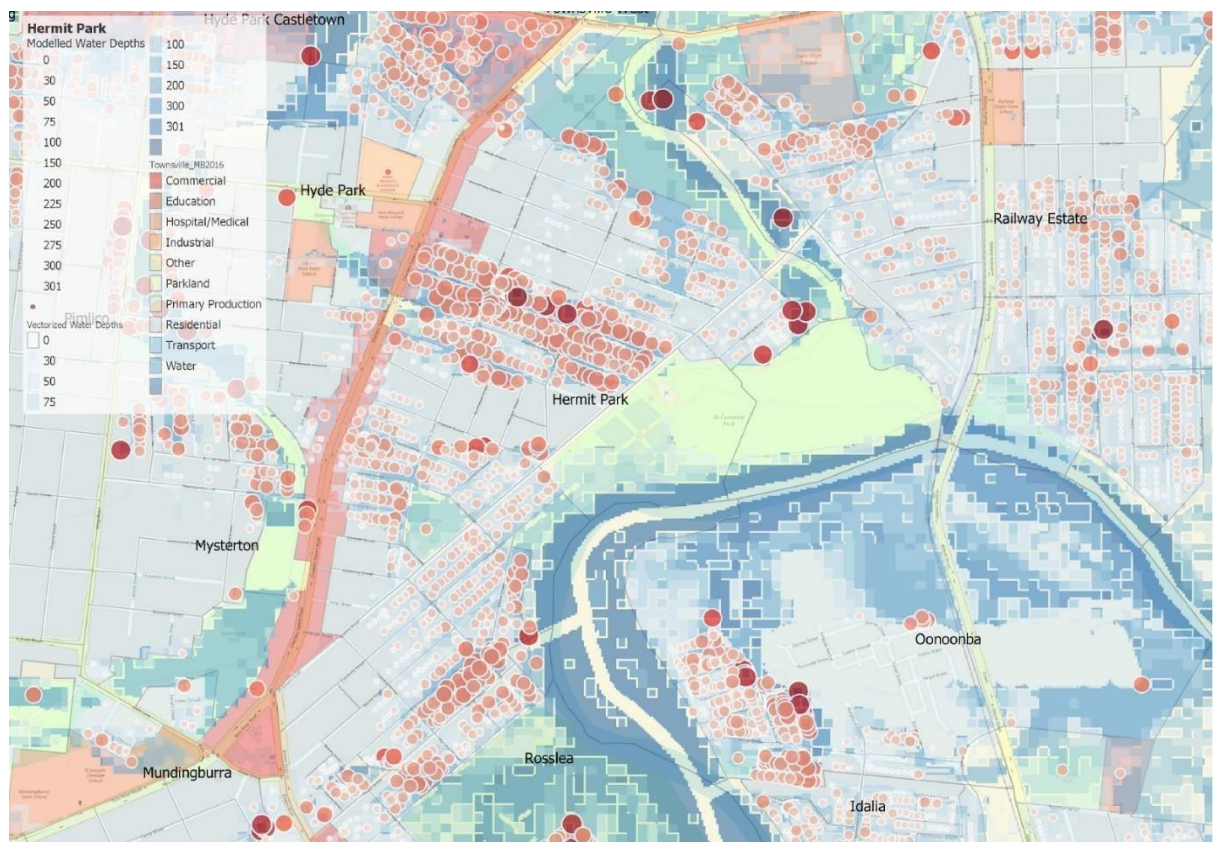
**Figure 1: Sample Townsville map showing modelled flood extents and depths from Townsville City Council and inferred property depths**

Before arriving in Townsville, Risk Frontiers acquired the Townsville city maps which indicated the likely flooding from a 2000 m<sup>3</sup>/s release from the Ross River dam and georeferenced that image onto the city. This was done by using the coordinates published on the frame of the map (the graticule) and linking that to points of reference on the ground. [See figure 1?]

Image classification was then used to extract the colours from the map which corresponded to the different depths of potential inundation and a GIS layer corresponding to those depths was created. Depths were then determined for every G-NAF (Geocoded National Address File) point which fell within the inundation layer and were mapped accordingly. OpenStreetMap data was also incorporated for a reference to the streets and other points of interest in the city, and the landuse data from ABS meshblocks (the smallest statistical area containing around 20 households) was used to quickly separate residential from commercial and industrial building types.

The purpose of this map was to identify the most affected areas to prioritise the investigation and to assist in validating the modelled depths (which seemed to be very accurate, with minor exceptions usually being lower elevations in parkland or likely due to very minor shifts (e.g. <1m) in registration of the image prior to the analysis being performed).

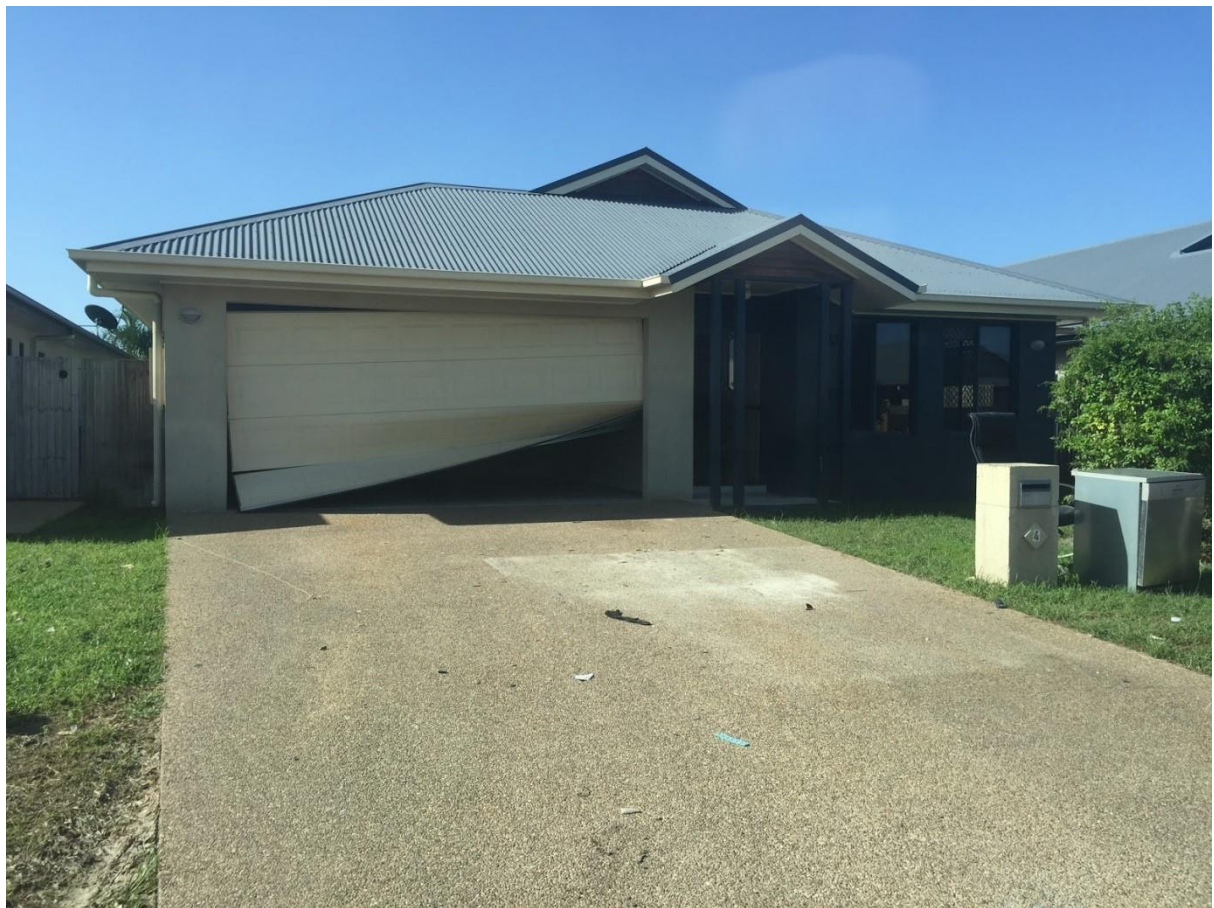
*Figure 2: Roller doors in Eastern Idalia potentially damaged by an electrical short. High flow flood waters were ruled out as a cause based on lack of debris and vegetation.*

While significant flood velocities were not reported in Idalia, some structural damage was observed to a few roller doors which were electrically operated. It was surmised that there may have been an electrical short causing the motor to attempt to open the door while it was locked in place, twisting and bending the door upwards within its frame. Figure 2 shows an example of this. There was also one occurrence of a tree having fallen on a building, seen in figure 3.

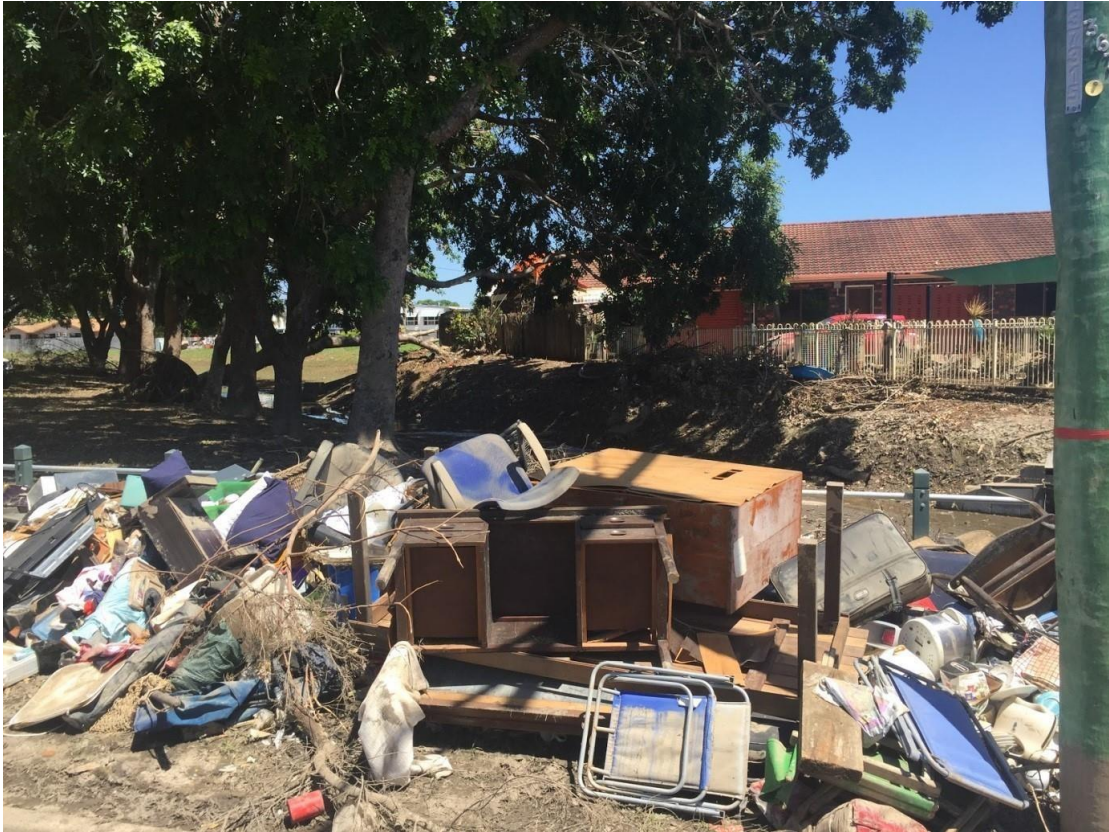
*Figure 3: Debris and furniture in the foreground. In the background, a tree has fallen on the roof of what appears to be a childcare centre.*

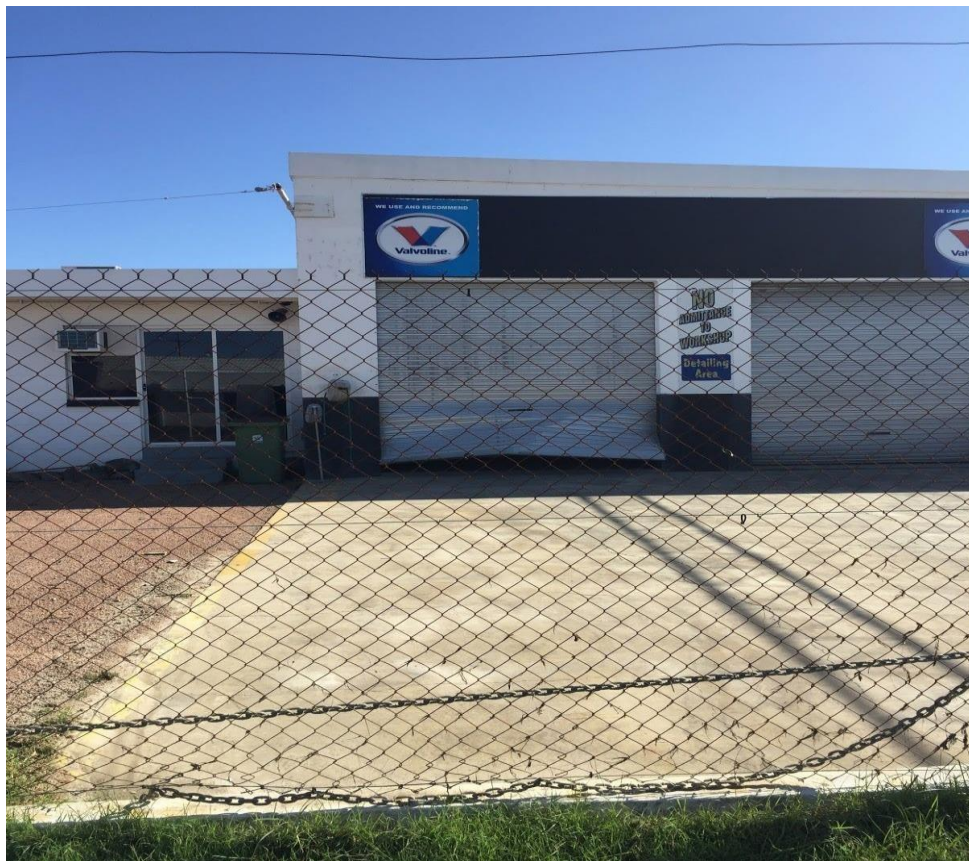
*Figure 4 – Showing damage to a commercial property's roller doors in Hyde Park.*
