SIMULATED WIND LOAD STRENGTH TESTING OF ENTRANCE DOORS

Alexis Leblais, David Henderson
Cyclone Testing Station, James Cook University, QLD

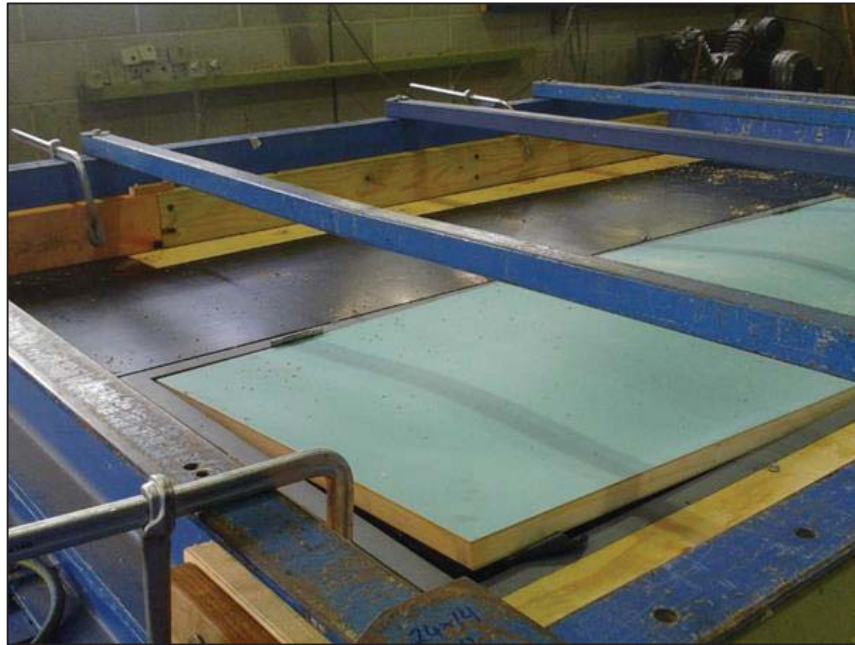
35mm hollow core door with budget lock.

Pressure held 1.93 kPa

Figure 6: Trial SS2 door deflection during test

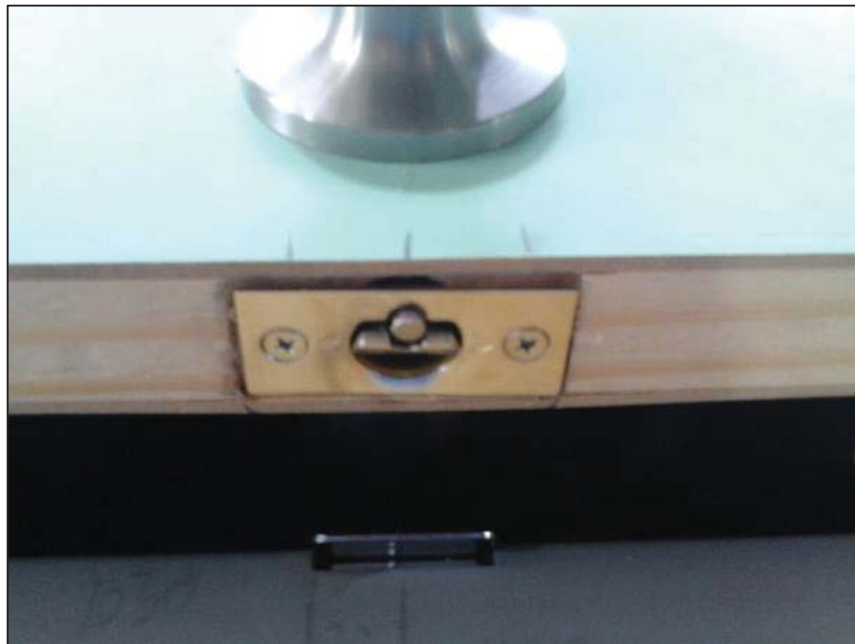
Observation: Lock released from strike plate with lock mechanism jammed in. Strike plate is bent, not much damage to door except skin started to separate from core at the lock.

Figure 7: Trial SS2 Lock Jammed

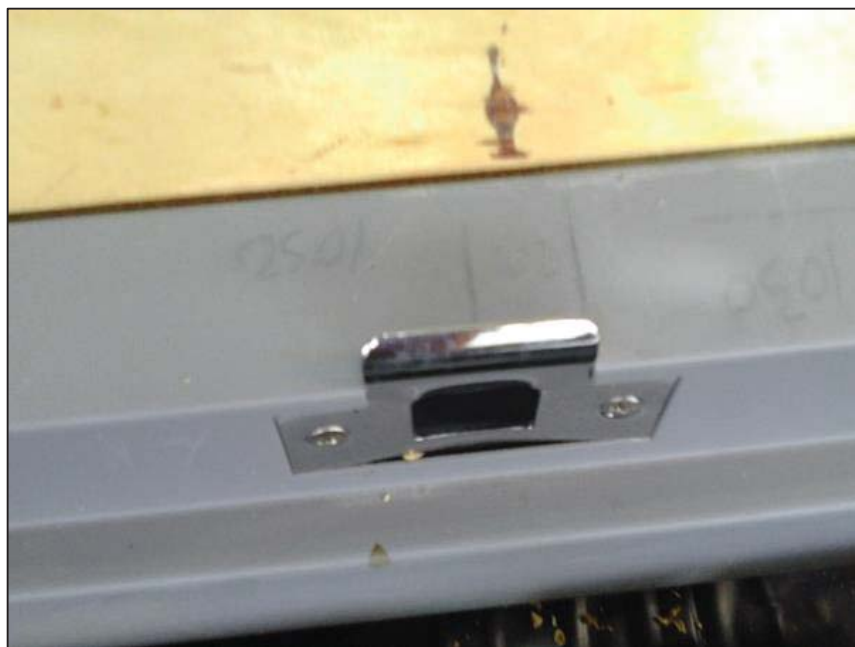
Figure 8: Trial SS2 Strike Plate Bent

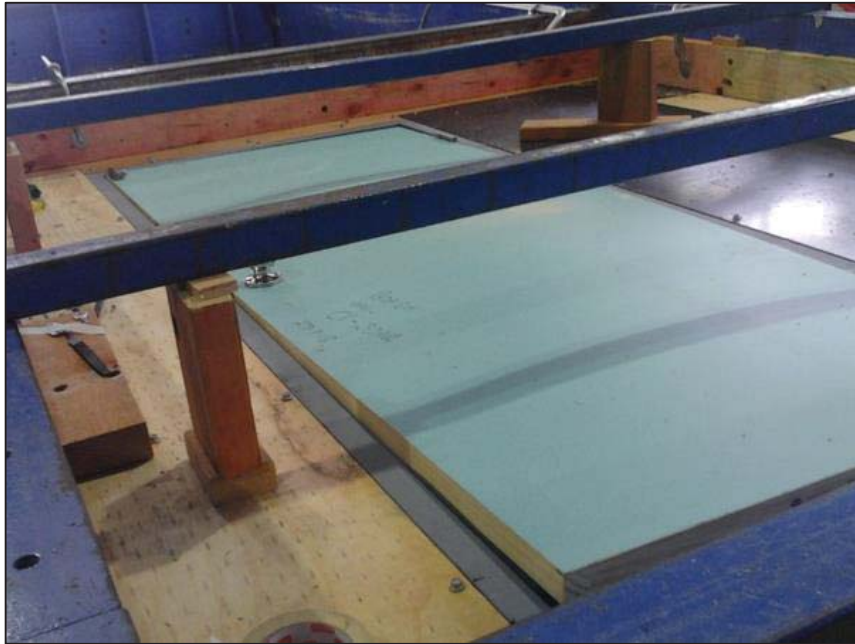
35mm hollow core door with budget lock and a barrel bolt fitted to the top of the door.

Held 2.11kPa

Figure 9: Trial SS3 Door Deflection During Test

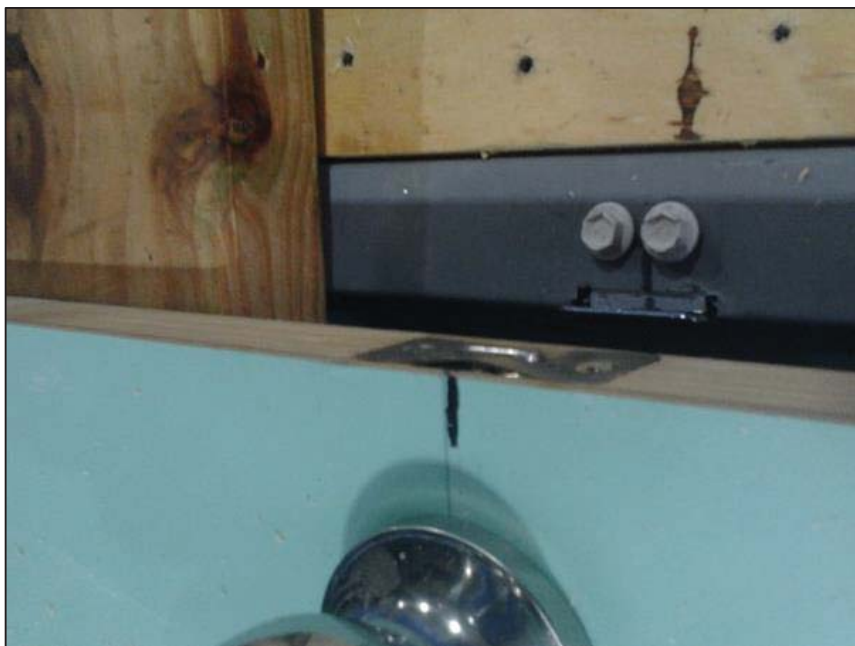
Observation: The latch from the lock mechanism released from the strike plate.

Figure 10: Trial SS3 Damaged Lock Mechanism

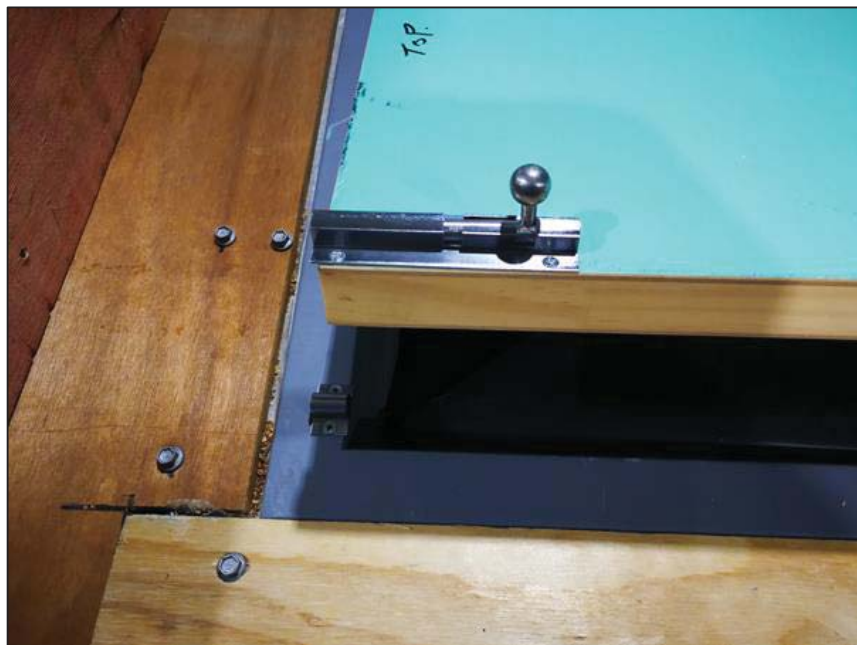
Figure 12: Trial SS4 Top Barrel Bolt Undamaged

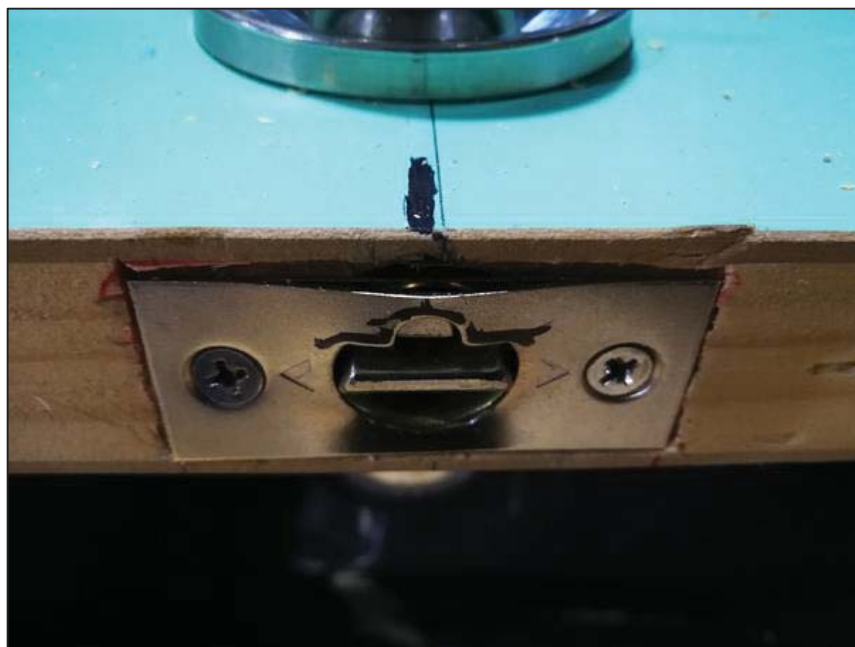
Observation: The bottom barrel bolt catch broke and then the lock latch pulled out of strike plate.

Figure 13: Trial SS4 Jammed Lock Mechanism

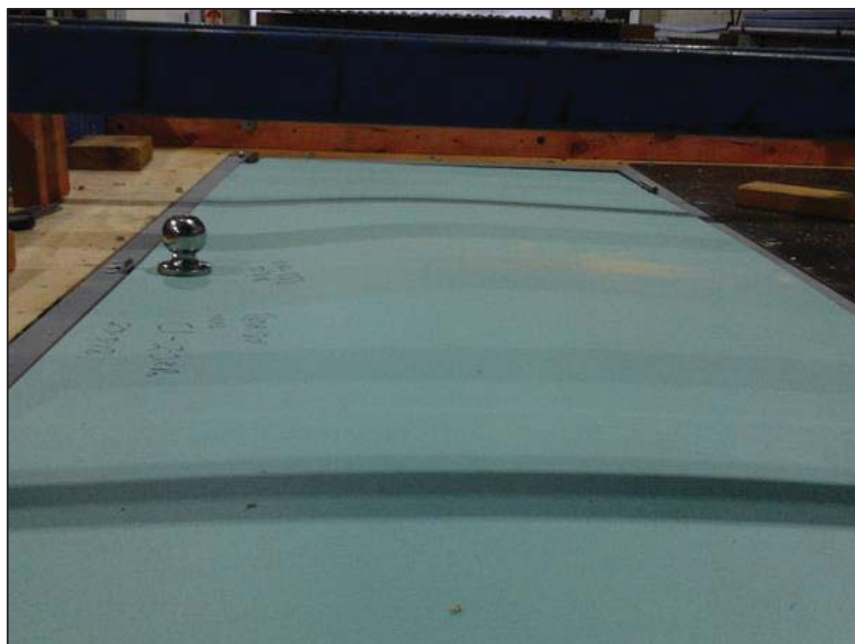
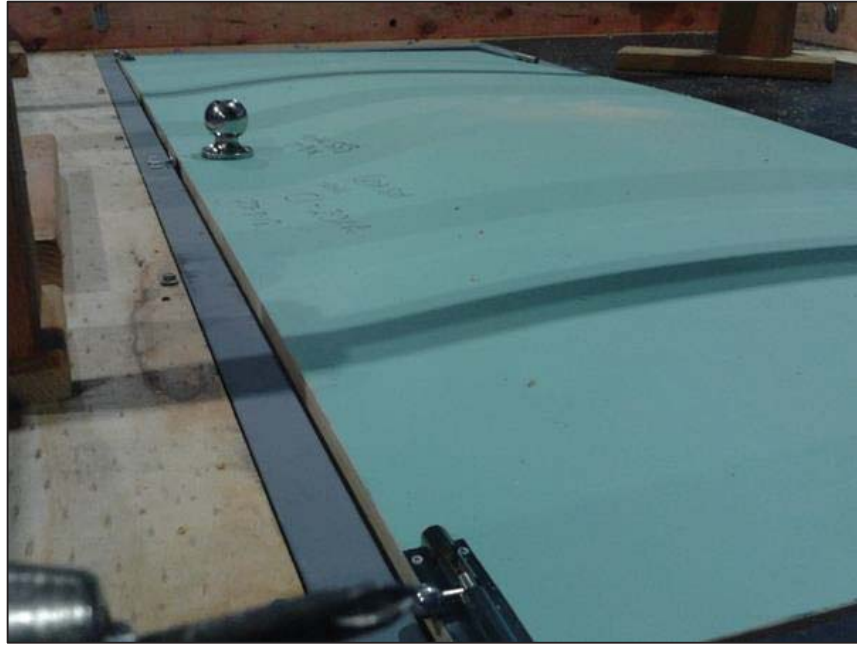
35mm hollow core door with budget lock and a barrel bolt fitted to the top and bottom of the door.

Held 3.18kPa

Figure 14: Trial SS4 Door Deflection during Test

Figure 15: Trial SS4 Door Deflection during Test

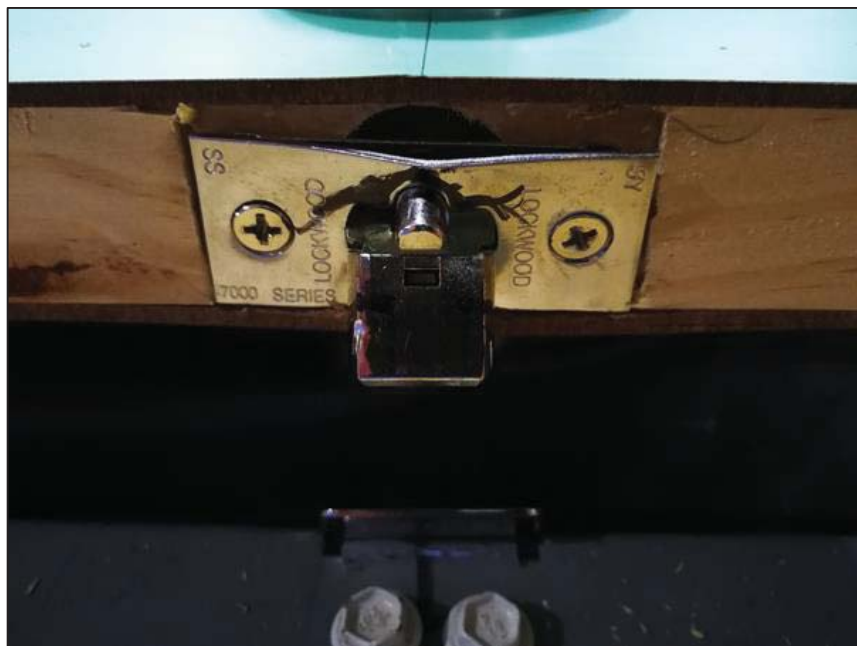
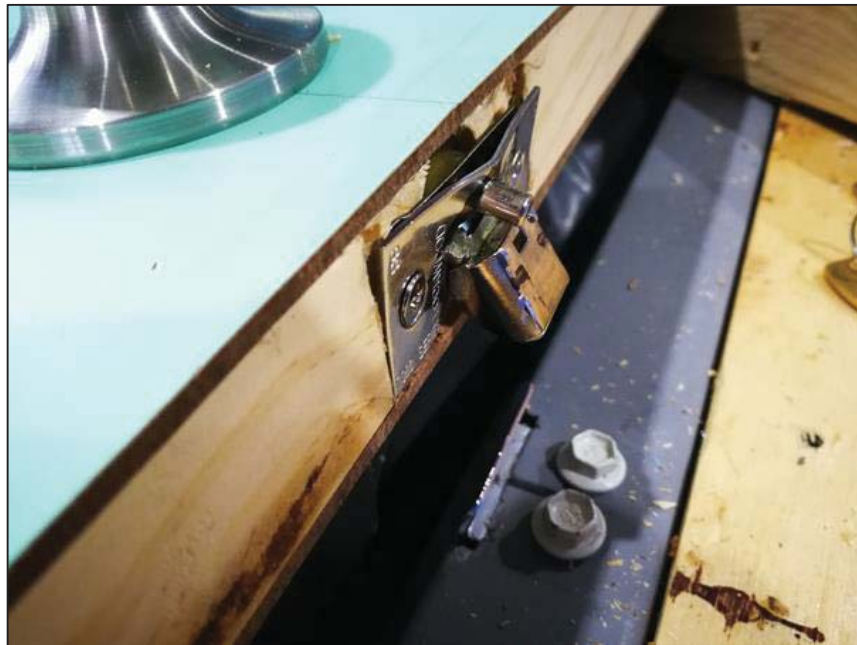
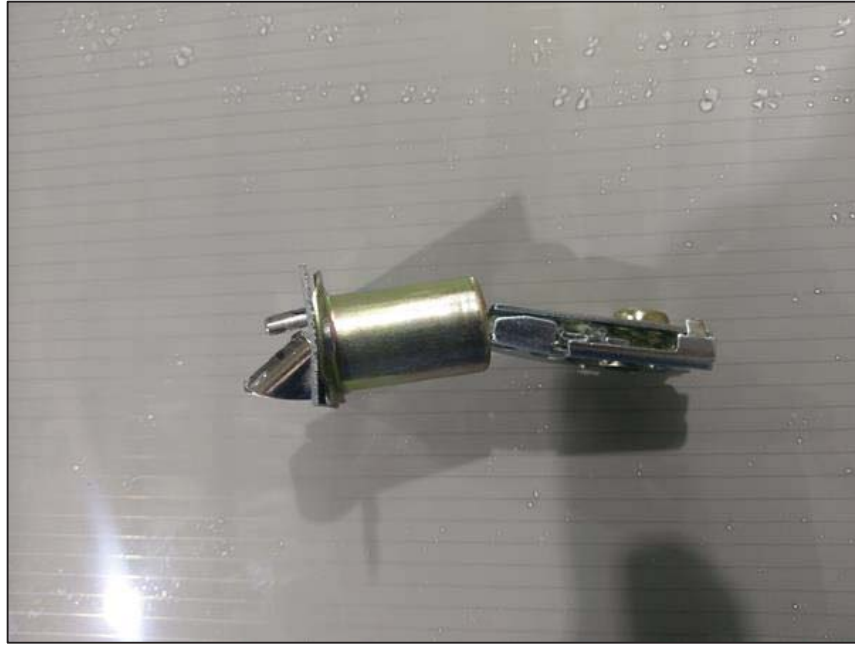
35 mm solid core door and mid-range entrance lock.

Held 4.22kPa

Observation: The latch released from strike plate and split across.

Figure 16: Trial SS5 Broken Lock Mechanism

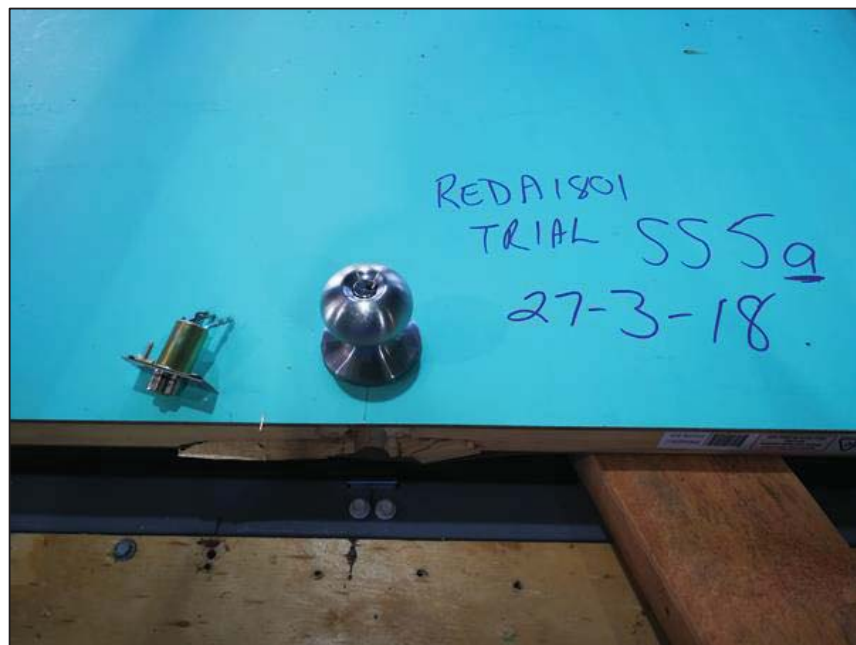
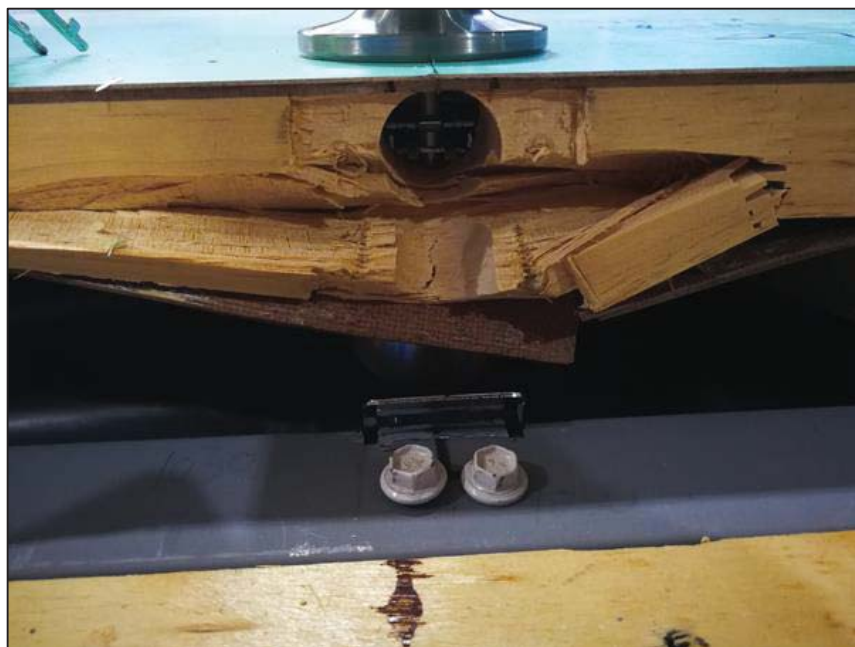
Observation: The edge of the door failed and the latch fell out of the lock completely. The edge of the door fractured.

Figure 20: Trial SS5a Broken Lock Mechanism and Damaged Door

Figure 21: Trial SS5a Broken Lock Mechanism and Damaged Door

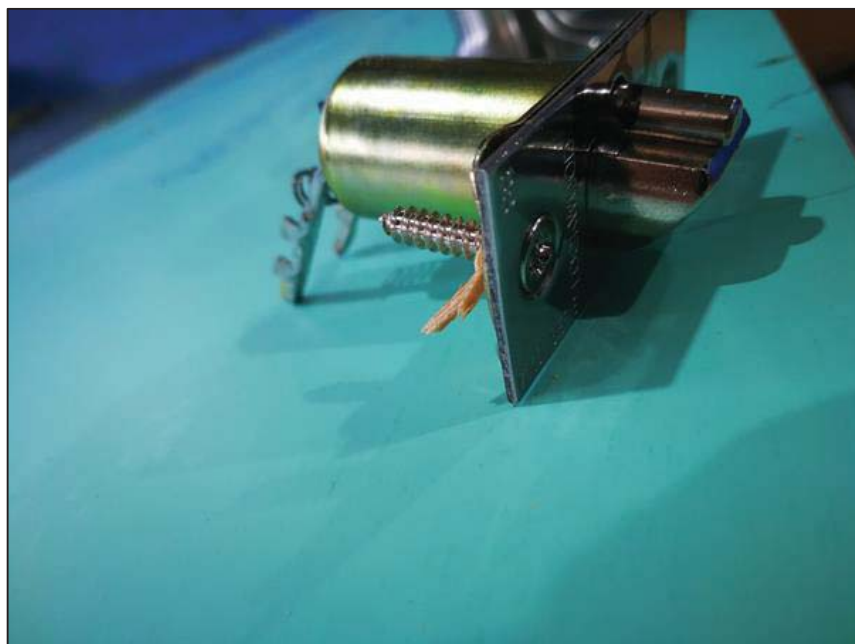
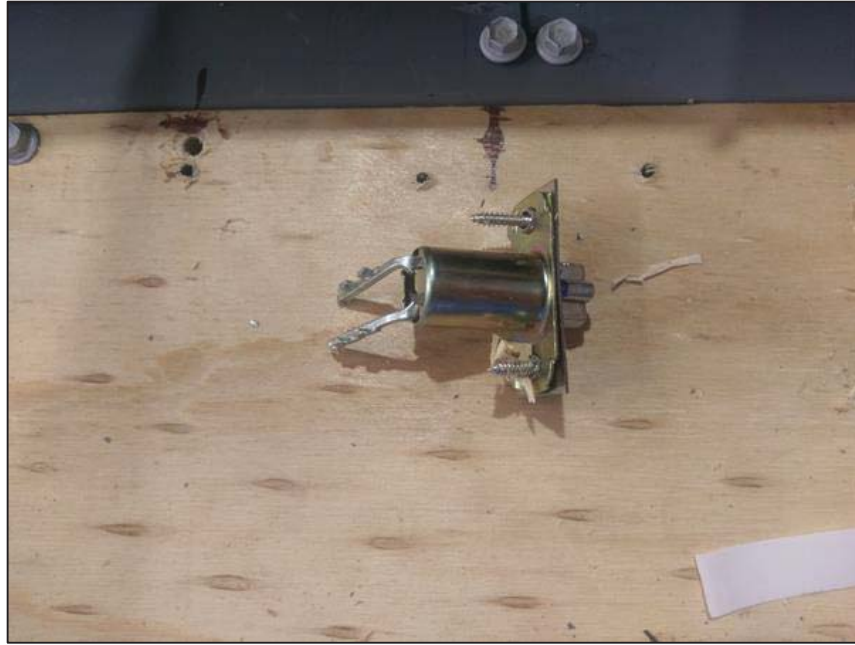
Figure 22: Trial SS5a Broken Lock Mechanism

Figure 23: Trial SS5a Broken Lock Mechanism

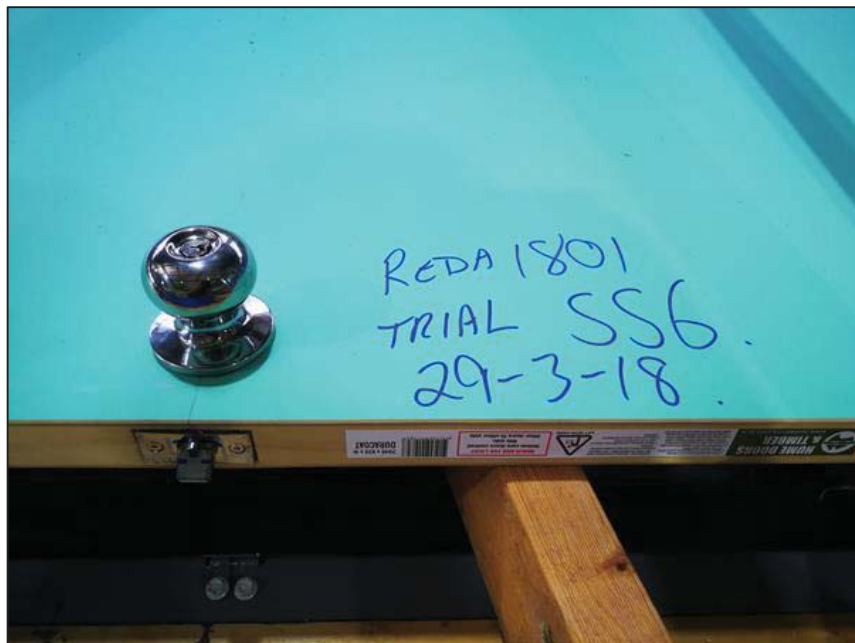
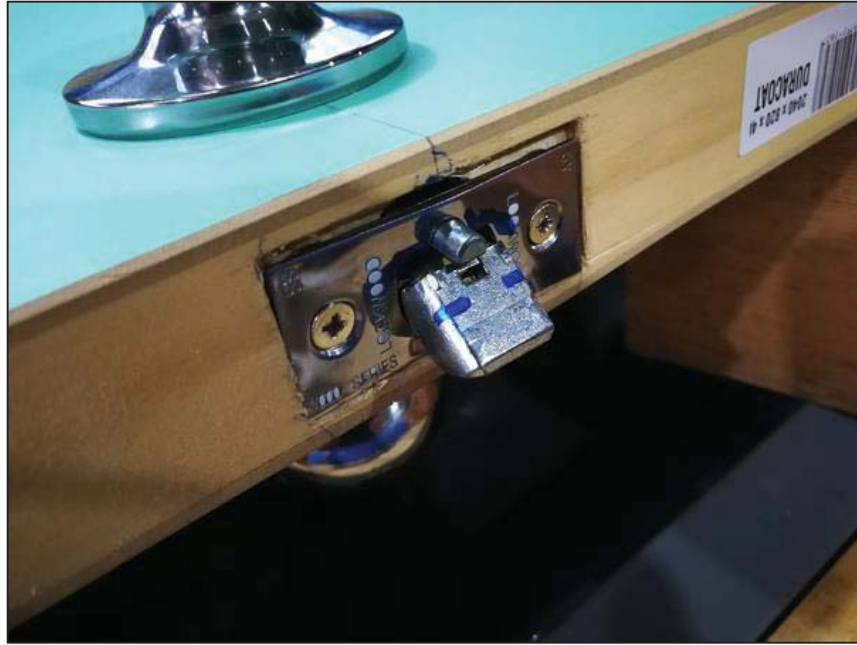
40mm hollow core door with mid-range lock.
Maximum door deflection measured: 40mm.

Held 3.82kPa

Observation: The lock mechanism broke, the latch split across and bent down releasing from strike plate. Small split in door edge at lock.

Figure 24: Trial SS6 Damage to Lock Mechanism

Figure 25: Trial SS6 Damage to Lock Mechanism

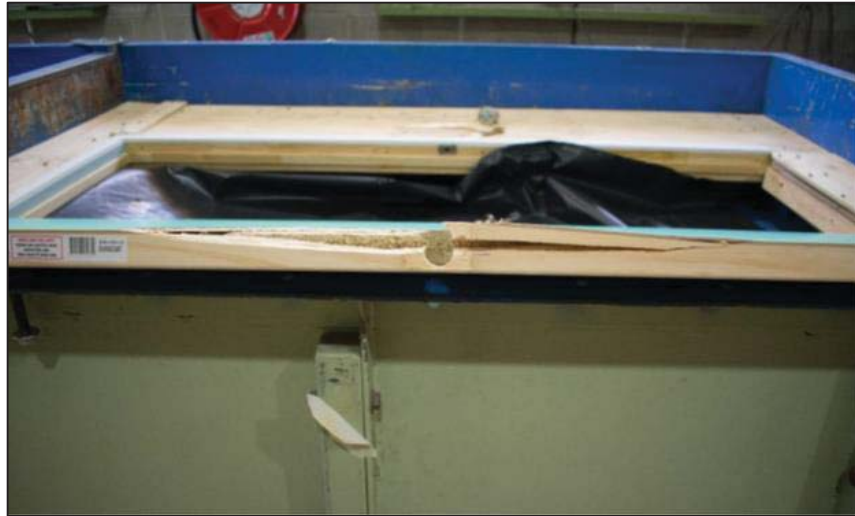
35mm hollow core door with budget lock.

Pressure held 1.90 kPa

Observation: Door handle loosened and sheared door.

Figure 26: Photograph of Damage from “*Design of Potential Dominant Opening to Resist Cyclonic Winds*” by Nicoline Thomson, David Henderson and John Ginger
