NSW MID NORTH COAST FLOOD IMPACT RESEARCH

Steven George, Salome Hussein, Ryan Crompton & Thomas Mortlock

Risk Frontiers & Bushfire and Natural Hazards CRC

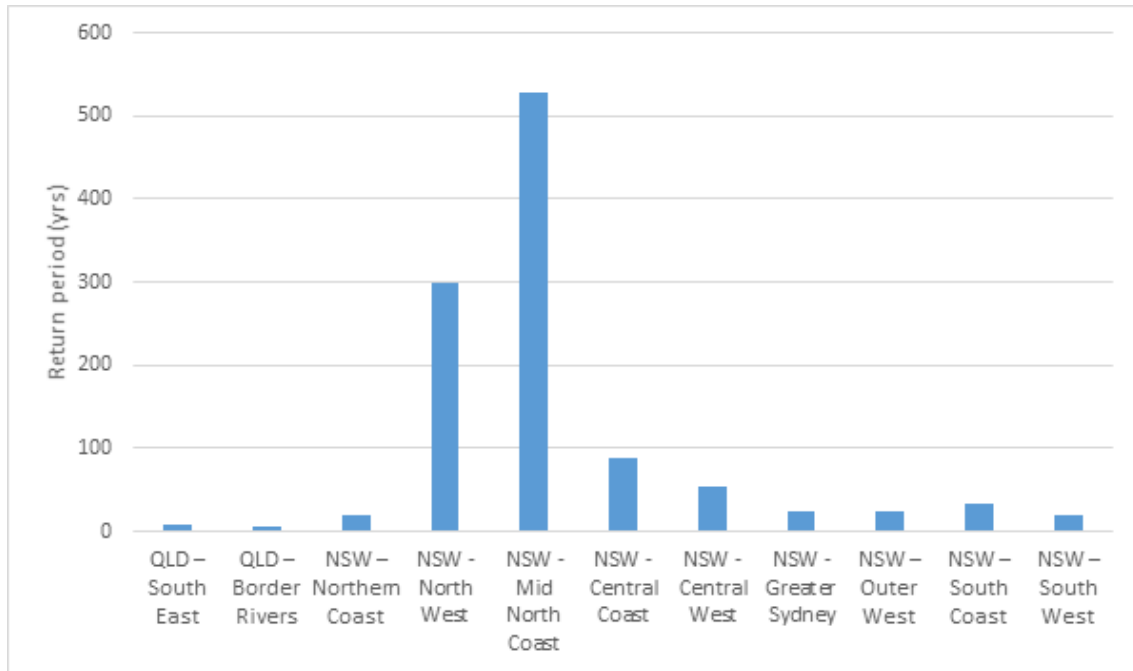
FIGURE 2. RETURN PERIOD ESTIMATES OF RAIN VOLUMES FOR THE MARCH 2021 FLOOD EVENT (REGIONS ORDERED APPROXIMATELY NORTH TO SOUTH).

Seven-day rainfall totals for the period 17th-23rd March 2021 were obtained for every BoM gauge in flood-affected regions. In total, 1,487 gauges were analysed. The 95th percentile of 7-day rain totals for each region was calculated, and gauges registering values greater than the 95th percentile were run through the Australian Rainfall and Runoff (AR&R) 2016 data portal to estimate return periods (Figure 2).

Results show that while this rain event impacted a large geographic area, there were some significant regional variations in rain volumes. As shown in Figure 2, the highest return period estimates and rain volumes were experienced on the NSW Mid North Coast (~ 500 years) and North West (~ 300 years) regions. The NSW Central Coast region also experienced return period rainfall at around the 100-year level. All other regions were at or below the 50-year return period level.

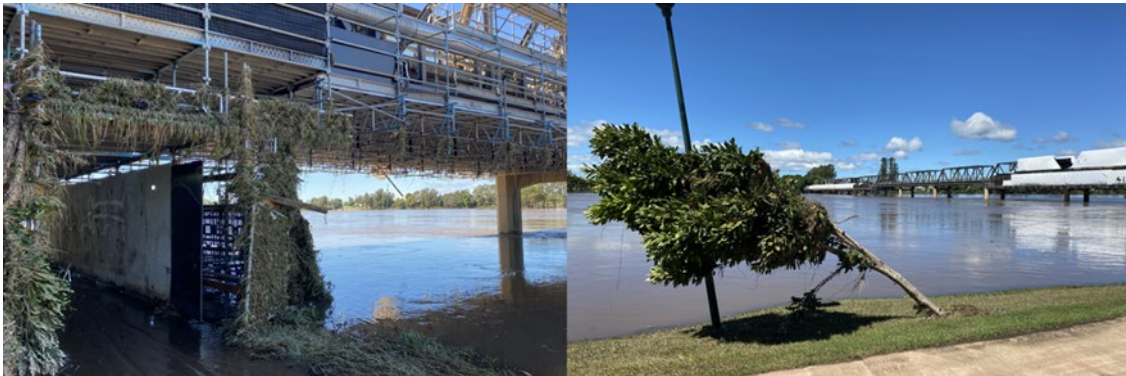
FIGURE 3. THE MANNING RIVER ADJACENT TO THE TAREE CBD. THE VEGETATION DEBRIS (LEFT) AND WATER HEIGHT (RIGHT) ON THE MARTIN BRIDGE INDICATE THE FLOOD PEAK.

Much of the damage in Taree was focused in a portion of the CBD near Brown's Creek. Nearby residential areas in lower lying areas, near the old railway, also experienced significant water levels with belongings piled by the curb for collection. The Martin Bridge, the main bridge over the Manning River, was undergoing general maintenance before the storm, but received significant structural damage at the flood's peak because of the heavy debris - contractors repairing the bridge cited a concrete tank, a cargo shipping container, and a floating house as having collided with the bridge (the final location of this debris was unknown). A significant amount of mud had been deposited on the banks of the river and was being cleaned from public walkways and parks near the bridge. There was seemingly little knowledge or concern about the potential for the flood water to be contaminated as many children were taking the opportunity to enjoy the river following several days of rain. The Taree Aquatic Centre was 75cm underwater and closed, as were a number of businesses near Brown's Creek, including an antique furniture store and motorcycle shop.

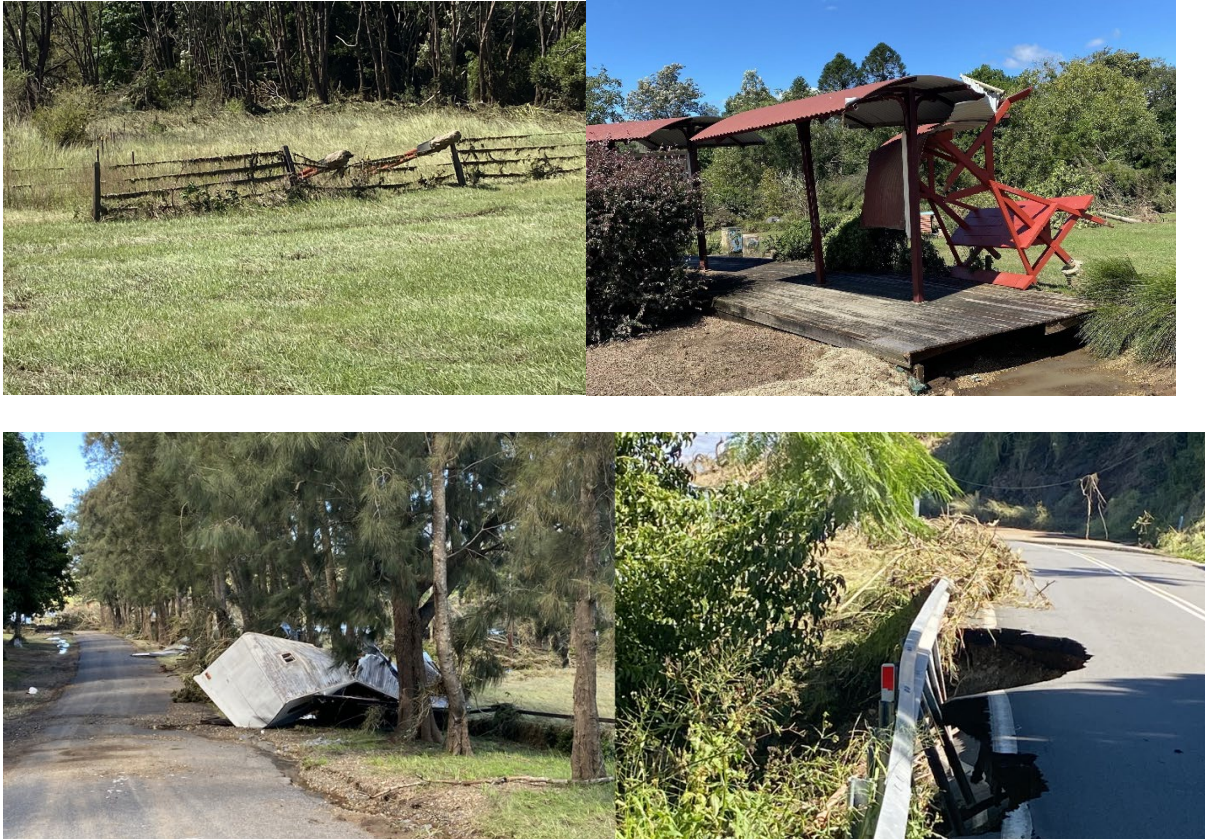
Tinonee Road was still underwater and closed with visible subsidence pictured in Figure 4. On Farquhar Street, we found examples of how powerful and damaging the flood waters were with heavy white goods strewn in the grass, many large scraps from farm buildings, and even an entire caravan wrapped around a tree (bottom left image of Figure 4). Saplings and shorter trees in the nearby floodplain were completely bent over, if not uprooted and carried from elsewhere.

FIGURE 4. POST-FLOODING IMPACTS AT WINGHAM. CHRISSY GOLLAN PARK (TOP), DEBRIS SCATTERED ACROSS THE FLOODPLAIN INCLUDING THIS CARAVAN WRAPPED AROUND A TREE (BOTTOM LEFT) AND THE CLOSURE OF TINONEE ROAD (BOTTOM RIGHT) DUE TO SUBSIDENCE.

The situation in Wingham was much more extreme regarding impact on residents and the extent of damage. The entrance to Wingham, Chrissy Gollan park, a local sheltered picnic area, shaped first impressions of the town and the fast, high flowing water it experienced. The water had raised and carried shelters from their concrete foundations and scattered them in the area, as well as dislodging mosaics and plaques from the paved walkways. The waterway at its back, Cedar Party Creek, also passes around a nearby neighbourhood Mortimer Street. Homes on this road were submerged past their eaves, with residents being rescued from their roofs via a neighbour's boat around 4am. No belongings were salvageable. The water height inside was at least 61cm higher than the 1978 flood as recalled by a resident on Mortimer Street, who has lived their entire life there.

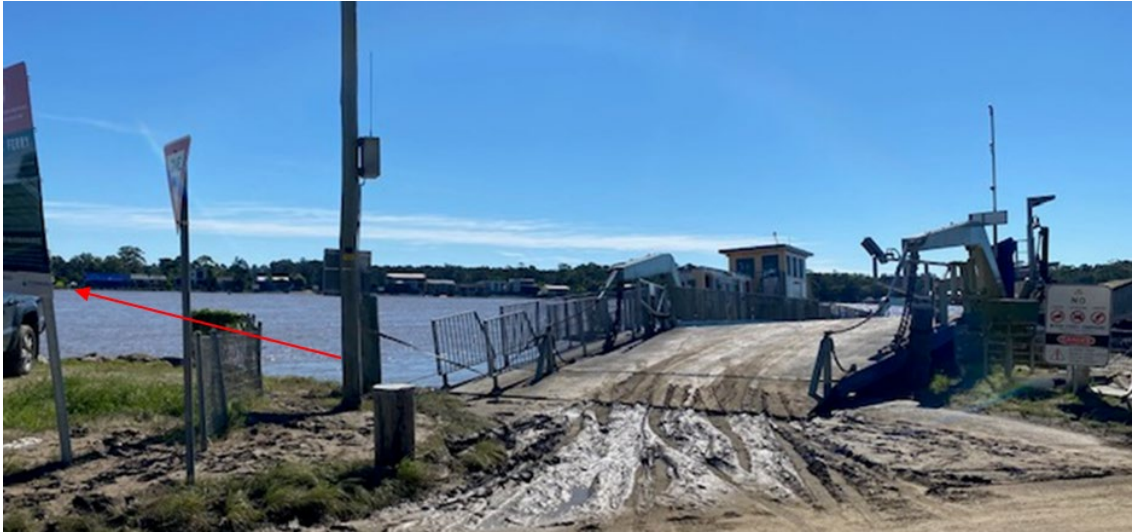
some businesses including a cafe and bed and breakfasts and the ferry (Figure 5). Emergency services and the Australian Defence Force were using shovels, bobcats and other machinery to move mud and debris, and the entire street was lined with piles of damaged furniture, spoiled groceries and white goods.

FIGURE 5. THE SETTLEMENT POINT FERRY AGROUND AND FACING ~45° DOWNSTREAM AFTER IT'S STEEL GUIDING CABLES RUPTURED BY THE VELOCITY OF THE HASTING RIVER FLOW. RED ARROW INDICATES THE FERRY'S USUAL DIRECTION OF TRAVEL AND WHERE THE FERRY WAS LOCATED ON THE OPPOSITE BANK PRIOR TO THE CABLES RUPTURING.

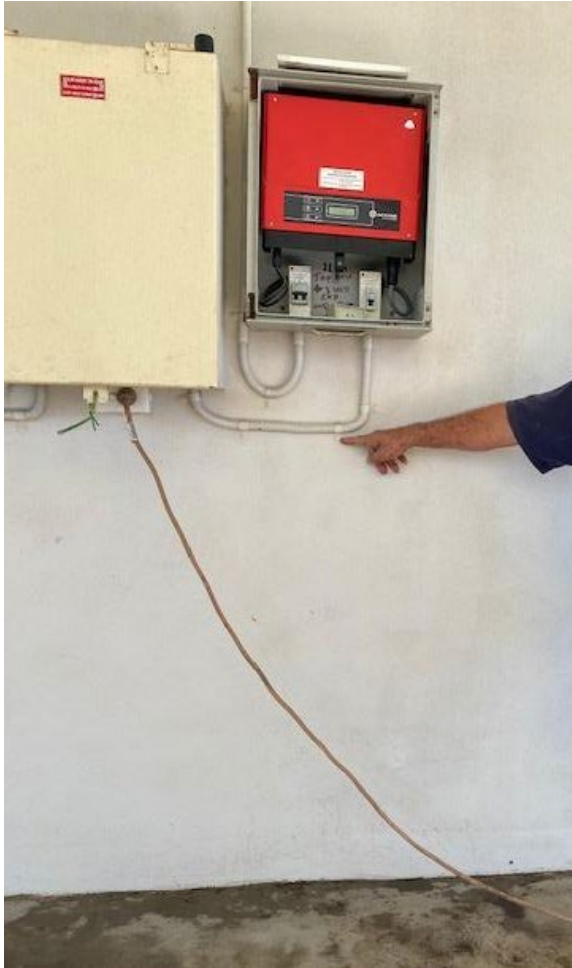
Local residents also expressed major discrepancies between warnings received and the ultimate outcomes of the storm as it proceeded. One recounted that after watching how quickly the water was rising, he initially called the SES and was told the flood would not exceed 1.65m. Not convinced this would be the case, he phoned the BoM who in turn referred him back to the SES. He then began photographing flood heights when it surpassed the 2m level on the flood depth indicator directly across from his property. Figure 6 shows this resident indicating the peak water height on an external wall just below his power box.

FIGURE 6. A RESIDENT FROM SETTLEMENT POINT ROAD, PORT MACQUARIE INDICATING THE PEAK WATER LEVEL FROM THE FLOOD ON AN EXTERNAL WALL OF HIS HOME.

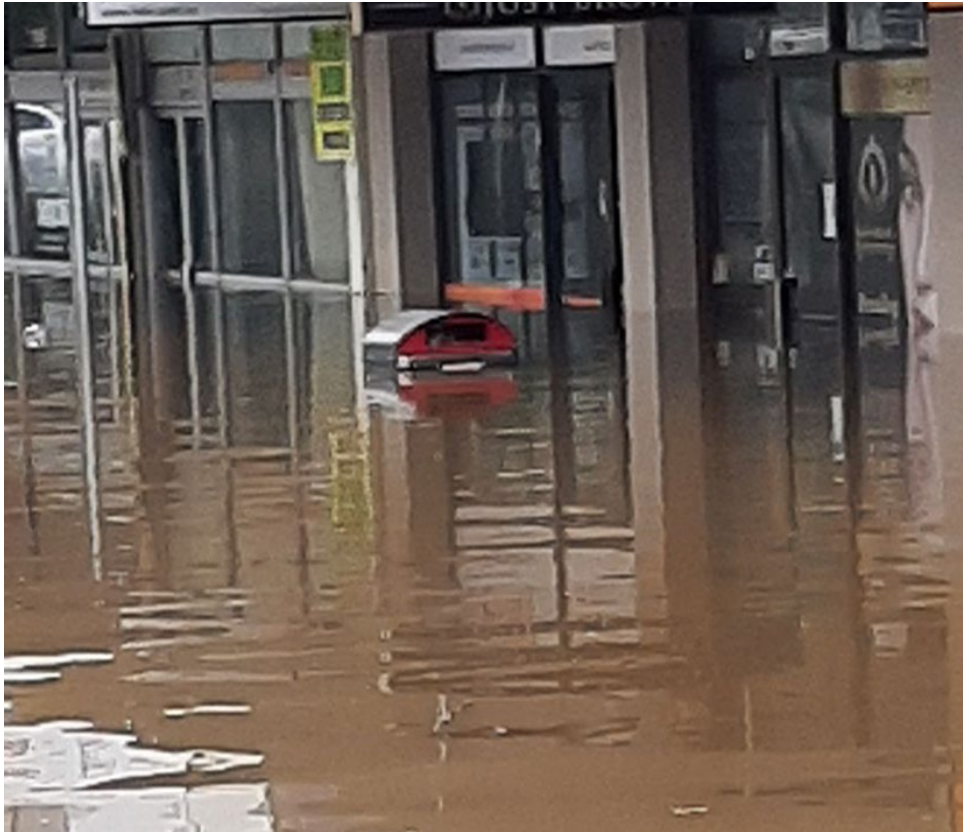
In the CBD, an office supply and consumer electronics business on one side of Short Street reported water depths as ankle deep (27cm), with an estimated \$20-\$40k damage (insured), mainly furniture products. Water entered through the front door gap and rear dock. The worst affected businesses on the other side of the street experienced depths almost above the pedestrian curbside rubbish bins (Figure 7), with a printer and fax shop, a sushi restaurant, and a tobacconist, losing most of their stock. The maximum water height on the inside of these businesses ranged from 80cm to 120cm.

FIGURE 7. WATER LEVEL AT THE SOUTH WEST END OF SHORT STREET, PORT MACQUARIE

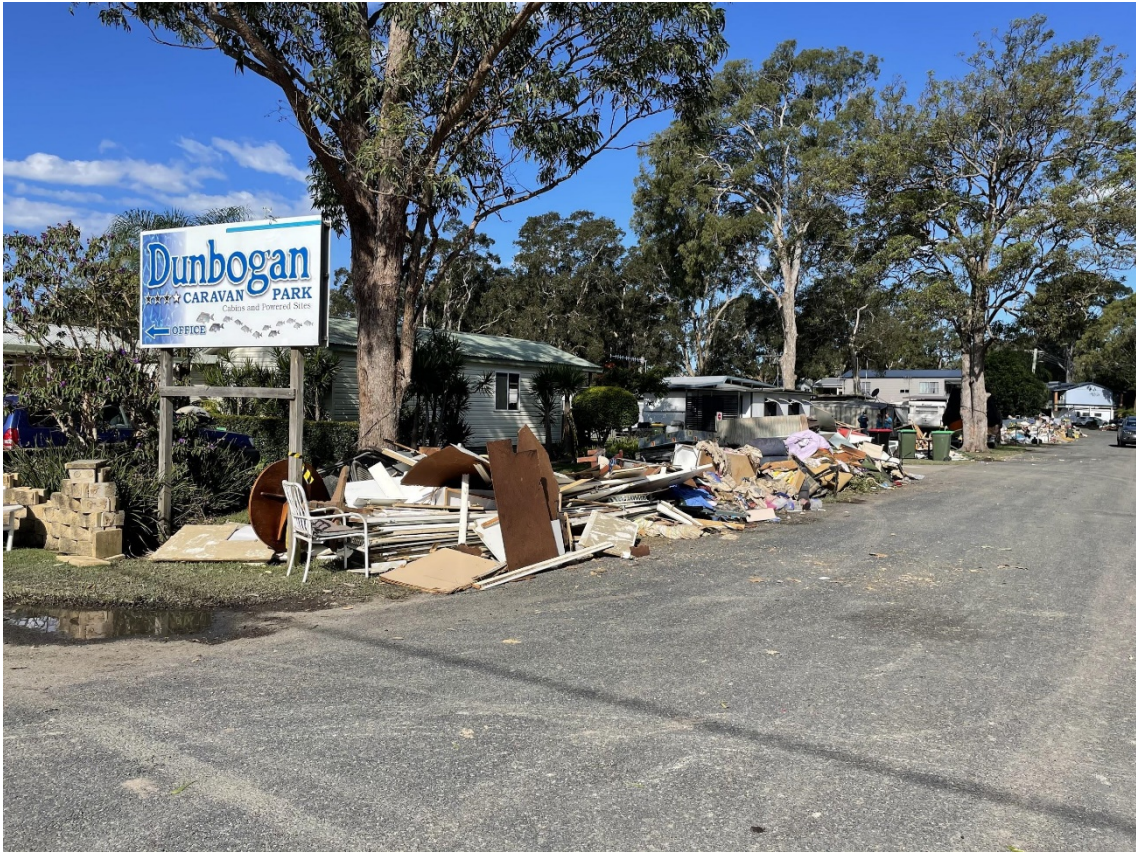
The last surveyed townships were Laurieton, Dunbogen, and North Haven along the Camden Haven River. The damage here was primarily residential, uninsured and numerous impacted dwellings were older, particularly in North Haven. Some buildings along Ocean Drive in North Haven saw water depths of ~20cm and greater depths were experienced in surrounding streets. Both North Haven and Dunbogan have large caravan parks (with permanent residential sections) and these suffered significant damage (Figure 8). These towns were reportedly inundated from multiple directions - from the rain itself (a resident from Kendell's rainwater gauge measured 980mm in 5 days), runoff from North Brother Mountain as well as the surrounding Camden Haven River, Gogleys Lagoon, Queens Lake and Stingray Creek. Residents on Camden Head Road saw water depths of at least one metre.

FIGURE 8. A CARAVAN PARK IN DUNBOGAN IN CLOSE PROXIMITY TO THE INLET THAT HAD BEEN HEAVILY IMPACTED.

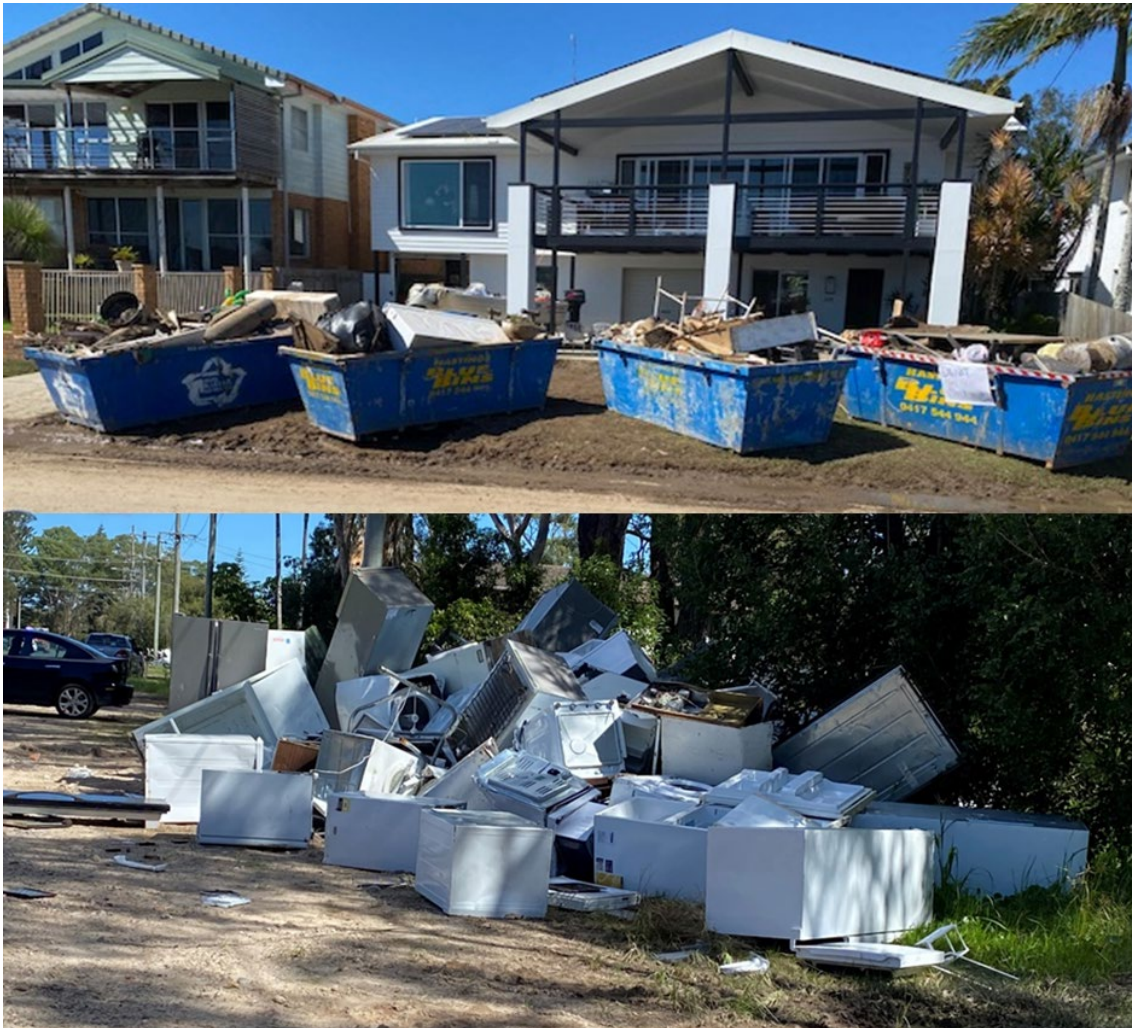
FIGURE 9. SKIP BINS FULL OF WATER DAMAGED BELONGINGS (TOP), A COMMON SIGHT THROUGH MANY OF THE SURVEYED NEIGHBOURHOODS. PILES OF WHITEGOODS SUCH AS FRIDGES, FREEZERS, WASHERS AND DRYERS WERE FREQUENTLY ENCOUNTERED (E.G. NORTH HAVEN, BOTTOM)
