# From storm to study: Insights on resilience from Tropical Cyclone Alfred

Understanding damage, vulnerabilities and future risk in  
south-east Queensland and north-east New South Wales

Report number: 45.2025

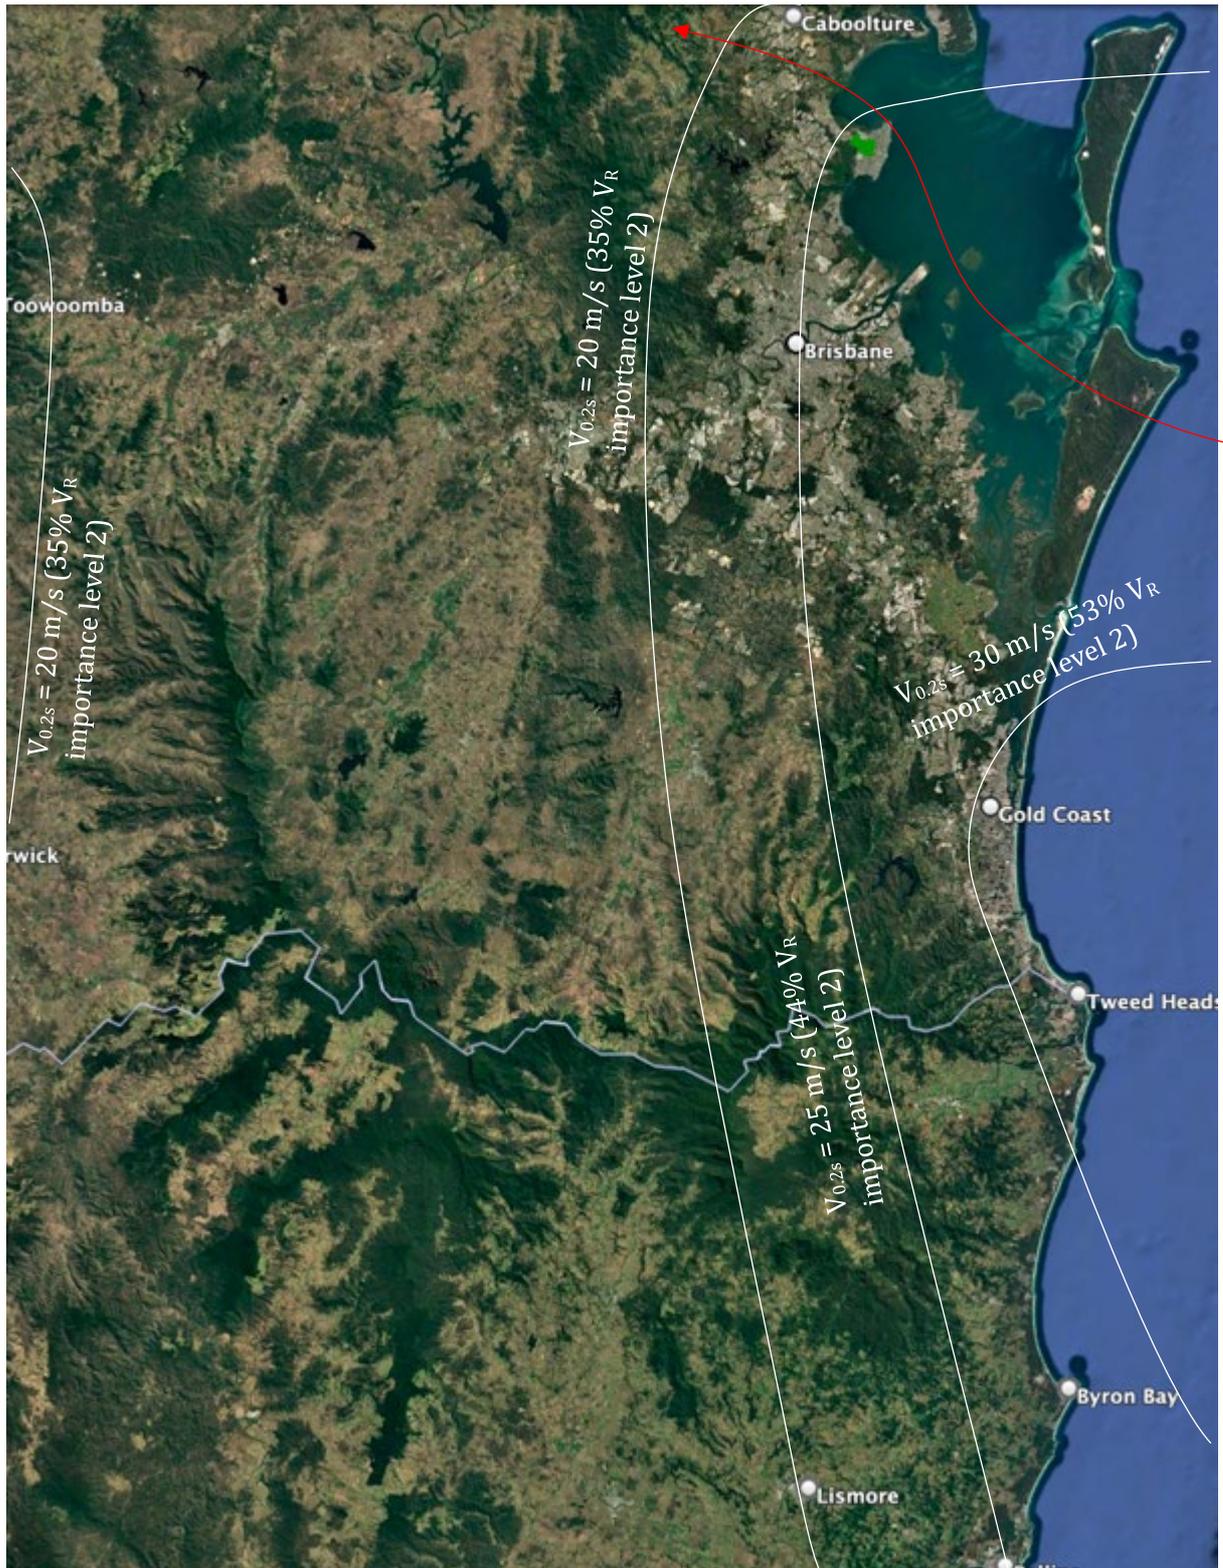
Figure 1: Estimates of wind speed as percentage of design

TC Alfred crossed the Australian coastline at latitude 27° 10', which is almost in the centre of wind region B1 which is applicable to south-east Queensland and northern NSW. All the discussion relates to the winds compared with those used as the basis of design of buildings in region B1.

- The maximum 0.2 s wind gust of 31 metres per second was 82 per cent of  $V_{20}$  for region B1 – usually used as the serviceability design wind speed
- The maximum 0.2 s wind gust of 31 metres per second was 55 per cent of  $V_{500}$  for region B1 – usually used as the ultimate design wind speed – appropriate for the strength design of Importance Level 2 Buildings such as houses, small offices, shops and warehouses.

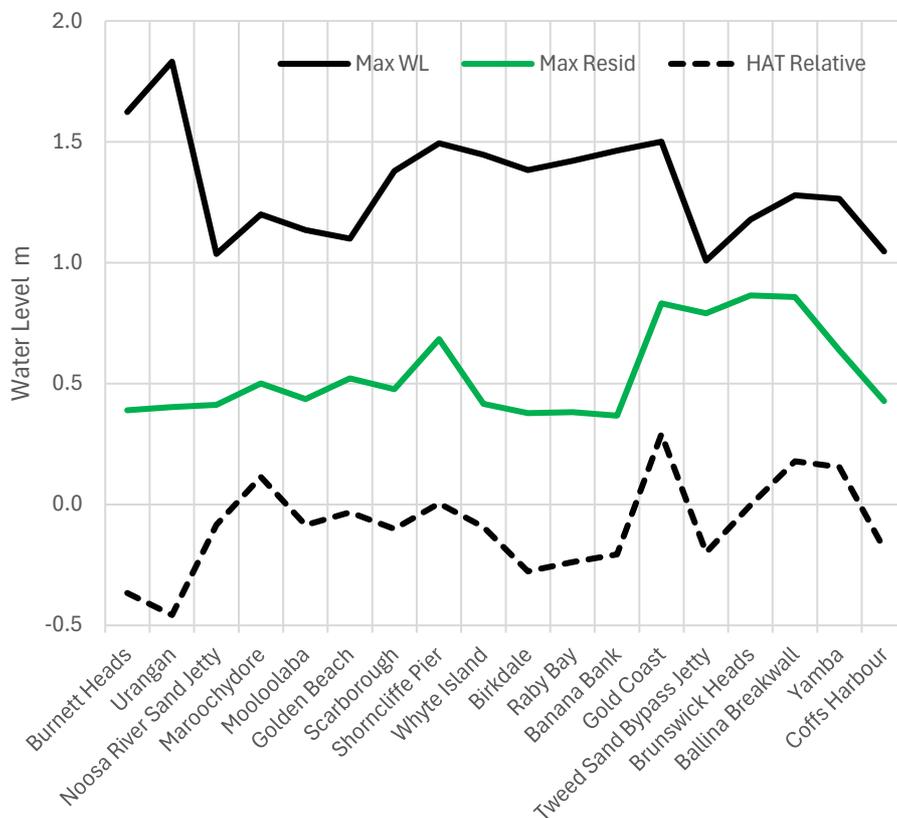
Figure 2: Estimates of water level above highest astronomical tide (HAT)

Data from tide gauges, storm tide gauges and wave buoys in both Queensland and NSW were obtained from the relevant government monitoring bodies and analysed to estimate the maximum height attained by storm tide (shown as the black line Max WL in Figure 2), and the water height above the normal astronomical tides – storm surge (the green line in Figure 2).

For the gauges within Moreton Bay, the measured storm surge was around 0.5 metres, and for tide gauges from Gold Coast to Yamba in NSW which were located on the open coast, the measured storm surge was around 0.8 metres. The difference is attributed to breaking wave setup produced by the large waves that were also measured in south-east Queensland and north-east NSW.

The storm tide reached around the Highest Astronomical Tide mark since the crossing of TC Alfred occurred during a period between spring tides and neap tides when the high tide level was falling from the spring tides five days prior to the crossing.

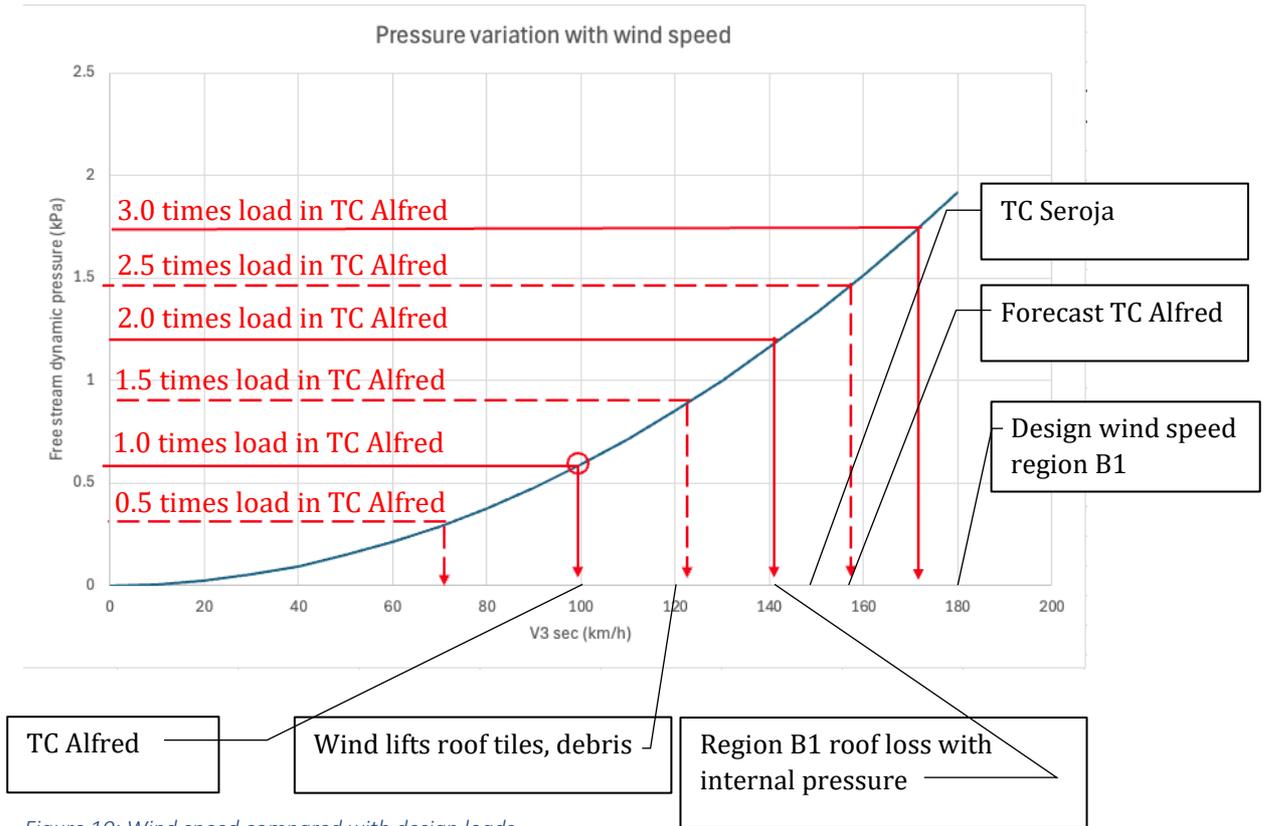
Figure 10: Wind speed compared with design loads

- Gust wind speeds of 155 kilometres per hour are similar to those measured in TC Seroja, which affected Kalbarri in Western Australia. Kalbarri has a latitude similar to Brisbane's and has the same design wind speed and design requirements. Kalbarri experienced a significant number of recently built buildings that had severe damage. (Refer to [Technical Report 66 – TC Seroja, Damage to Buildings in the Mid-West Coastal Region of WA](#))

- The combination of a higher storm surge and higher high tides will mean that the water level would be well above Highest Astronomical Tide. This would lead to more storm tide damage to structures.

TC Alfred has made the population of this region aware of the chance that cyclones could impact this area in the future. It was fortunate that it crossed with a much lower wind speed than originally forecast and this contributed to the low levels of structural damage observed in the investigation.
