# IMPROVING THE RESILIENCE OF EXISTING HOUSING TO SEVERE WIND EVENTS

Annual project report 2014-2015

Daniel Smith<sup>1,3</sup>, David Henderson<sup>1,3</sup>, John Ginger<sup>1,3</sup>, Martin Wehner<sup>2,3</sup>

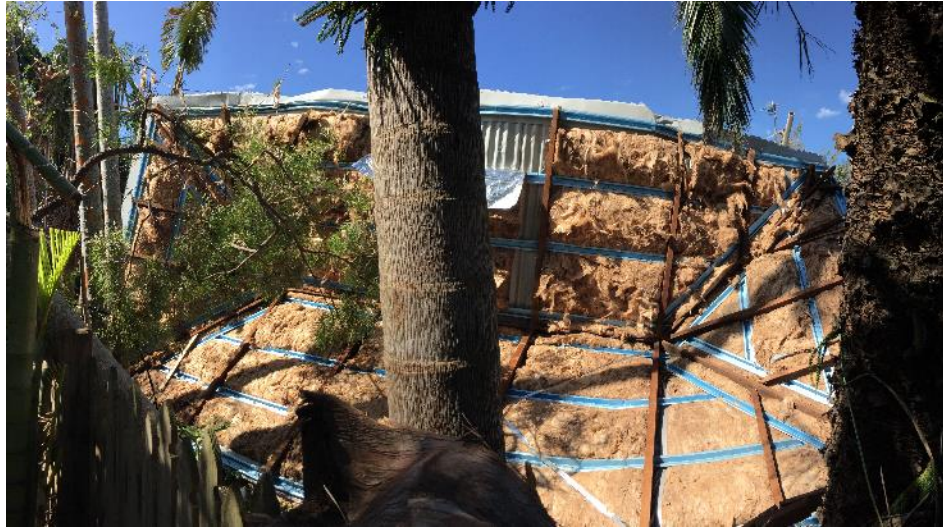
FIGURE 1. WIND-INDUCED FAILURE OF A NEW (< 1 YEAR) METAL CLADDING ROOF ON AN OLD HOUSE AT THE RAFTER TO TOP-PLATE CONNECTION DURING CYCLONE MARCIA (2015) IN YEPPON, AUSTRALIA - THERE APPEARED TO BE NO RETROFITTING OF THE WEAKER CONNECTIONS.

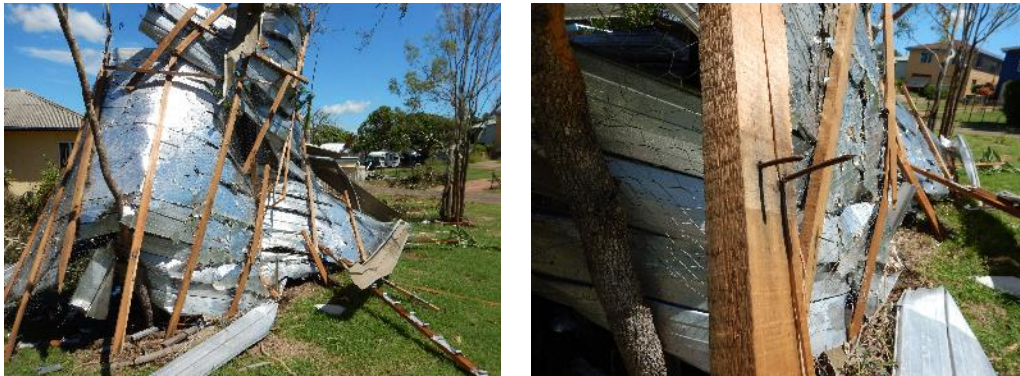
FIGURE 2. WIND-INDUCED FAILURE OF A METAL CLADDING ROOF (LEFT) AT THE BATTEN TO RAFTER CONNECTION (RIGHT) DURING CYCLONE MARCIA (2015) IN YEPPON, AUSTRALIA.

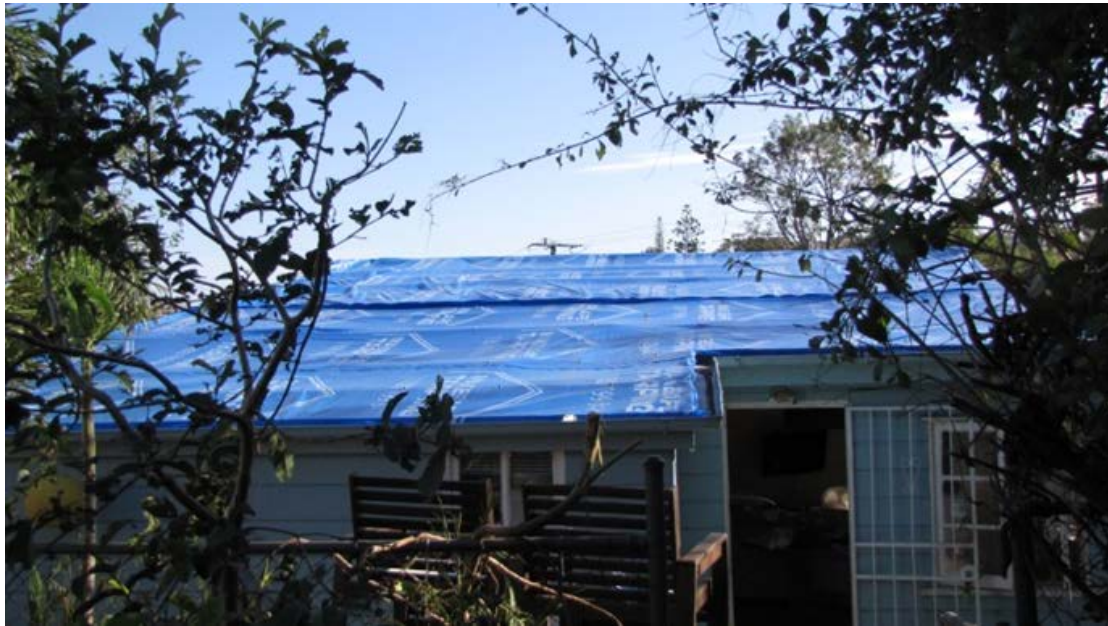
FIGURE 3. FAILED HOUSING AFTER BRISBANE THUNDERSTORMS (NOVEMBER 2014) WITH MISSING ROOFING FROM NOT IMPROVING THE BATTEN TO RAFTER CONNECTION WHEN UPGRADING THE ROOFING TO BATTEN CONNECTION (EXAMPLE 1)

The issues of poor construction practices in renovation, degradation of materials (lack of advice for maintenance), etc. are not constrained to northern Australia. Damage investigations in Brisbane, Dubbo and Perth revealed similar issues. Figure 3 and Figure 4 show failed housing with missing roofing from not improving the batten to rafter connection when upgrading the roofing to batten connection.

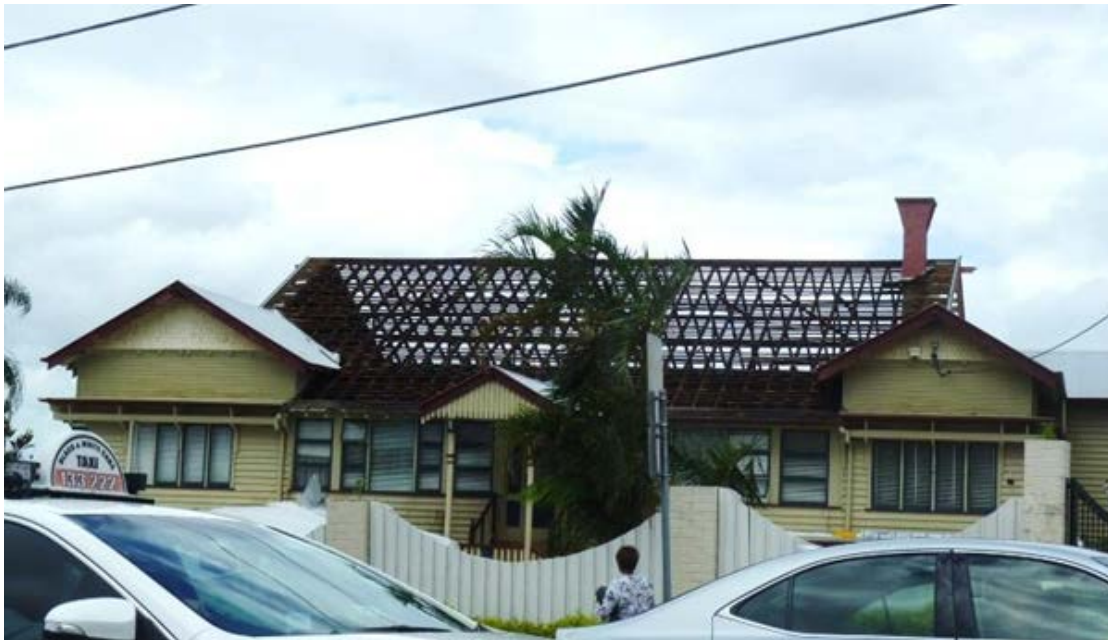
FIGURE 4. FAILED HOUSING AFTER BRISBANE THUNDERSTORMS (NOVEMBER 2014) WITH MISSING ROOFING FROM NOT IMPROVING THE BATTEN TO RAFTER CONNECTION WHEN UPGRADING THE ROOFING TO BATTEN CONNECTION (EXAMPLE 2)

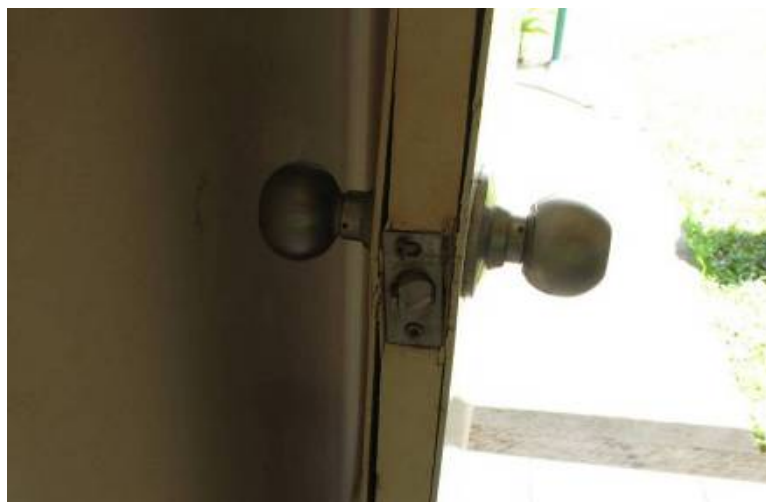
FIGURE 5. TYPICAL LOCK AND DAMAGED DOOR AFTER BEING BLOWN INWARD DURING CYCLONE YASI IN 2011.

Maintaining a sealed building envelope is critical to the wind resistance of buildings. If there is a breach on the windward face, (i.e., from broken window or failed door) (Figure 5), the internal pressure of the house can be dramatically increased. The internal loads act in concert with external pressures, increasing the load on cladding elements and the structure. Depending on the geometry of the building, the increase in internal pressure caused by this opening can double the load in certain areas, increasing the risk of failure, especially if the building has not been designed for a dominant opening.

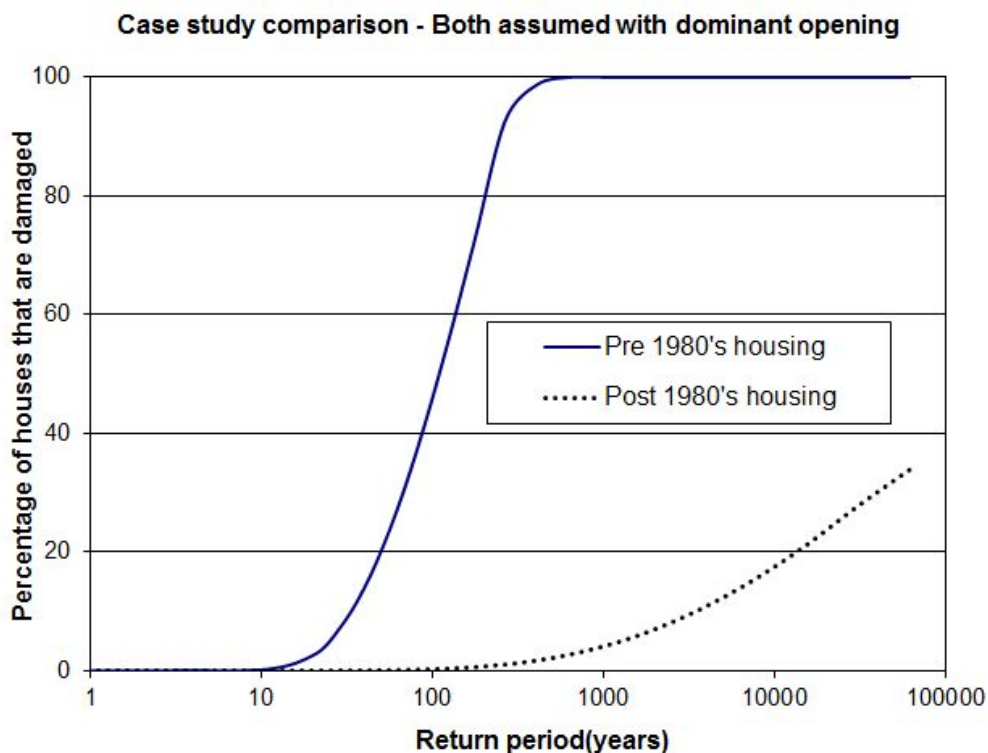
FIGURE 6. VULNERABILITY CURVES FOR PRE-1980S AND POST-1980S RESIDENTIAL STRUCTURES WITH INCREASING RETURN PERIOD [18]

AS/NZS 1170.2 [2] provides information for selecting the design wind speed related to the return period. Using vulnerability curves developed by CTS, Figure 6 shows the percentage of housing damaged versus the return period for homes in a typical cyclonic region C, suburban site. These curves show the significant decrease in damage to housing that could be achieved if pre-1980s houses were upgraded to the wind resistance of contemporary post-1980s houses.

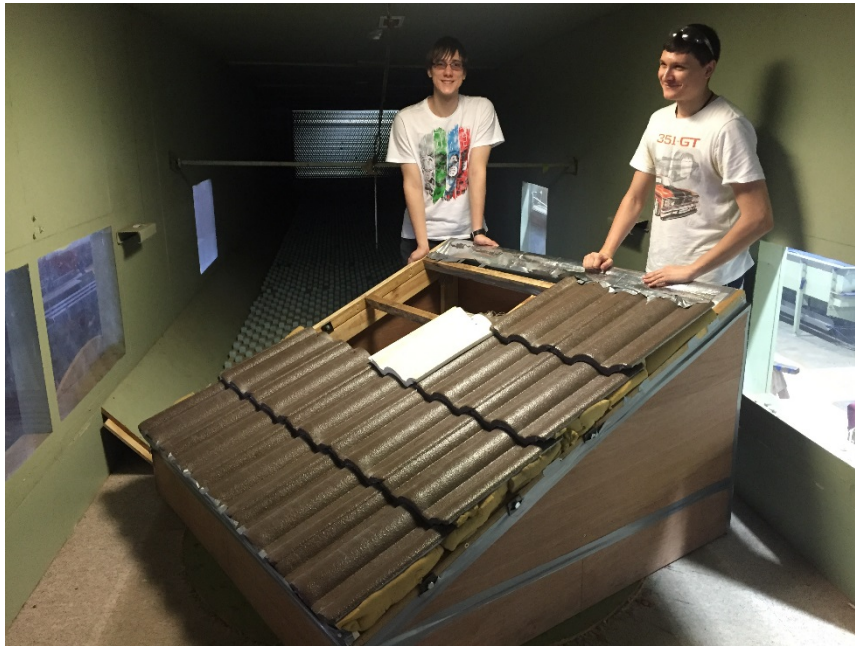
FIGURE 8. UNDERGRADUATE STUDENTS AT JAMES COOK UNIVERSITY CONTRIBUTE TO THE PROJECT BY CONDUCTING WIND LOAD CHARACTERIZATION TESTING FOR ROOFING TILES IN THE CTS WIND TUNNEL AS PART OF A FOURTH YEAR THESIS PROJECT

The Roofing Tile Association of Australia (RTAA) has supported research to improve the wind resistance of roofing tile systems. Removal of roofing tiles has been observed frequently during post-storm damage investigations in Australia in both new and older construction. In order to improve the wind resistance of roofing tiles and inform vulnerability modeling for this project, the wind loading mechanism on tiles must be understood. Two undergraduate engineering students at James Cook University were selected to conduct the research on roofing tiles at the CTS as their fourth year thesis project (Figure 8).
