# FINAL REPORT: SEISMIC RETROFIT TESTS OF URM CAVITY WALLS

**Derakhshan, H., Lucas, W., Visintin, P., and Griffith, M.**

School of Civil, Environmental, and Mining Engineering, University of Adelaide  
Bushfire and Natural Hazards CRC

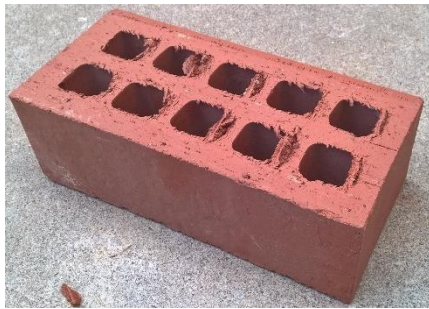
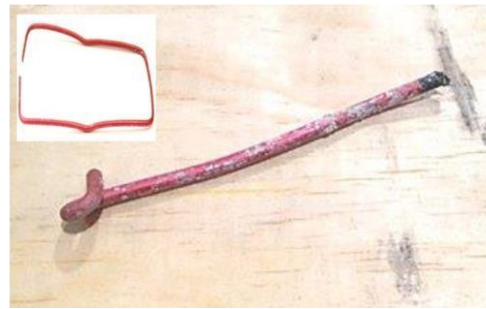
(a) Perforated clay brick (b) 3 mm thick wall ties; inset shows the bent shape as used in walls Figure 2: Standard masonry units and wall ties

The average material properties for the masonry walls and CFRP strips are listed in Table 2. The material properties in Table 2 were tested in accordance with AS3700 and AS/NZS 4456. The walls and associated material tests were constructed over a single day by 3 qualified bricklayers operating under laboratory controlled conditions to minimize any variations in material components. The masonry units comprised of standard Australian clay bricks with nominal dimensions of 230 x 110 x 76mm and 2 rows of 5 perforations (Figure 2(a)). All masonry was constructed using brick units from the same manufacture batch. Mortar joints were nominally 10mm thick and mixed using Portland cement, hydrated lime and sand in a 1:1:6 ratio by volume. For all cavity walls red galvanized double legged wall ties 230 x 3mm in size (Figure 2(b)) were utilized.

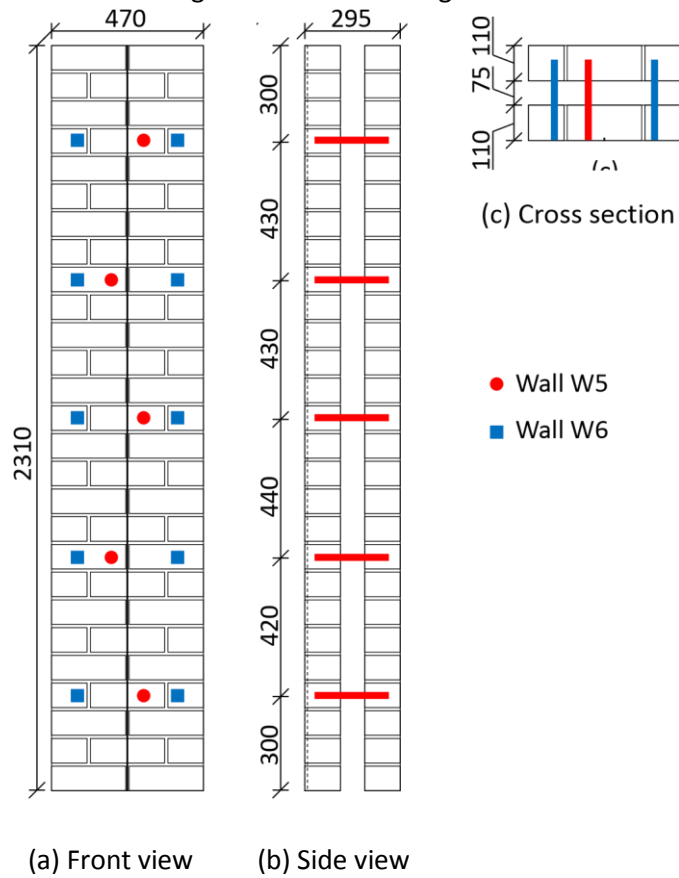
Figure 4: Helical anchor configuration

*Helical anchors (W5, W6) Figure 4:* The helical anchors were retrofitted to the wall prior to testing. In all cases existing wall ties were cut such that the helical anchors provided the sole connection across the cavity. Installation involved drilling a pilot hole through the reinforced wall leaf, through the center of a brick unit, and 75mm into the loaded leaf. The helical wall anchors were then pushed into the wall using an SDS type hammer drill. For wall W5 one anchor per level was installed at 430mm vertical spacing, 40mm offset from the NSM FRP strip on alternating sides per level. For wall W6 the vertical spacing remained constant at 430mm, however, each layer involved the installation of 2 anchors. Each anchor was installed 80mm from each side of the masonry wall.

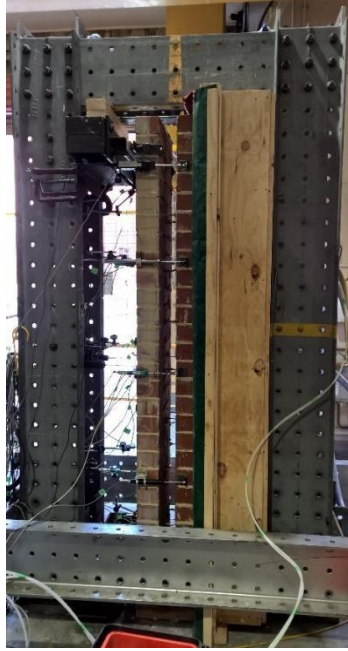
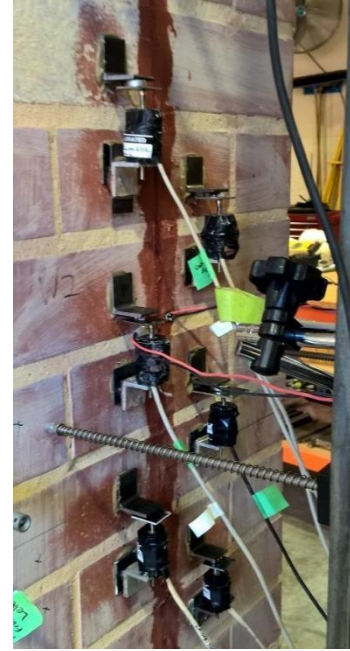
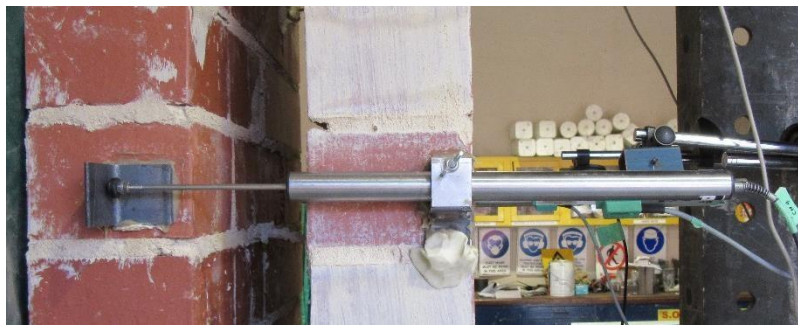
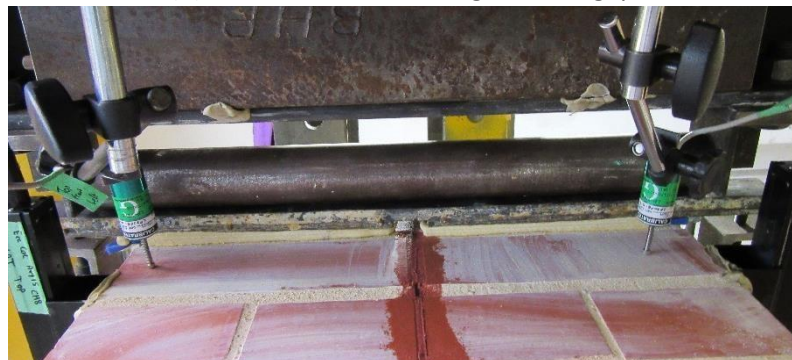
(a) Schematic of the setup

(b) Typical test setup

(c) Front LVDT and crack width LVDTs

(d) LVDT to monitor changes in the gap

(e) Bottom view of the top roller support Figure 6: Test setup

The 26 LVDTs were installed at various wall heights to capture the deflected shape profile of the reinforced leaf, the change in the cavity dimension (subsequently providing the deflected shape profile of the loaded leaf) and the flexural crack widths near the mid-height of the masonry wall (Figure 6(b) and (c)). Table 3 below documents the height of the installed face and side LVDTs. The 6 LVDTs configured to record the crack width opening were positioned at mid-height covering the 11<sup>th</sup> to 17<sup>th</sup> brick courses.

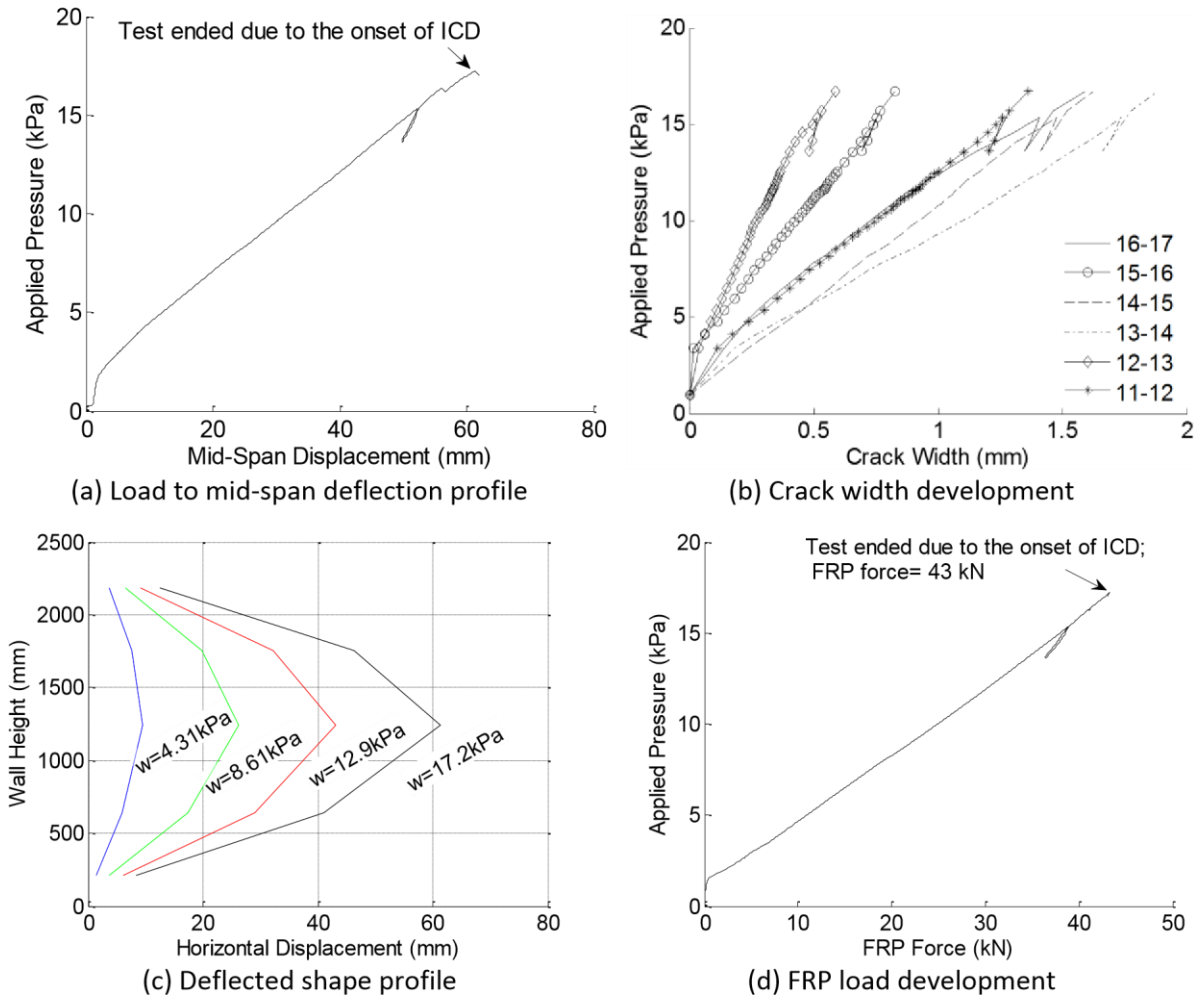
Figure 8: Wall 1 test results

Figure 8(a) shows the load to mid-height deflection profile for the single leaf wall. At an applied pressure of 1.7 kPa a horizontal crack formed along the brick unit to mortar interface between the 14<sup>th</sup> and 15<sup>th</sup> courses. Figure 8(a) shows that the formation of this first crack coincides with a significant change in the load-deflection behavior which is caused by the reduction in sectional stiffness.

Closer inspection of the mortar joints near the center height of the wall (shown in Figure 8(b)) shows that after the formation of the first horizontal crack between the 14<sup>th</sup> and 15<sup>th</sup> courses additional horizontal cracks form along the 16<sup>th</sup> to 17<sup>th</sup>, 11<sup>th</sup> to 12<sup>th</sup>, and 13<sup>th</sup> to 14<sup>th</sup> courses almost immediately.

Following this initial set of cracking small horizontal cracks were visible on the wall at approximately every second mortar joint near the wall mid-height. At an approximate pressure of 3.8 kPa additional horizontal cracks formed along the 12<sup>th</sup> to 13<sup>th</sup>, and 15<sup>th</sup>-16<sup>th</sup> courses such that small horizontal cracks were present at each mortar joint near the mid-height of the wall. This behavior is consistent with the formation of primary and secondary cracks as described within partial-interaction theory (Visintin et al., 2013).

Continued loading of the single leaf wall resulted in the formation of herringbone cracking (Figure 9(c)) associated with partial interaction debonding of the FRP strip. Interestingly the single leaf scenario demonstrated clear herringbone cracking on both sides of the brick unit indicating that debonding is occurring in both directions over the height of a single brick unit. This behavior is consistent with the multiple cracking scenario described in recent partial interaction studies (Oehlers et al., 2015) and the visible confirmation of this behavior is something that has not been documented elsewhere. In the case of this single leaf test, global IC debonding ultimately resulted in failure of the wall at an applied pressure of 17.2 kPa, at a pressure that was 10 times the initial cracking pressure of 1.7kPa. The global IC debonding resulted in a sudden increase in the width of the crack at the interface between the 17<sup>th</sup> and 18<sup>th</sup> brick courses as the entire FRP strip above the crack slipped approximately 30mm as shown in Figure 9(a) and (b). Interestingly the recorded crack width behavior in Figure 8(b) did not

demonstrate any evidence of the crack closure theorized (Oehlers et al., 2015) to be associated with the shift from the observed multiple crack debonding to the single crack debonding associated with the global IC debonding behavior. It is also interesting to note that in this case failure of the bond between the FRP and the brick unit did not occur within the brick unit itself which has previously been documented (Kashyap et al., 2011) but rather failure occurred within the surface layers of the FRP. This behavior was also observed in the material tests undertaken in conjunction with the wall tests. It is theorized that this failure mechanism is directly related to the fact that the FRP strips were manufactured using the pultrusion method and that it is possible that the release agent used during manufacture became mixed with the binding agent in the outer layers of the FRP strip resulting in a weak surface layer within the material itself.

Interestingly the IC debonding pressure for this NSM FRP strip was estimated from pull test to be approximately 17.5kPa. This combined with Figure 8(d) indicates that following the onset of IC debonding there was a significant increase in force within the FRP strip. This is likely caused by a combination of friction and tension stiffening behavior. The deflected shape profile shown in Figure 8(c) was consistent with the desired simply supported test configuration.

32.3 kN, which is approximately 75% of the force (43 kN from Figure 8d) required to induce IC debonding in the single-leaf Wall 1.

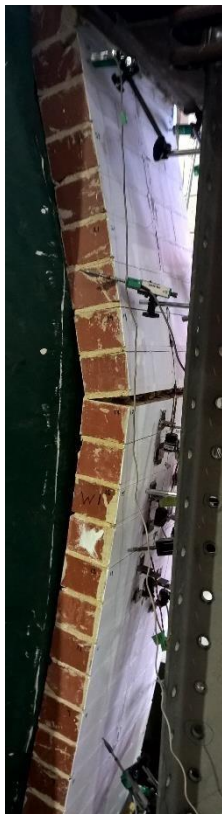
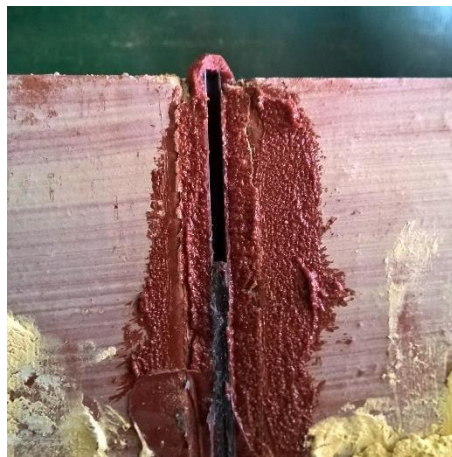
Figure 9: Wall 1 final cracking pattern

(a) Deflection profile at failure

(b) Slip of the FRP reinforcement associated with IC debonding formation

(c) Dual direction herringbone crack formation

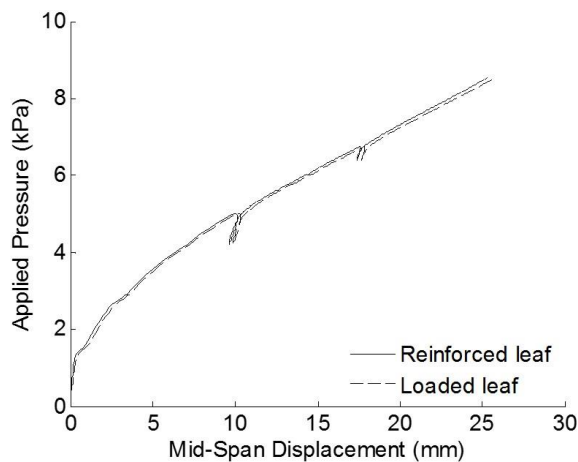
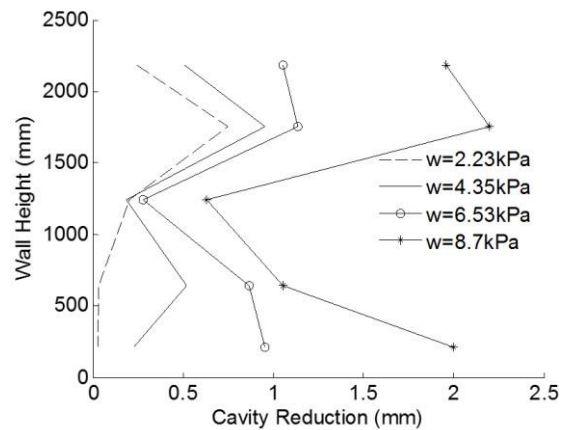
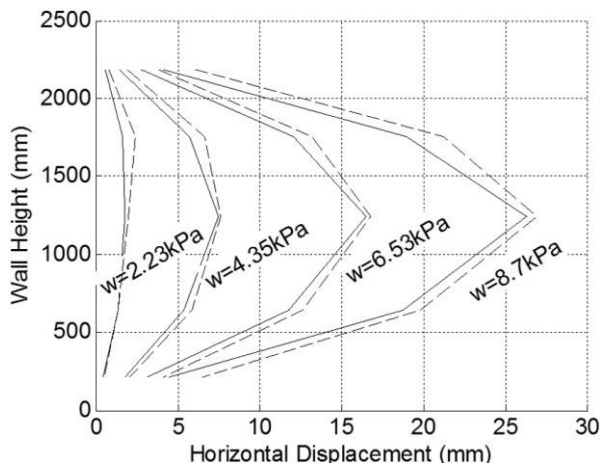
Figure 13: Wall 3 test results

Figure 13(a) shows the load vs mid-height deflection response for wall test where the ‘blue’ line shows the mid-height deflection of the R reinforced leaf and the ‘green’ line shows the mid-height deflection of the airbag loaded leaf. Figure 13(a) shows that the loaded leaf follows closely the path of the reinforced leaf and demonstrates that the wall ties were capable of maintaining the cavity width at mid-height. This observation is further highlighted in Figure 13(b) which shows that the maximum reduction in the cavity width prior to achieving the maximum applied pressure of 8.7 kPa was 2.3mm at three quarters of the wall height. Similarly Figure 13(c) demonstrates the horizontal deflection profile of the wall at various applied loads. In Figure 13(c) the solid line corresponds to the deflection of the reinforced leaf and the dashed line shows the deflection of the loaded leaf. Once again this clearly shows that the wall ties were able to maintain the cavity dimensions right up to the point at which buckling of the wall ties occurred. Importantly the wall ties were able to maintain a simply supported deflected shape in the loaded leaf.

(a) Load vs mid-span displacement

(b) Reduction in cavity width

(c) Deflected shape profile

(d) Crack width development

As previously observed there is a significant change in behavior of the wall around an applied load of 0.8 kN/m corresponding to initial tensile cracking of the masonry. In the case of the loaded leaf a horizontal crack first occurred in the 18<sup>th</sup> to 19<sup>th</sup> mortar joint and was followed shortly by the formation of a second crack at the 11<sup>th</sup> to 12<sup>th</sup> mortar joint (Figure 12(b)) such that the loaded leaf now behaved as 3 rigid bodies. Cracking in the reinforced leaf followed a similar pattern to that of the single leaf wall test with the formation of primary and secondary cracking such that small horizontal cracks formed at most mortar joints. As demonstrated by the recorded crack widths in Figure 13(d) horizontal

cracks formed at each of the 6 central mortar joints prior to a pressure of 4.3 kPa being applied to the wall.

Post cracking of the masonry, increased loading resulted in roughly linear deflected behavior right up to the ultimate pressure of 8.7 kPa being achieved at which point the wall ties at the 19<sup>th</sup> to 20<sup>th</sup> and 25<sup>th</sup> to 26<sup>th</sup> mortar joints buckled resulting in a sudden reduction of the cavity width (Figure 12(c)). Unfortunately failure of the strain gauges attached to the FRP strip meant that no data could be collected on the force in the FRP strip. It can be stated that at failure of the cavity connections there was no visible herringbone crack formations around the FRP strip potentially indicating that no significant debonding had been achieved.

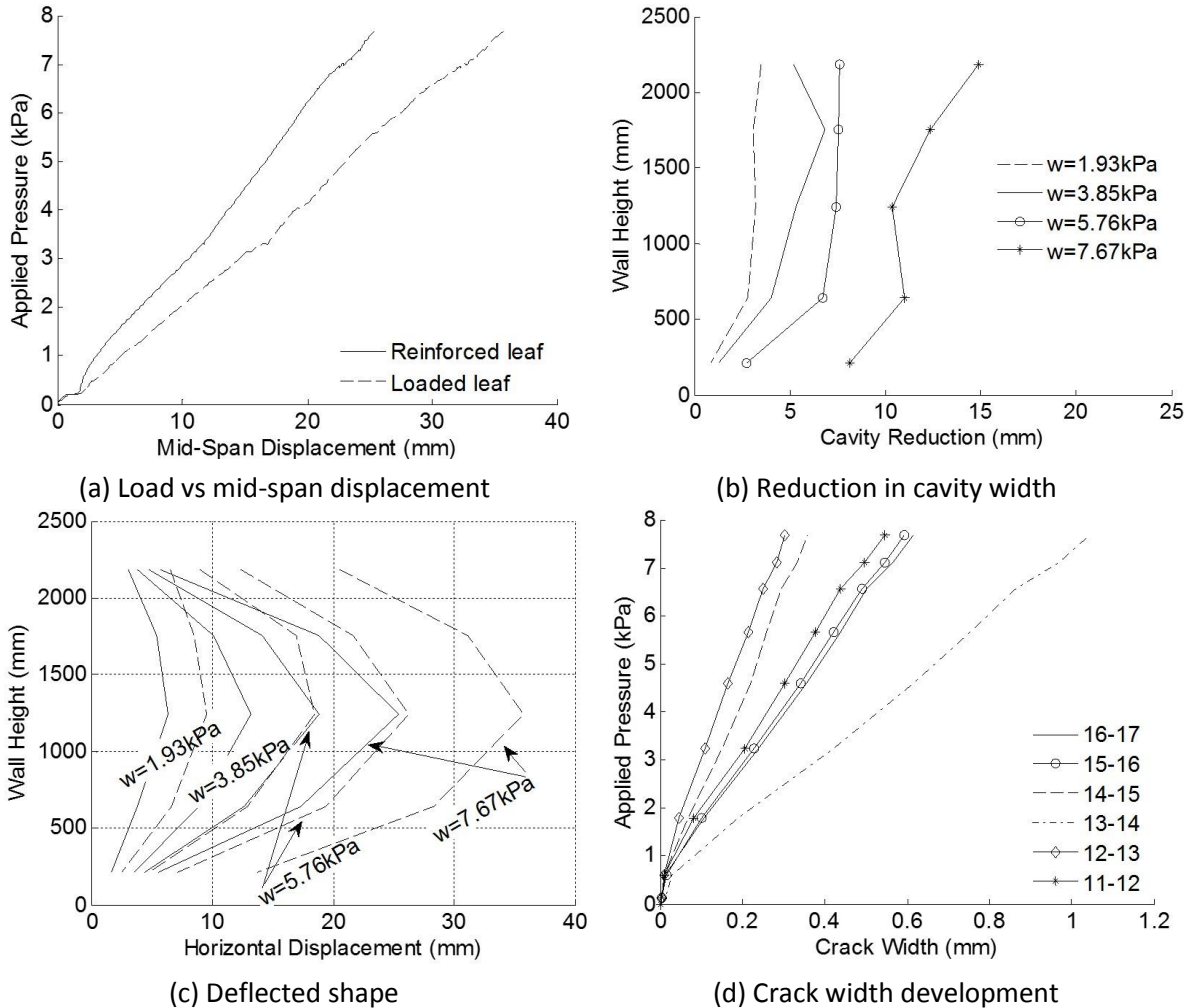
Figure 17: Wall 5 test results

Figure 17(a) shows the load to mid-height deflection profile for wall test 5 where the 'blue' line shows the mid-height deflection of the R reinforced leaf and the 'green' line shows the mid-height deflection of the airbag loaded leaf.

It is immediately clear that significantly larger differential wall deformation was associated with the mechanical anchors, with reduction in the cavity width being greater than that in Wall 3 that had standard wall ties. Figure 17(b) and (c) show that the cavity reduced by a maximum of 16mm corresponding to a 20% reduction in overall cavity width. This was likely caused by the anchors failing to achieve a good bond with the reinforced leaf, possibly affected by the conical brick failure during predrilling or potentially the 10 perforations present in the brick units. It was observed that at completion of the test the wall anchors had been pushed 15mm out of the reinforced wall leaf such that they pultruded 10mm out of the face of the wall leaf.

Unlike the previous wall tests Wall 5 did not display the initial stiff load deflection behavior due to the pre-existing cracks existing in both wall leaves. Figure 17(d) shows that the flexural cracks near the

center of the reinforced leaf began to reopen immediately and a constant linear load-deflection behavior was observed throughout the test.

Unfortunately wall test 5 failed prematurely due to the lateral buckling of the top most wall anchor at a pressure of 7.7 kPa. The green canvas containing the air bag detached from the timber framework on the right hand side of the test wall. This resulted in the airbag wrapping around the edge of the test wall and applying an additional lateral load leading to premature buckling of the anchors.

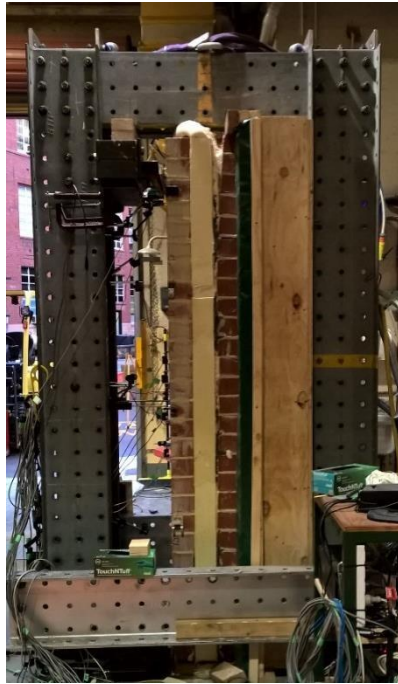
Testing of the 7<sup>th</sup> wall was undertaken on the 17<sup>th</sup> of September 2015 in the Chapman Laboratory at The University of Adelaide. The 7<sup>th</sup> wall test reused the pre-cracked wall from wall test 4 and was designed to investigate the use of self-expanding foam as a method of transferring compression loads between the masonry leaves. In the case of wall test 7 the cavity was completely filled with foam (Erathane TX56) to create a sandwich panel consisting of FRP reinforced masonry skins and a foam core (Figure 19(a)).

(a) Foam cored cavity wall

Secondly as the wall was pre-cracked from previous testing, the pressure induced by the expanding foam resulted in bowing of the masonry leaves apart and increasing the cavity width. Additionally the foam in its viscous state was able to flow into the preexisting cracks and the subsequent expansion resulted in further opening of the cracks and the corresponding wall deflections (Figure 19(b)). Both of these problems could be addressed by the selection of a more suitable foam with reduced viscosity and through propping of the walls to prevent any unintended expansion damage.

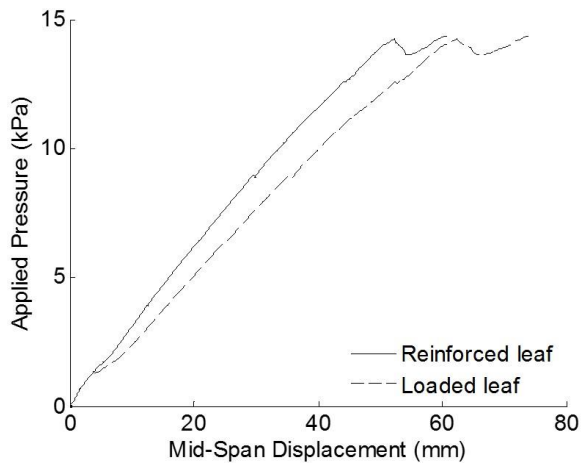
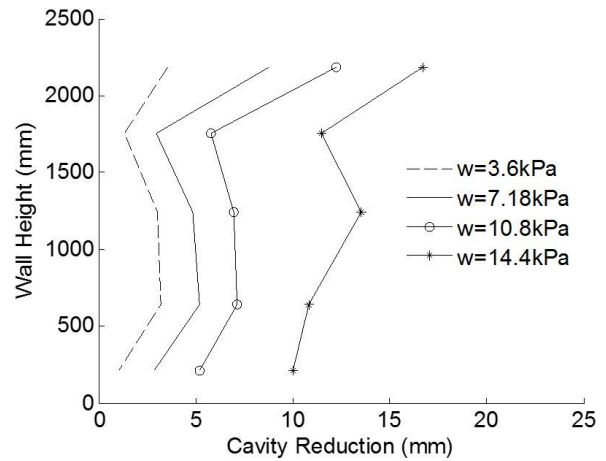
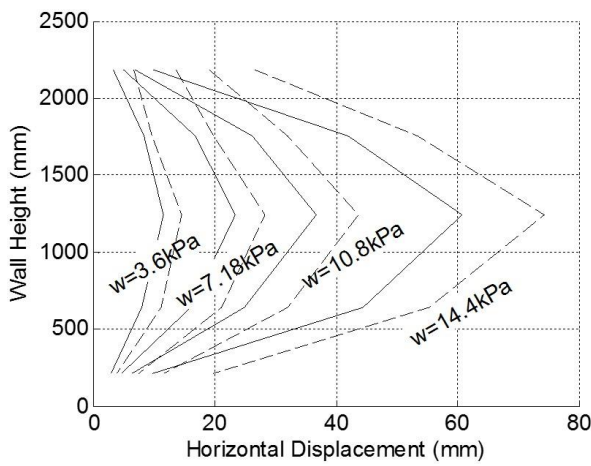
Figure 20: Wall 6 test results

(a) Load vs mid-span displacement

(b) Reduction in cavity width

(c) Deflected shape profile

(d) Crack width development

Figure 20(a) shows the load vs mid-height displacement response of wall test where the ‘blue’ line shows the mid-height deflection of the R reinforced leaf and the ‘green’ line shows the mid-height deflection of the airbag loaded leaf. Again the pre-loading of the test wall results in immediate

reopening of the cracks in the mortar joints (Figure 20(d)) and the linear load-deflection behavior throughout the entire test range.

Interestingly while the mechanical anchors didn't buckle there was still a significant reduction in the cavity width as evident in Figure 20(b) and Figure 18(b). This reduction was again accommodated by the mechanical anchors being pushed out of the reinforced leaf.

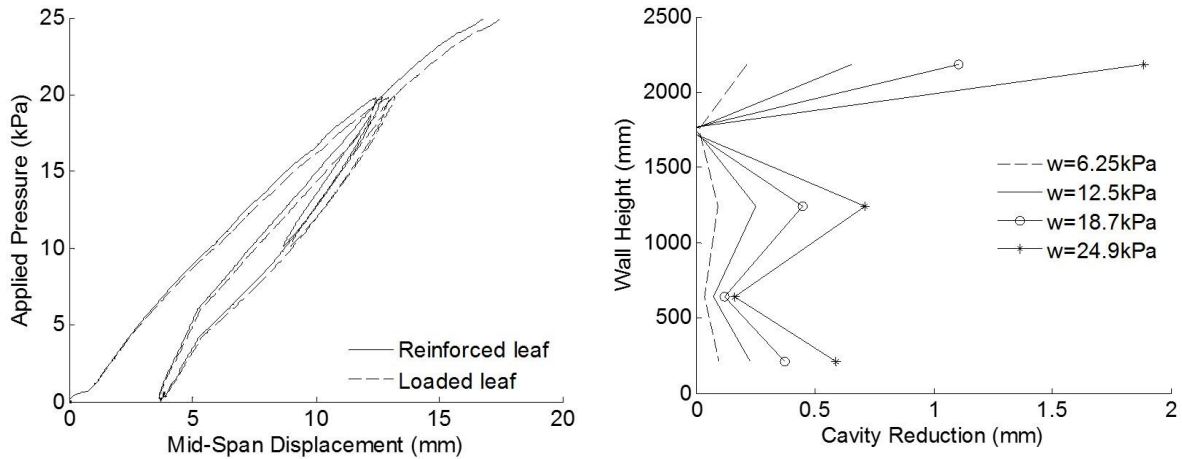
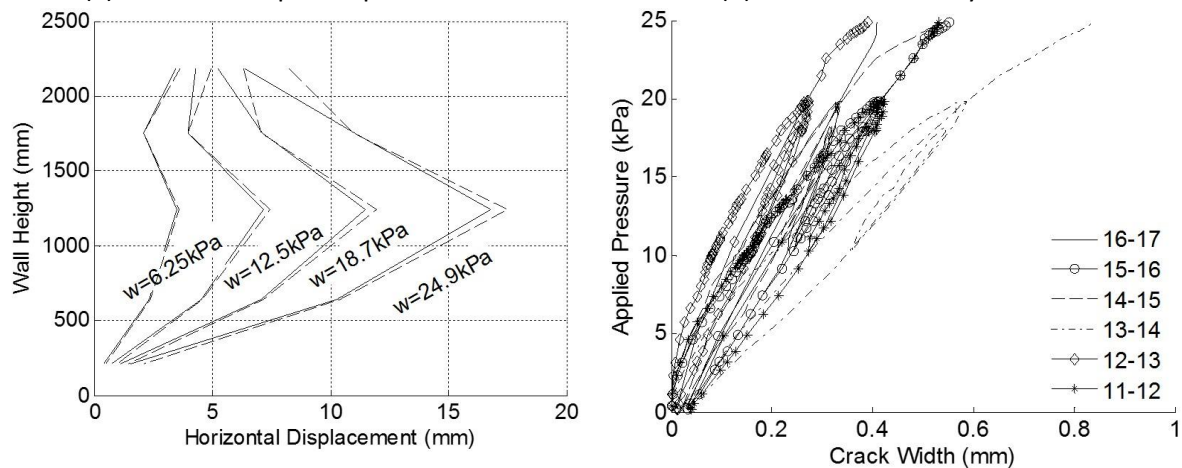
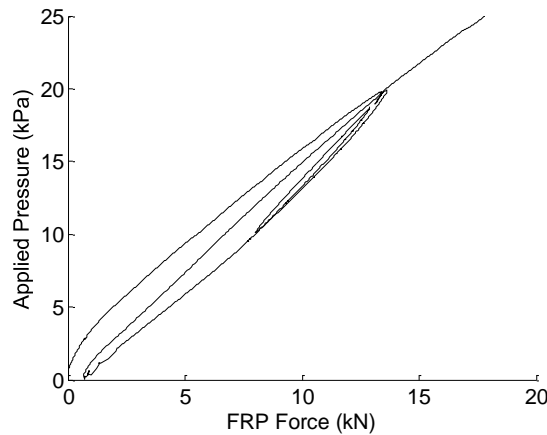
(a) load vs mid-span displacement

(b) reduction in cavity width

(c) wall deflected shape

(d) crack width development

(e) measured FRP force

Figure 21(a) shows the load to mid-height deflection profile for wall test where the 'blue' line shows the mid-height deflection of the R reinforced leaf and the 'green' line shows the mid-height deflection of the airbag loaded leaf. Again the pre-loading of the test wall resulted in immediate reopening of the cracks in the mortar joints (Figure 21(d)) and a linear load-deflection behavior throughout the entire test range.

Wall test 7 demonstrated the significant increase in strength achievable using the expanding foam as a connection method within the cavity. Wall 7 was subjected to an applied pressure of 24.9 kPa which was the upper limit that could be applied using the designed test rig. At this load it was found that there was a negligible reduction in the cavity width (Figure 21(b)).

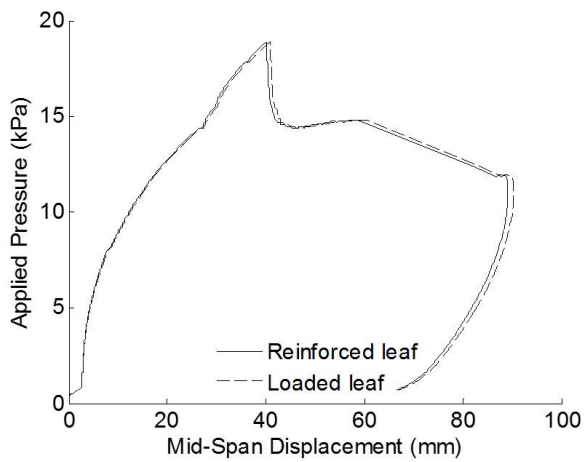
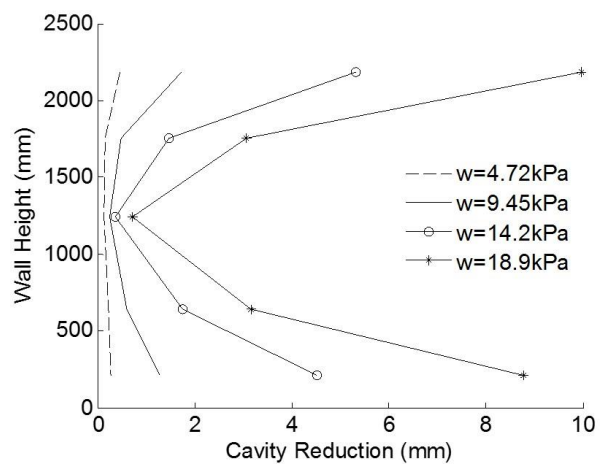
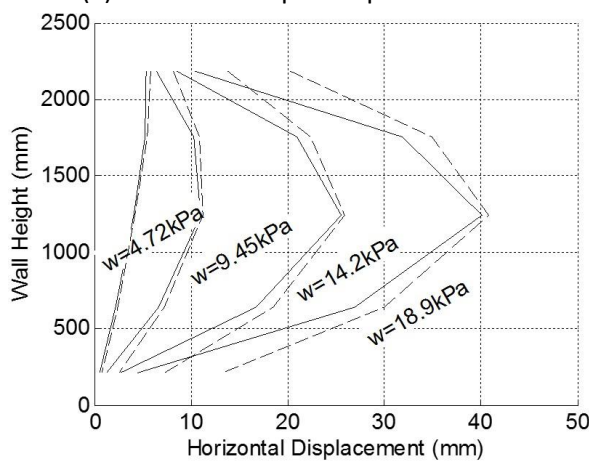
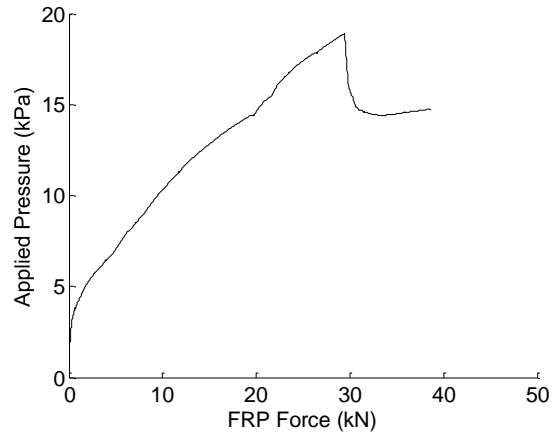
Figure 23: Wall 8 test results

(a) Load vs mid-span displacement

(b) Reduction in cavity width

(c) Deflected shape profile

(d) Crack width development

(e) FRP force development

Figure 23 shows the load vs mid-height deflection profile where the 'blue' line shows the mid-height deflection of the front, unreinforced leaf and the 'green' line shows the mid-height deflection of the airbag loaded leaf. Figure 23(a) shows that the loaded leaf follows closely the path of the front, unloaded leaf and shows that the foam was capable of maintaining the cavity width at mid-height. Near the supports, however, the foam was gradually compacted such that, on achieving the maximum resisted 18.9 kPa, the cavity width had reduced by 10 mm (Figure 23(b)). Figure 23(c) shows the horizontal deflection profile of the wall at various applied loads. In Figure 23(c) the solid line corresponds to the deflection of the reinforced leaf and the dashed line shows the deflection of the loaded leaf. From this figure it can be seen that both leaves rotated, such that just below the support a displacement of 5 mm was achieved, before the wall engaged the top support.

Figure 23(d) shows the crack width development near mid height of the front leaf. For this test it appears that significant crack growth did not begin until an applied pressure of 3.0 kPa was achieved. It is also interesting to note that unlike the wall tie connections or mechanical anchorage connections of test walls 3 through 6, the initiation of crack growth did not result in a sudden change in behavior but rather a gradual reduction in stiffness as evident in Figure 23(a). As demonstrated by the recorded

crack widths in Figure 23(d) horizontal cracks had formed at each of the 6 central mortar joints prior to a pressure of 7.0 kPa being applied to the wall.

The development of force in the NSM FRP strip is shown in Figure 23(e). Once again it can be seen that it is not until after the formation of flexural cracks at an applied pressure of 3.0 kPa that the FRP strip is utilized. It is also interesting to note that the force in the FRP strip continues to increase following compressive failure of the foam at an applied pressure of 18.9 kPa. This shows how the force in the FRP strip is tied to the growth of the crack widths and not the applied pressure. In the case of this test wall, the force in the FRP continued to increase to a load of 40 kN at which point IC debonding occurred. This debonding load is consistent with the 44 kN achieved in the FRP strip from the first wall test (Figure 8(d)). It is worth noting that in both cases the horizontal crack associated with debonding was located 3-4 courses away from the strain gauges attached to the FRP strip and may not be an accurate reflection of the max force in the FRP strip which would be expected to occur at the location of the dominant horizontal crack.

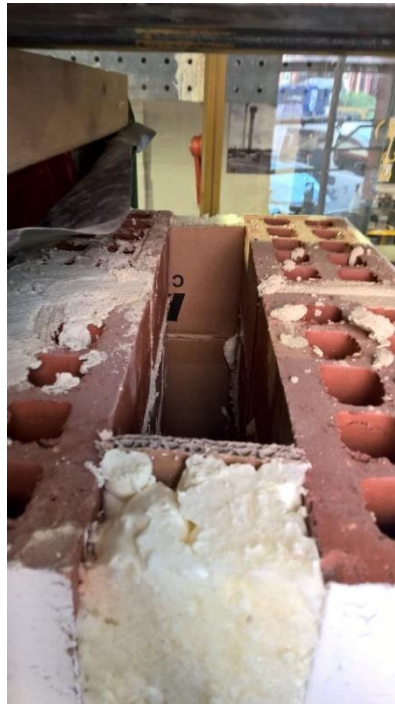
Figure 24: Wall 9 cracking pattern

(a) Overall test configuration

(b) Foam cavity

(c) Flexural failure

The 9<sup>th</sup> wall test consisted of an unreinforced cavity wall, i.e. no FRP, where the existing wall tie connection between the masonry leaves was cut and replaced with a nominally 50mm deep channel of foam on either side of the strip wall. Testing was undertaken on the 28<sup>th</sup> of April 2016 in the Chapman Laboratory at The University of Adelaide. The general test setup for the test wall is shown in Figure 24(a) and a close-up of the foam channel is shown in Figure 24(b).

The testing of the 9<sup>th</sup> wall followed a similar behavior to that observed with the 2<sup>nd</sup> wall test where no reinforcement was present. Specifically the testing of the unreinforced, foam channel cavity wall was dominated by the formation of 3 horizontal cracks. A single crack formed in the front, unloaded leaf between the 18<sup>th</sup>-19<sup>th</sup> courses and the remaining 2 cracks formed in the loaded leaf between the 17<sup>th</sup>18<sup>th</sup> and 19<sup>th</sup>-20<sup>th</sup> courses as shown in Figure 24(c). Subsequent loading resulted in increased deflections, accommodated by the growth of these 3 cracks, with minimal increase in the resisted pressure. From Figure 24(c) it can also be seen that the foam channel enabled the wall cavity wall to achieve composite action with the flexural crack progressing through the front, unloaded wall and into the foam channel.

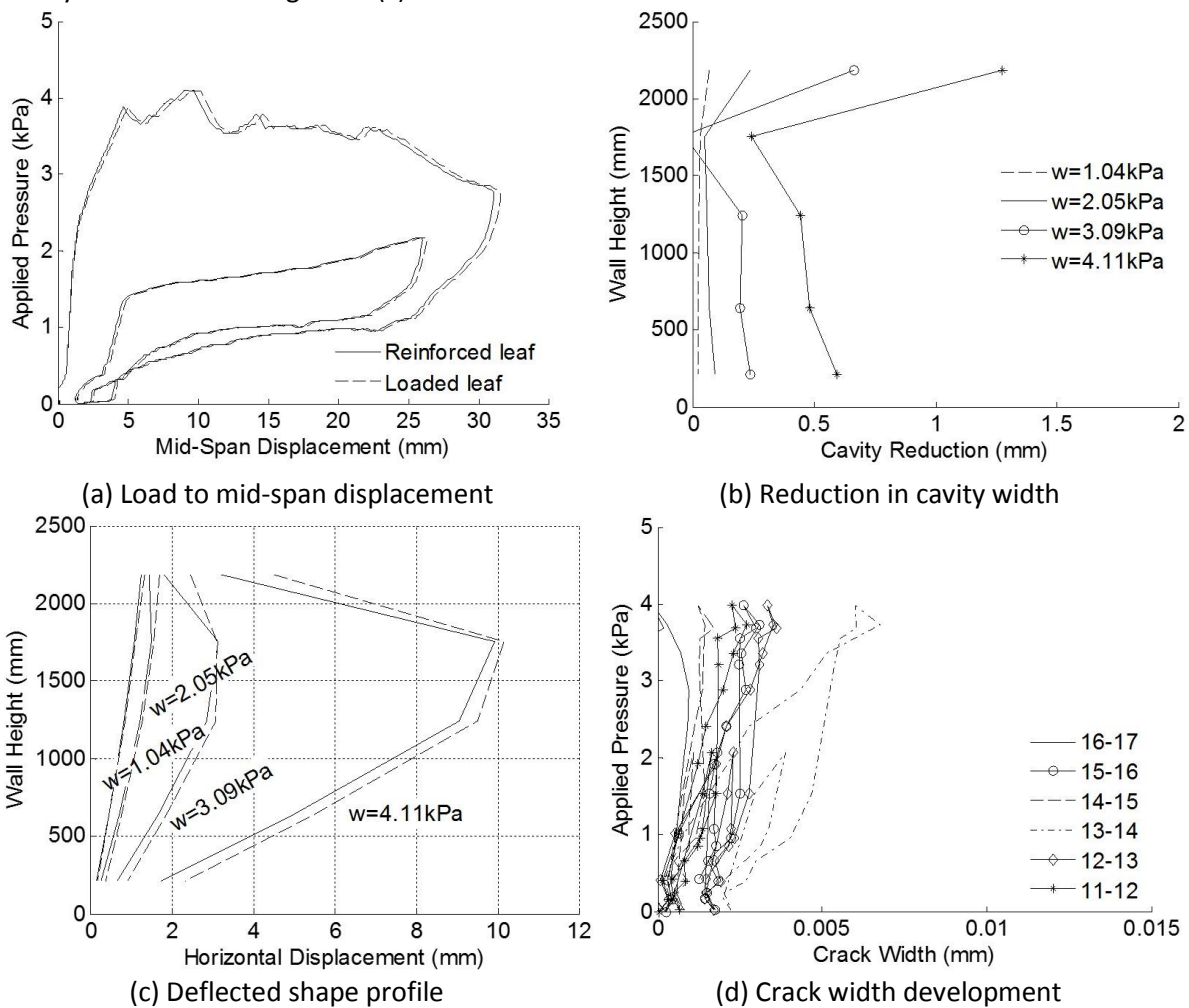
Figure 25: Wall 9 test results

Figure 25(a) shows the load to mid-height deflection profile for the 9<sup>th</sup> test wall where the 'blue' line shows the mid-height deflection of the front, unreinforced leaf and the 'green' line shows the midheight deflection of the airbag loaded leaf. It should be noted that the initial deflection prior to 2 mm was caused by a rotation of both wall leaves such that good contact was made with the top roller support at the 26<sup>th</sup> course. This initial rotation displacement is exaggerated with wall height as can be seen by the blue line in Figure 25(c).

Figure 25(a) shows that the loaded leaf follows closely the path of the front, unloaded leaf and demonstrates that the foam channels were capable of maintaining the cavity width at mid-height. This observation is further highlighted in Figure 25(b) which shows that the maximum reduction in the cavity width prior to achieving the maximum applied load was 1.5 mm at the top of the wall. Figure 25(c) shows the horizontal deflection profile of the wall at various applied loads. In Figure 25(c) the solid line corresponds to the deflection of the reinforced leaf and the dashed line shows the deflection of the loaded leaf. Once again this clearly shows that the foam channels were able to maintain the cavity dimensions up to the maximum applied load. Finally, Figure 11(d) shows the crack width development near mid height of the front loaded leaf. From Figure 25(d) it can be seen that none of the instrumented mortar joints near wall mid-height developed any flexural cracking.

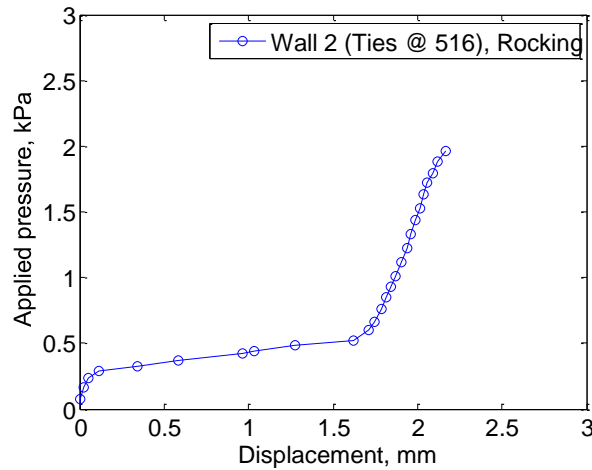
Figure 26: Applied pressure vs max displacement response of the unretrofitted cavity wall 2

The backbone curve for the recorded force-displacement data of the unretrofitted wall W2 is separately shown in Figure 26, with Figure 27 showing the backbone curve for the walls retrofitted using different techniques. The plotted data represent the part of the tests during which the cavity gap was maintained by the ties, and the ties/anchors failed under forces beyond that shown in these plots.

From Figure 26, it can be seen that the as-built anchors cannot maintain the cavity gap for applied pressures up to approximately 2 kPa, which corresponds to a lateral acceleration of 0.5g applied on a

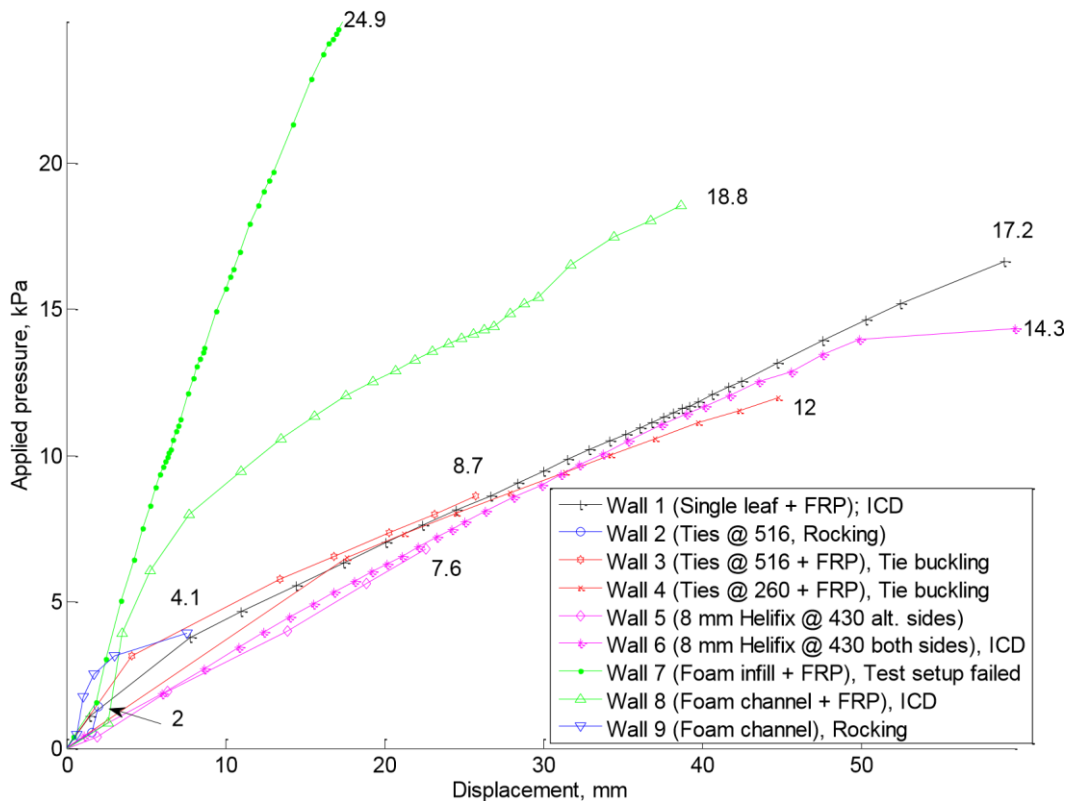
Figure 27: Applied pressure vs max displacement response of the tested walls

From Figure 27, it can be seen that all of the retrofitted walls, except for Wall 9 (foam strips but no FRP), significantly increased the wall strength, and the increase was at least 280% (i.e. 7.6 kPa for Wall 5 vs. 2 kPa for Wall 2). With this increased strength the walls will satisfy seismic requirements in Australia with acceptable safety factor.

It can be seen from the plots in Figure 27 that the two walls that were retrofitted using foam + FRP had the greatest initial stiffness, but the initial stiffness of other retrofitted walls were almost the same. From the two walls with foam contribution, the one that had foam strips had its stiffness reduced with the increase in the applied load, with the residual stiffness appearing to be of the same magnitude as that of the walls with anchor/tie + FRP.
