TESTING OF SIMULATED FLOOD EFFECT ON THE STRENGTH OF SELECTED BUILDING COMPONENTS

Tariq Maqsood¹, Martin Wehner¹, Mark Edwards¹, Simon Ingham²
and David Henderson²

¹ Geoscience Australia

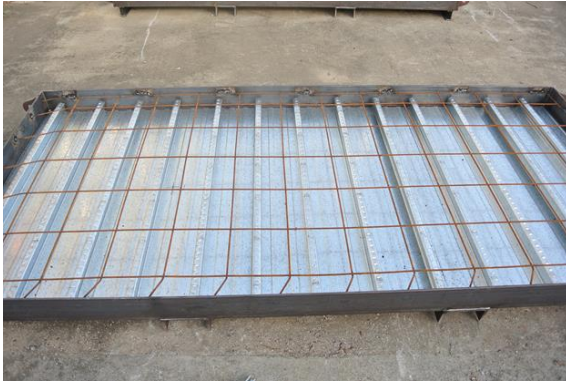
FIGURE 2: STEEL BED FOR CONCRETE SLAB

Three simulated bathroom samples were manufactured. The samples comprised a concrete slab poured into a steel bed (Figure 2), on which three stud walls were built (Figure 3). Pine planks were used to simulate door jambs (Figure 4). The wall sides facing the inside of the samples were lined with fibrecement sheeting affixed with stud glue and nailed onto the studs at the joints. The wall sides facing the outside of the samples were lined with plasterboard using stud glue and no lining was used for the end wall (Figure 5). The plasterboard sheeting was primed and painted with two coats of anti-bacterial paint (Figure 6). The corners between walls and between walls and floor were then sealed and waterproofed (Figure 7 and Figure 8). Finally the floors and wall ceramic tiles were glued onto the floors and walls respectively (Figure 9, Figure 10, Figure 11 and Figure 12), grouted (Figure 15), and corner gaps were sealed with silicone (Figure 16 and Figure 17).

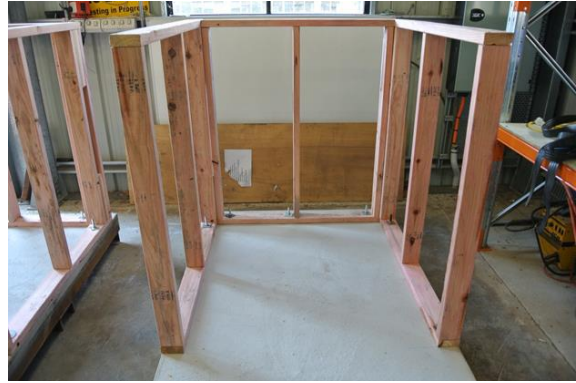
FIGURE 3: TWO LATERAL AND ONE END STUD WALLS

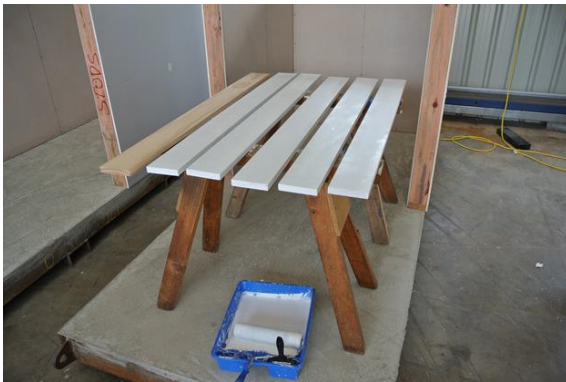
FIGURE 4: PINE PLANKS USED TO SIMULATE DOOR JAMBS

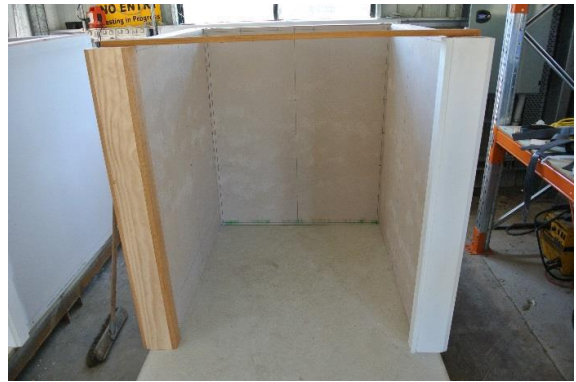
FIGURE 5: STUD WALLS LINED AND DOOR JAMBS INSTALLED

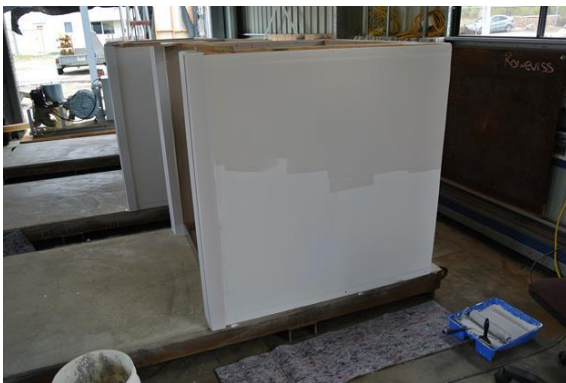
FIGURE 6: PAINTING OF PLASTER BOARD

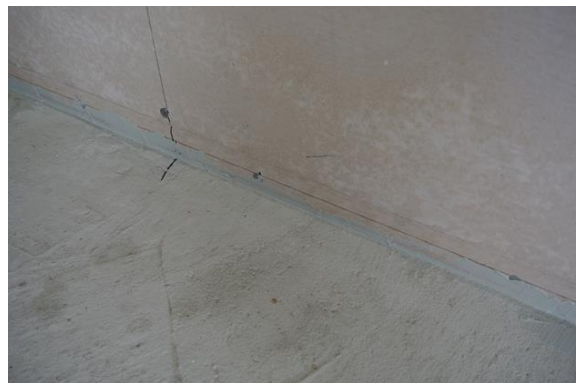
FIGURE 7: FILLING OF WALLS AND WALLS AND FLOOR CORNERS

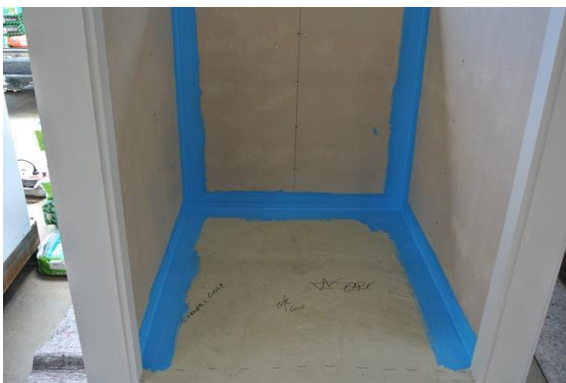
FIGURE 8: WATERPROOFING OF CORNERS BETWEEN WALLS AND WALLS AND FLOOR

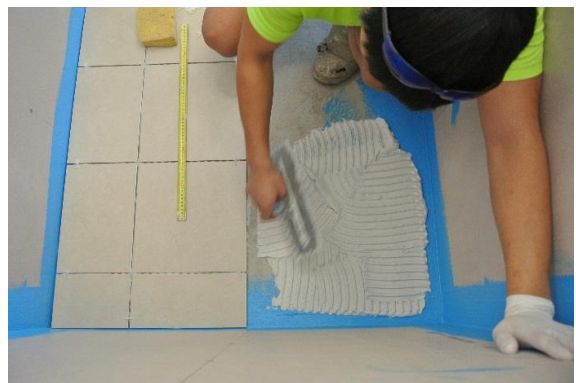
FIGURE 9: FLOOR TILING

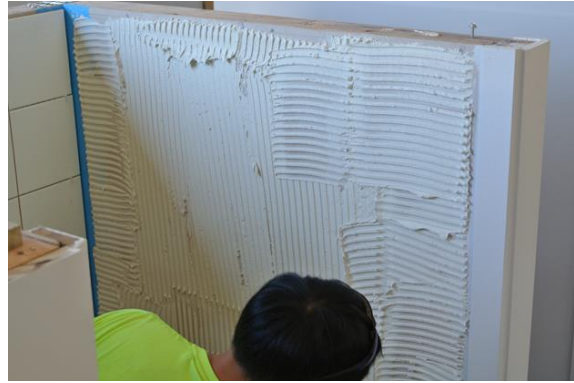
FIGURE 11: WALL TILING

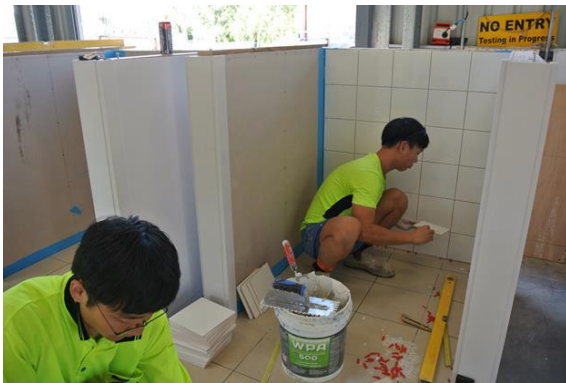
FIGURE 12: WALL TILING

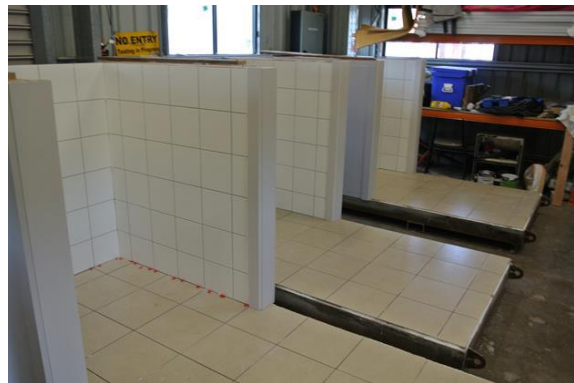
FIGURE 13: SAMPLES TILED

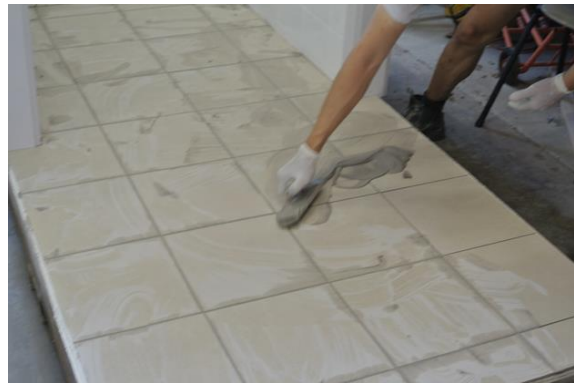
FIGURE 15: TILES GROUTING

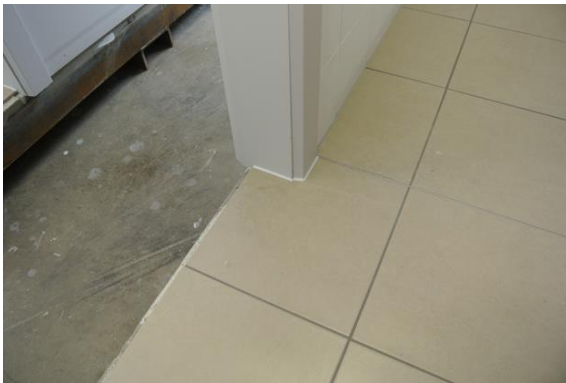
FIGURE 16: GAPS FILLED WITH SILICONE

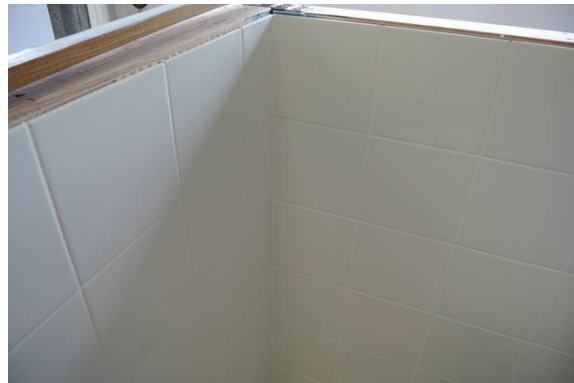
FIGURE 17: GAPS FILLED WITH SILICONE

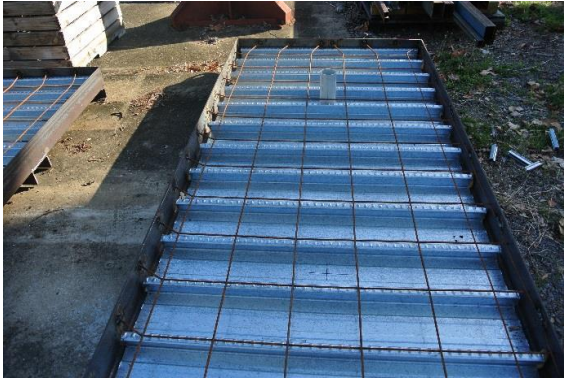
FIGURE 18: STEEL BED FOR CONCRETE SLAB WITH PVC PIPE

Three simulated shower samples were manufactured. The samples comprised a concrete slab poured into a steel bed, fitted with a PVC pipe to simulate the shower floor waste (Figure 18), on which three stud walls were built (Figure 19). Pine planks were used to simulate door jambs (Figure 20). The wall sides facing the inside of the samples were lined with fibrecement sheeting affixed with stud glue and nailed onto the studs at the joints. The wall sides facing the outside of the samples were lined with plasterboard using stud glue and no lining was used for the end wall (Figure 21). The plasterboard was primed and painted with two coats of anti-bacterial paint (Figure 22). The entrance of the shower enclosure was fitted with a screed angle (Figure 23 and Figure 24). The corners between walls and between walls and floor were sealed and the whole shower enclosure was waterproofed (Figure 25 and Figure 26). The shower enclosure was filled with a cement screed to create falls to the floor waste (Figure 27 and Figure 28). Finally the floors and wall ceramic tiles were glued onto the floors and walls, respectively, (Figure 29, Figure 30, Figure 31 and Figure 32), grouted (Figure 35), and corner gaps were sealed with silicone (Figure 36 and Figure 37).

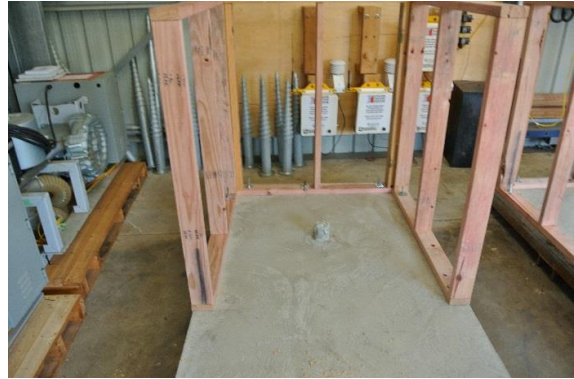
FIGURE 19: TWO LATERAL AND ONE END STUD WALLS

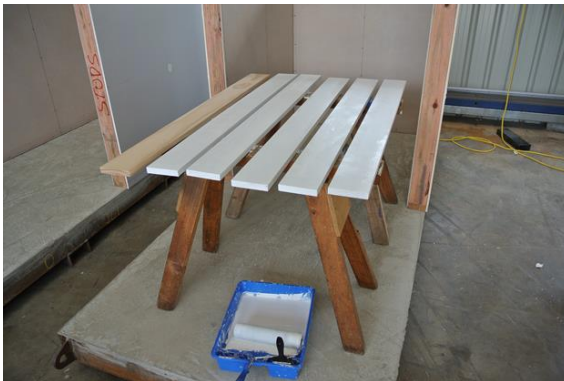
FIGURE 20: PINE PLANKS USED TO SIMULATE DOOR JAMBS

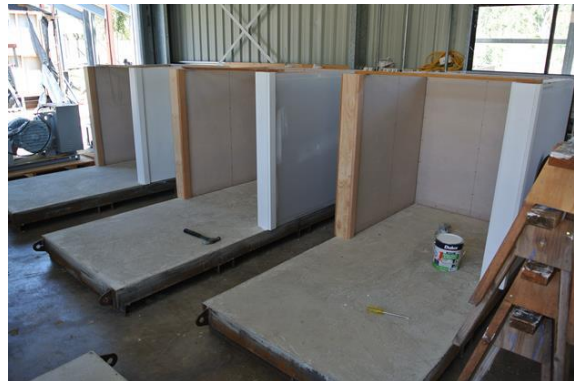
FIGURE 21: STUD WALLS LINED AND DOOR JAMBS INSTALLED

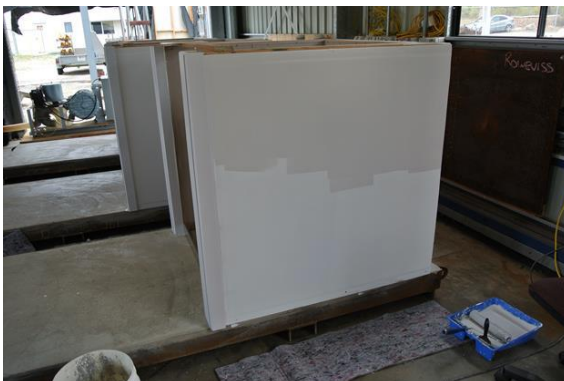
FIGURE 22: PAINTING OF PLASTER BOARD

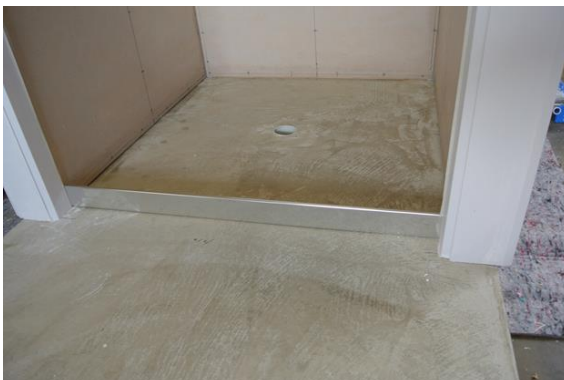
FIGURE 24: SHOWER SEAL FITTED TO ENTRANCE OR ENCLOSURE

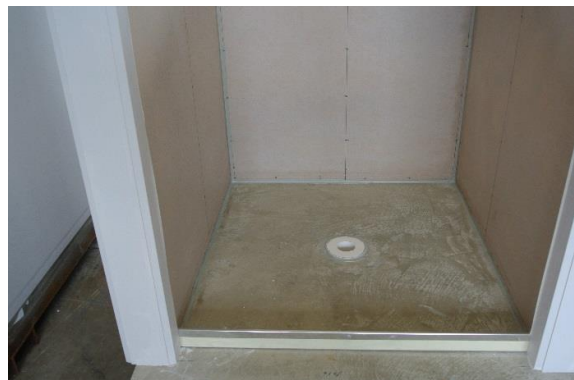
FIGURE 25: FILLING OF CORNERS BETWEEN WALLS AND FLOOR

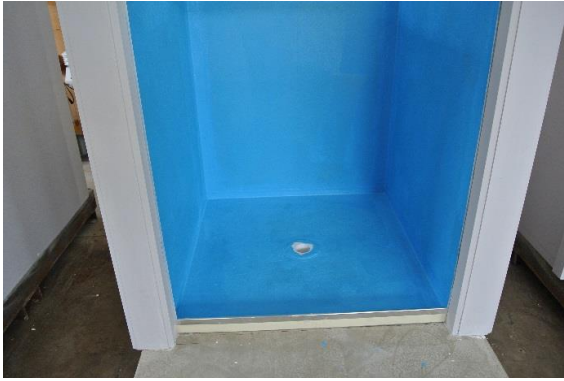
FIGURE 26: WATERPROOFING OF SHOWER ENCLOSURE

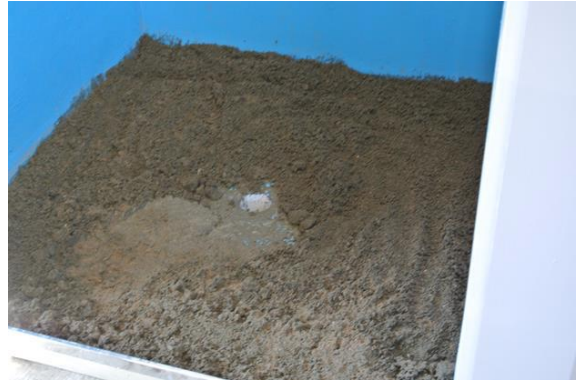
FIGURE 27: RECESSING OF SHOWER ENCLOSURE

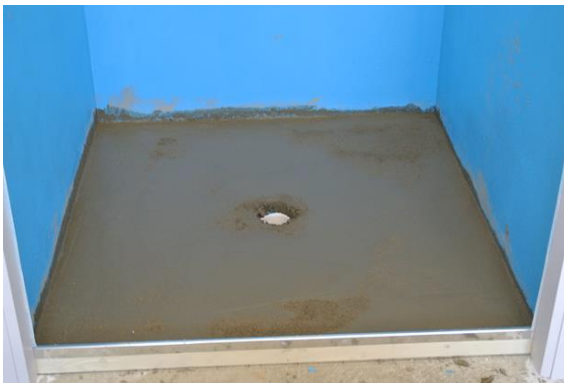
FIGURE 28: SHOWER ENCLOSURE RECESSED

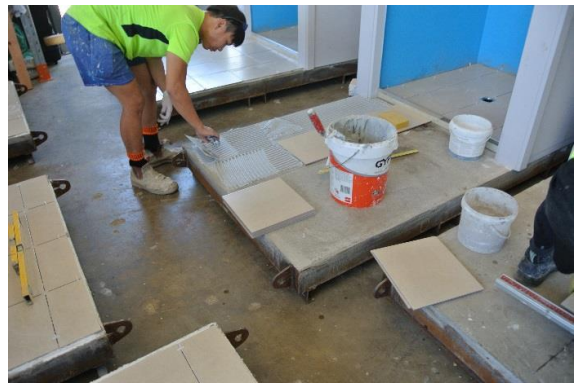
FIGURE 29: FLOOR TILING

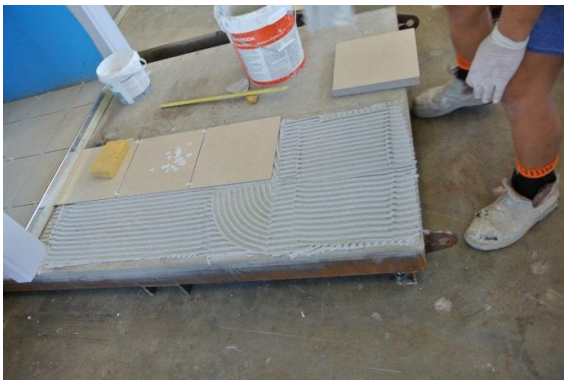
FIGURE 30: FLOOR TILING

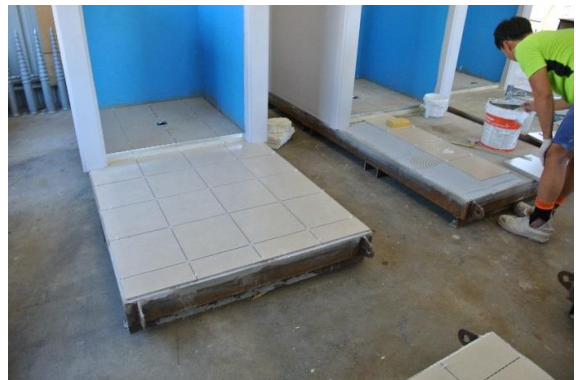
FIGURE 31: FLOOR TILING

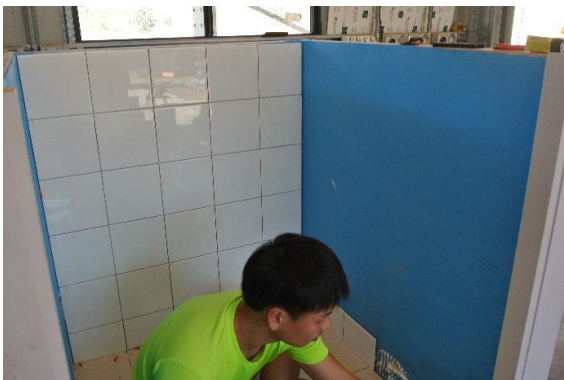
FIGURE 32: WALL TILING

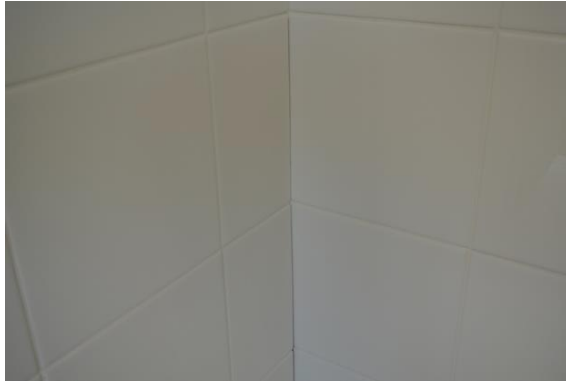
FIGURE 34: GAP BETWEEN TILES AT WALLS CORNERS

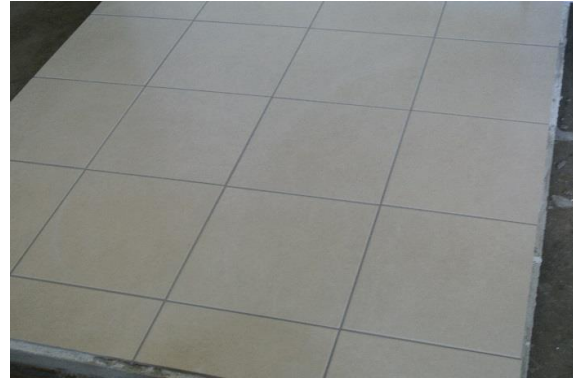
FIGURE 35: TILES GROUTING

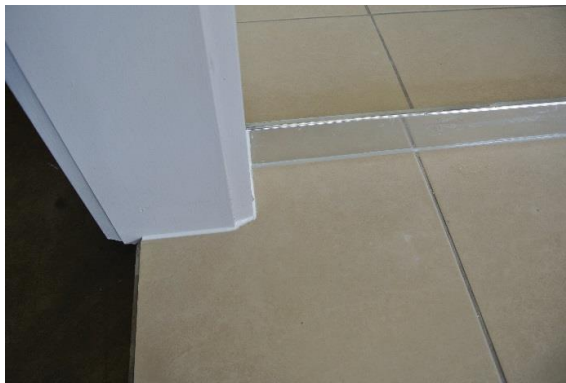
FIGURE 36: GAPS FILLED WITH SILICONE

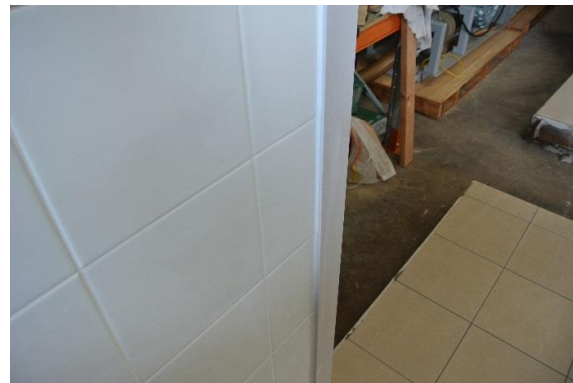
FIGURE 37: GAPS FILLED WITH SILICONE

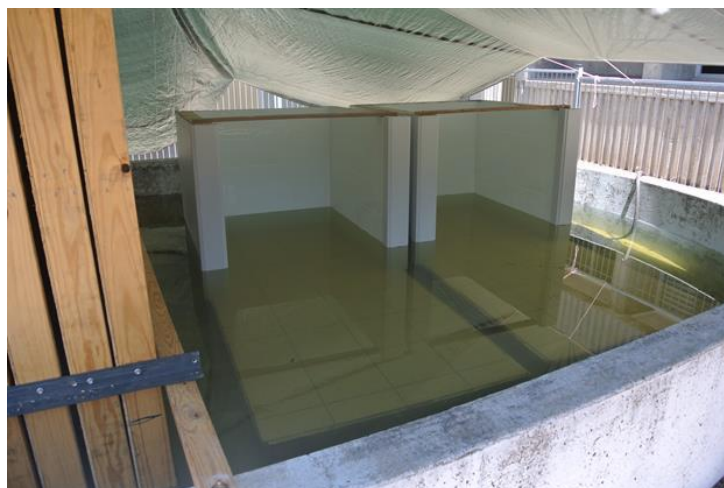
Two bathroom and two shower simulated samples were placed in a water tank and the water level was raised to 600 mm above the floor tiles for four days. Figure 38 shows two samples in the tank with water. Subsequently the water was drained out, the samples were removed from the tank and were placed in a ventilated sheltered drying area for a duration of six weeks.

FIGURE 38: TWO SAMPLES IN THE WATER TANK DURING THE FLOOD SIMULATION

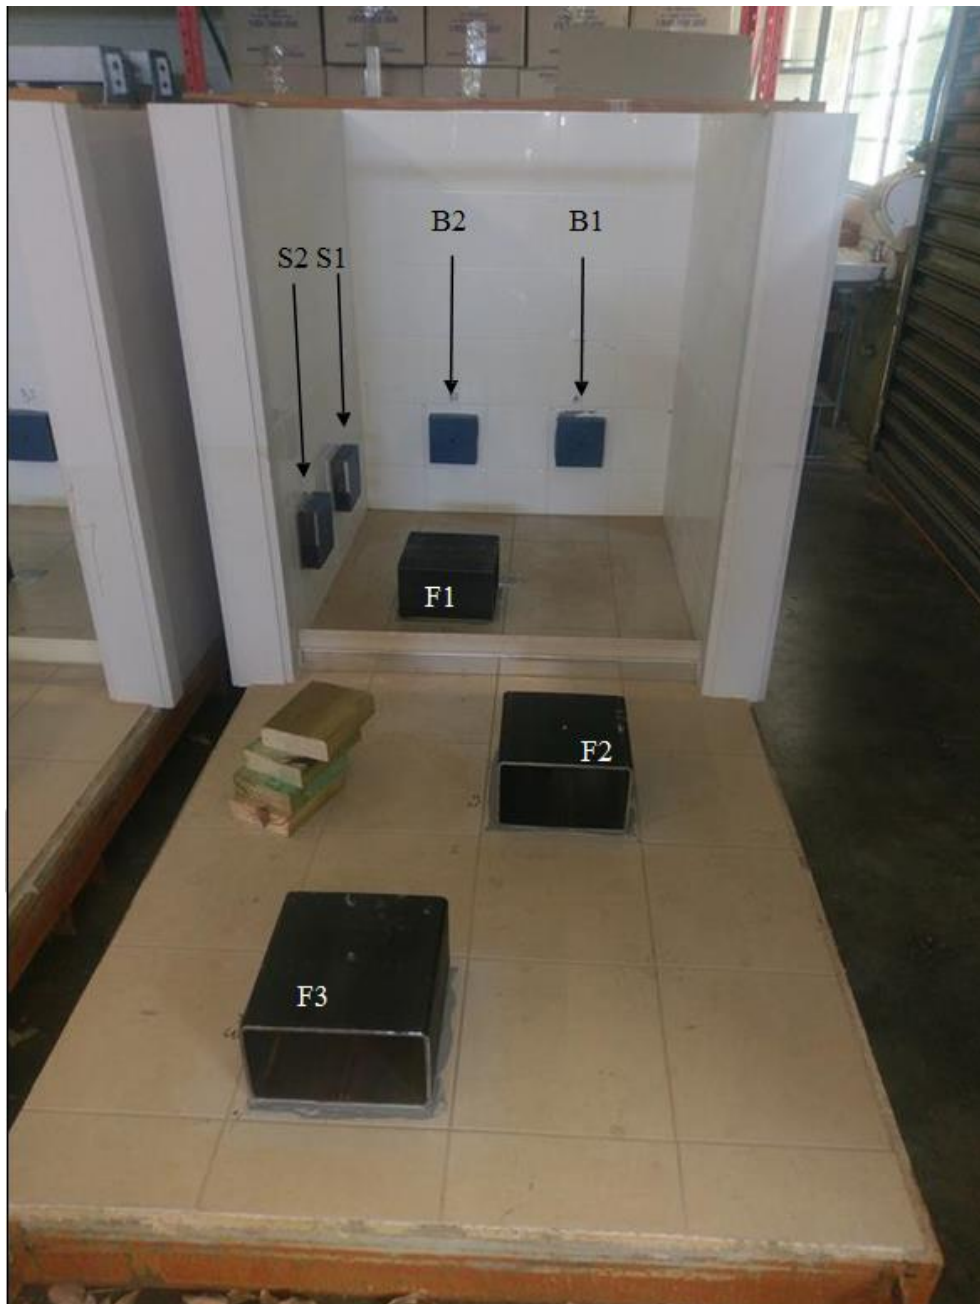
For each sample a total of seven tile pull-out tests were performed, three on floor tiles and four on wall tiles (two on the end wall and two on the left side wall). Steel RHS sections were bonded to the surface of the tiles to be tested in order to provide an anchoring point to perform the testing. The same method was used for both wall and floor tiles, but using two different RHS sizes to accommodate the difference in size between wall and floor tiles. Figure 39 shows the locations of the seven RHS attachment points (F1, F2, F3, B1, B2, S1 and S2) bonded to the tiles of one sample. These locations were kept consistent across all samples.

FIGURE 39: LOCATION OF TILES TO BE TESTED AND RHS ANCHORING POINTS BONDED ON TILES

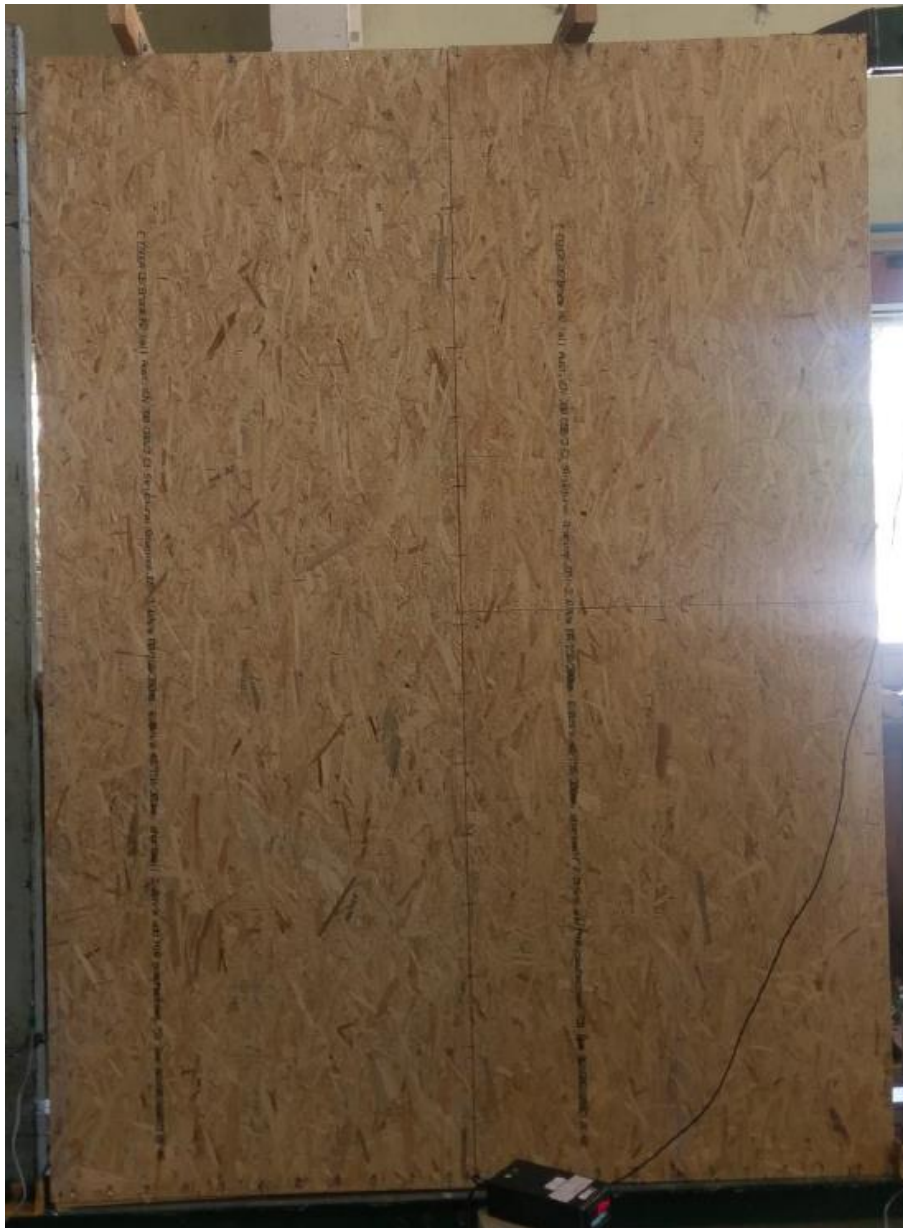
Two types of timber wall samples were manufactured to perform this test programme, the first type of wall frame was braced with OSB sheeting and the second type with HDF sheeting. The samples were comprised of MGP10 timber frames nominally 1,800 mm wide and 2,400 mm high with studs at approximately 450 mm centres. Either OSB or HDF wall sheet bracing was fixed to the frames using 2.5mm diameter by 32mm length electro galvanized head nails in accordance with the manufacturer's specifications. For the OSB samples the sheeting was fixed to the timber frame at the following spacings: to the top and bottom plates at nominally 80mm centres, to the other edge of sheet at nominally 150mm centres, to the internal studs at 300mm centres and at the vertical butt joint at 80 mm centres (see Figure 43).

FIGURE 43: CONSTRUCTED OSB SAMPLE

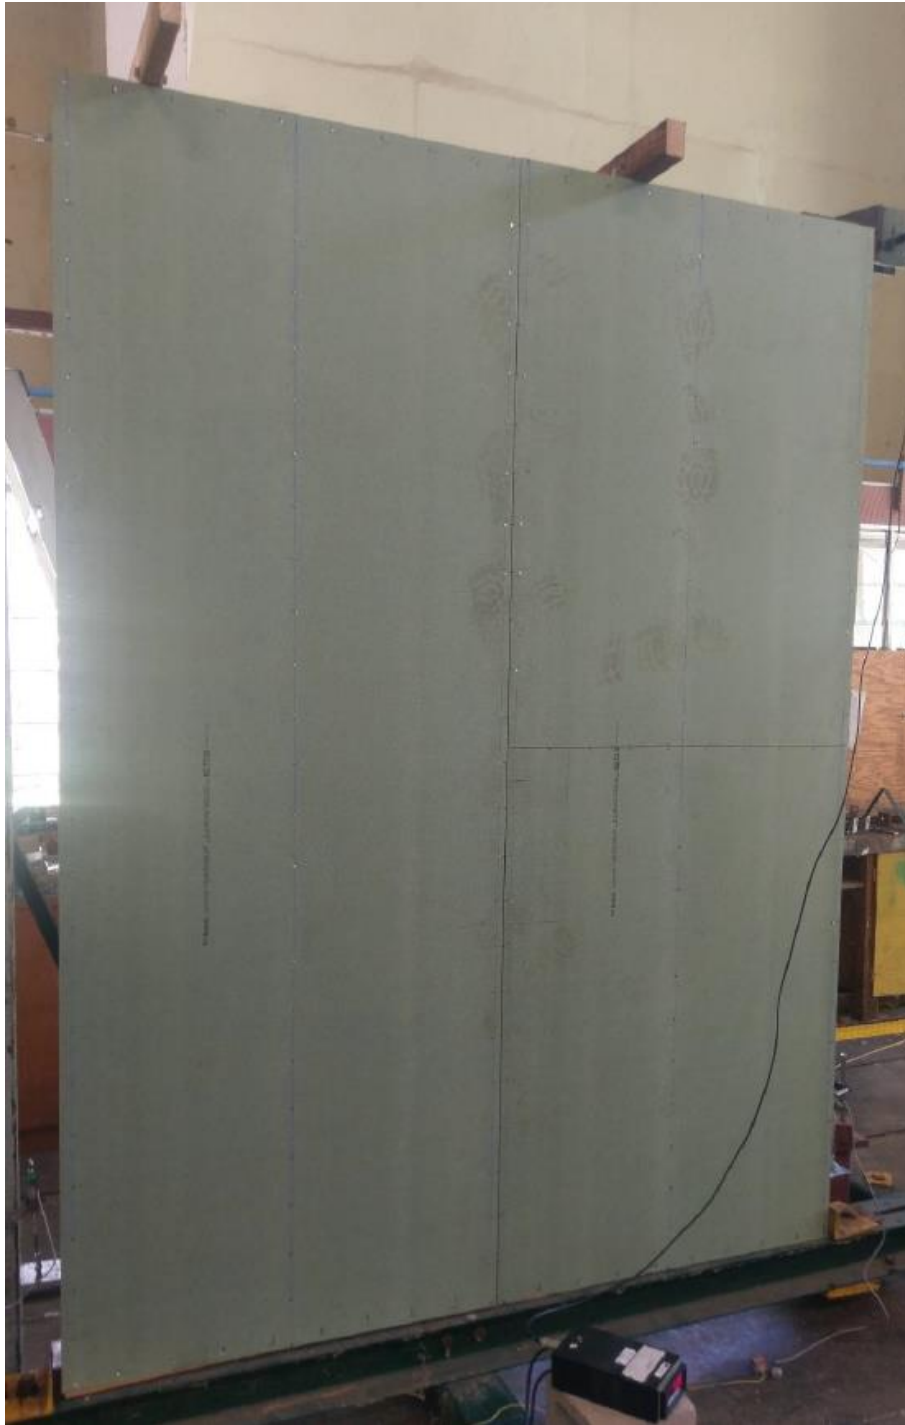
For the HDF samples the sheeting was fixed to the frame at 100 mm centres in all locations as per the manufacturer's specifications. All nails were positioned at a minimum edge distance of 12mm. Figure 44 shows a constructed HDF sample.

FIGURE 44: CONSTRUCTED HDF SAMPLE

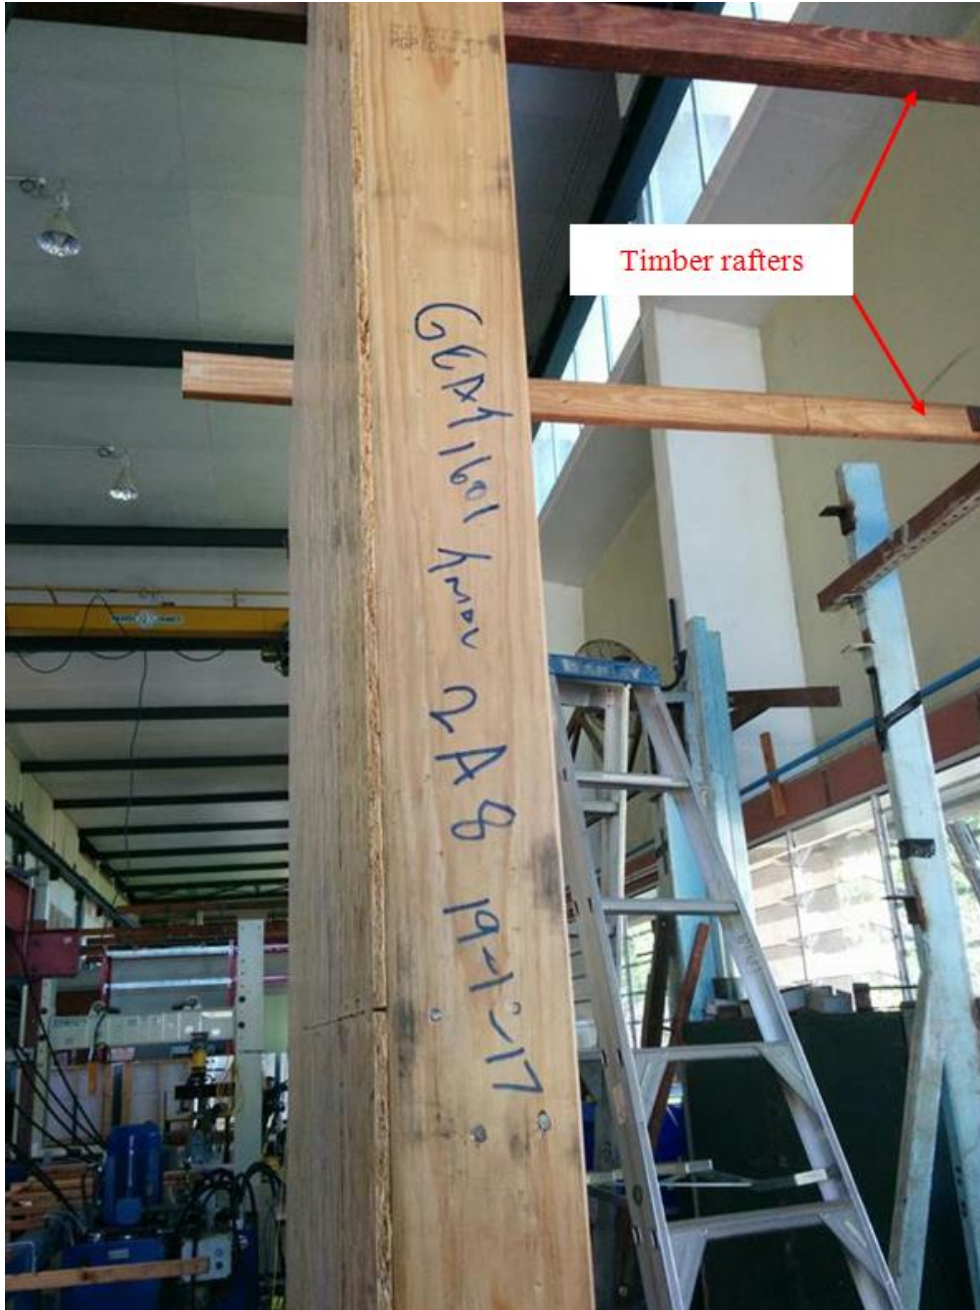
To ensure the wall remained in a vertical position at all times, two timber rafters were fixed to the top plate and attached to a supporting frame, which was fixed to the concrete structural floor. The timber rafters were free to rotate at their attachment points with the supporting frame to minimise their effects on the test results. Figure 47 shows the location of the timber rafters.

FIGURE 47: AFTER PULL-OUT TESTS ON FLOOR TILES

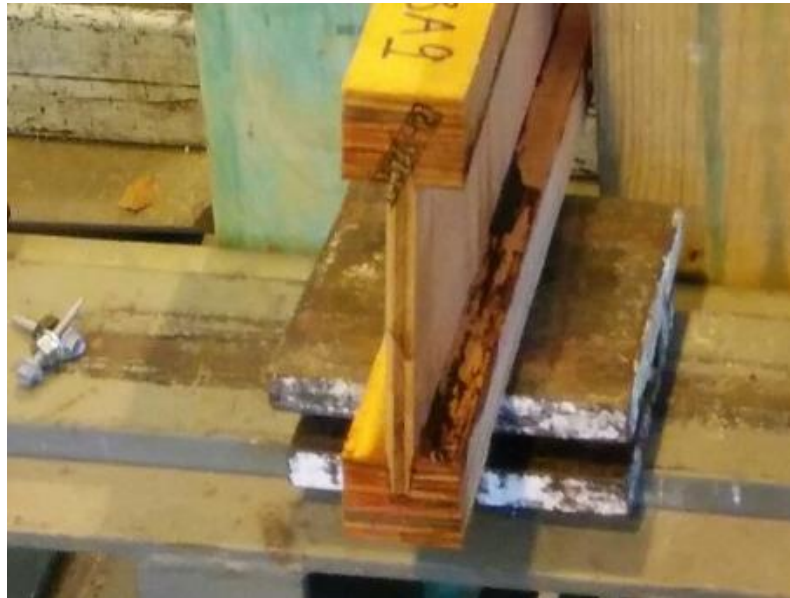
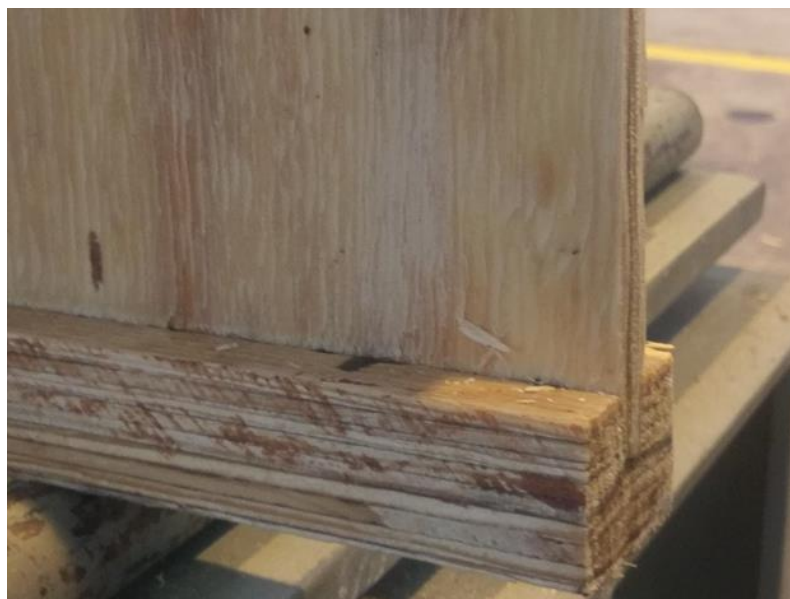
The samples were prepared by drilling a 100 mm diameter hole into the web at a location approximately 1,350 mm from one end and a 40 mm diameter hole into the web at a location approximately 100 mm from the opposite end. The holing in the joists was as per limits specified by the manufacturer. Figure 49 shows the profile and bottom flange to web connection of a typical sample in this testing programme. The sample specification is provided in Appendix C.

(A) PROFILE

(B) DETAILED VIEW

FIGURE 49: PROFILE AND DETAILED VIEW OF BOTTOM FLANGE TO WEB CONNECTION OF A TYPICAL SAMPLE USED IN THIS TESTING PROGRAMME

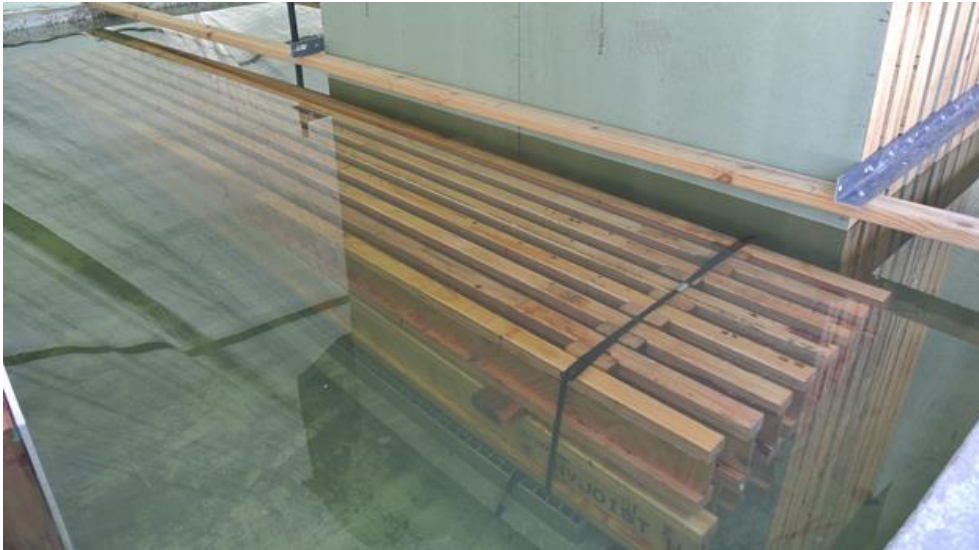
Additionally, another eight H2 treated and eight untreated samples were installed in an immersion tank and the water level was raised to completely submerge the samples for a duration of nominally four days. Subsequently the tank was drained and the samples removed from the tank and immediately tested. Moisture was measured as 99.9% for all samples at the time of testing. Figure 50 shows a batch of samples submerged in the immersion tank.

FIGURE 50: SAMPLES SUBMERGED IN THE IMMERSION TANK DURING THE FLOOD SIMULATION

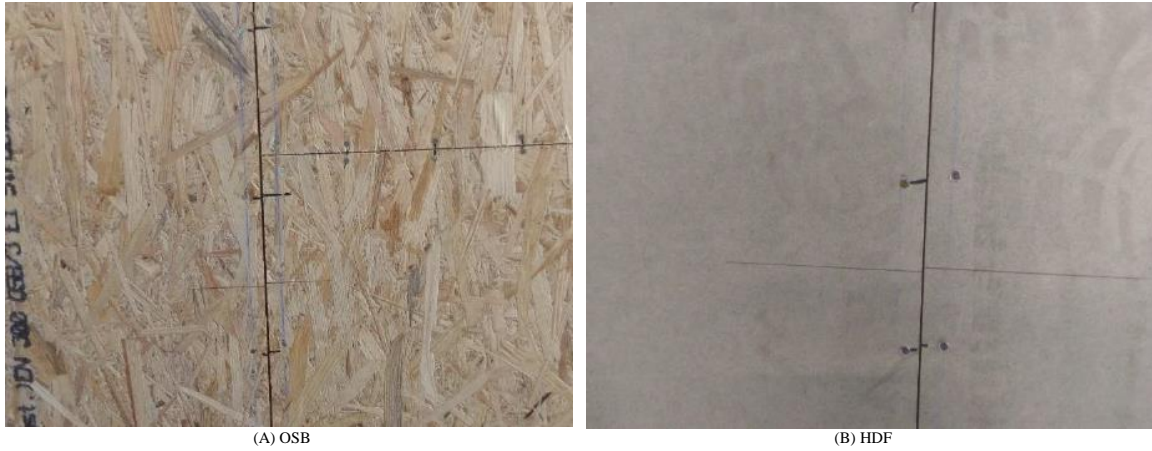
FIGURE B8: SLIPPAGE OBSERVED BETWEEN ADJACENT BRACING SHEETS

In all cases slippage between adjacent sheets and stud withdrawal from the bottom plate was observed.

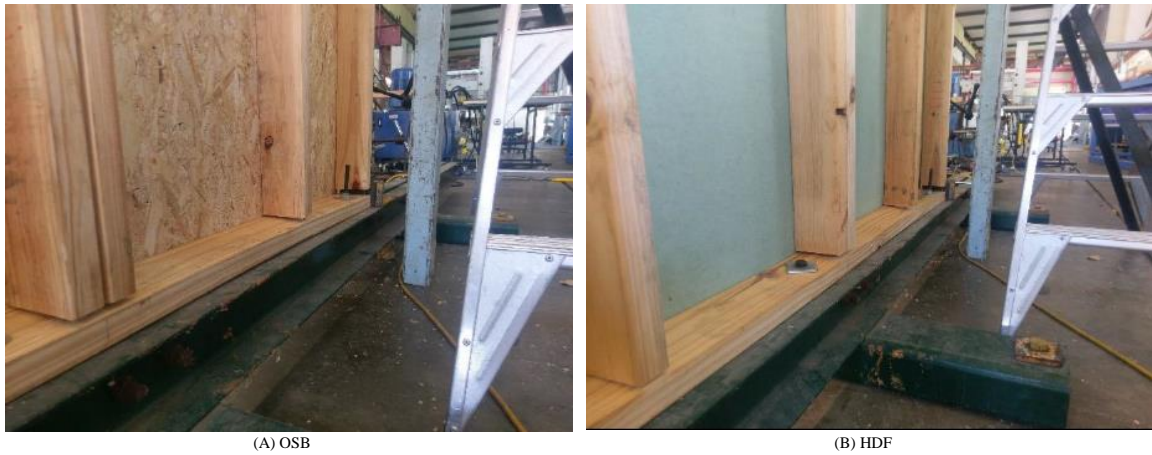
FIGURE B9: STUD WITHDRAWAL FROM BOTTOM PLATE

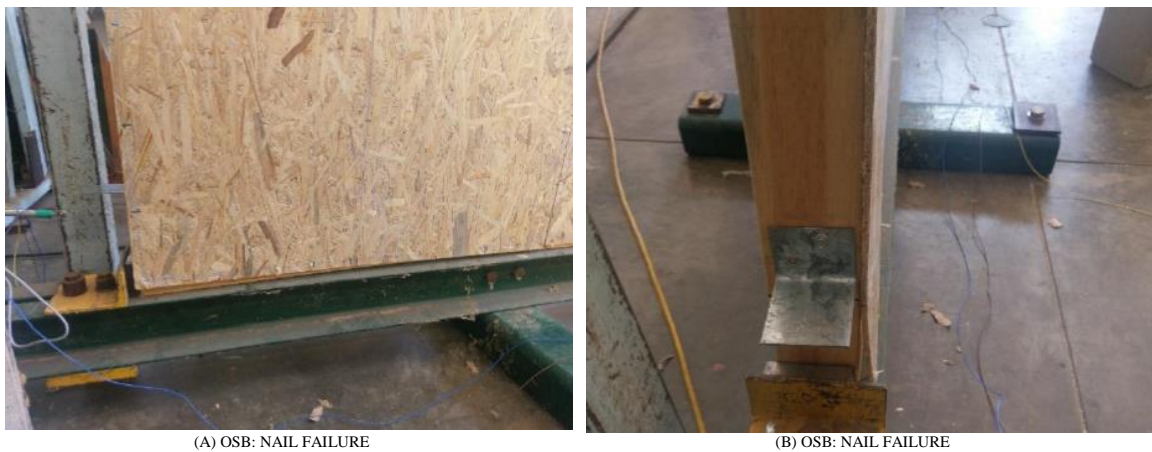
FIGURE B10: NAIL FAILURE (DRY-DRY SAMPLES)

- Bracing failure: where the bracing sheeting had pulled over the nails in the lower edge of the sheeting or torn the sheeting at the nails,
- Nail failure: where nails withdrew from the bottom plate, and
- Nail and sheeting failure: where the nails withdrew from the bottom plate and the sheeting was torn at some nails.

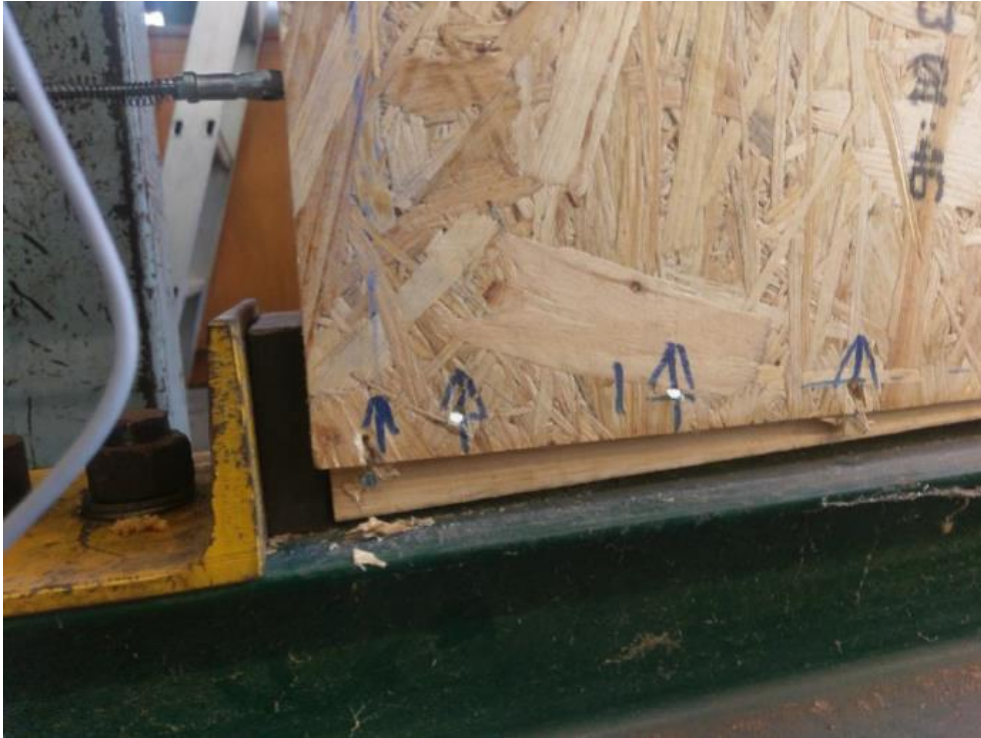
FIGURE B11: OSB BRACE SHEETING FAILURE (DRY-DRY SAMPLES)

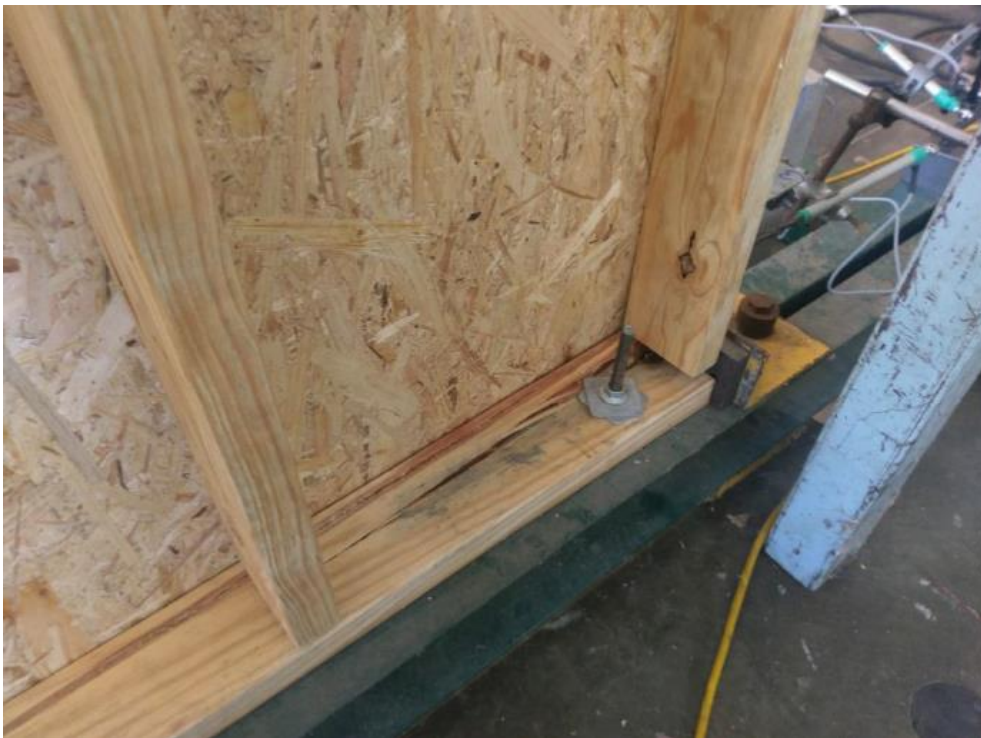
FIGURE B12: OSB BOTTOM PLATE FAILURE (DRY-DRY SAMPLES)

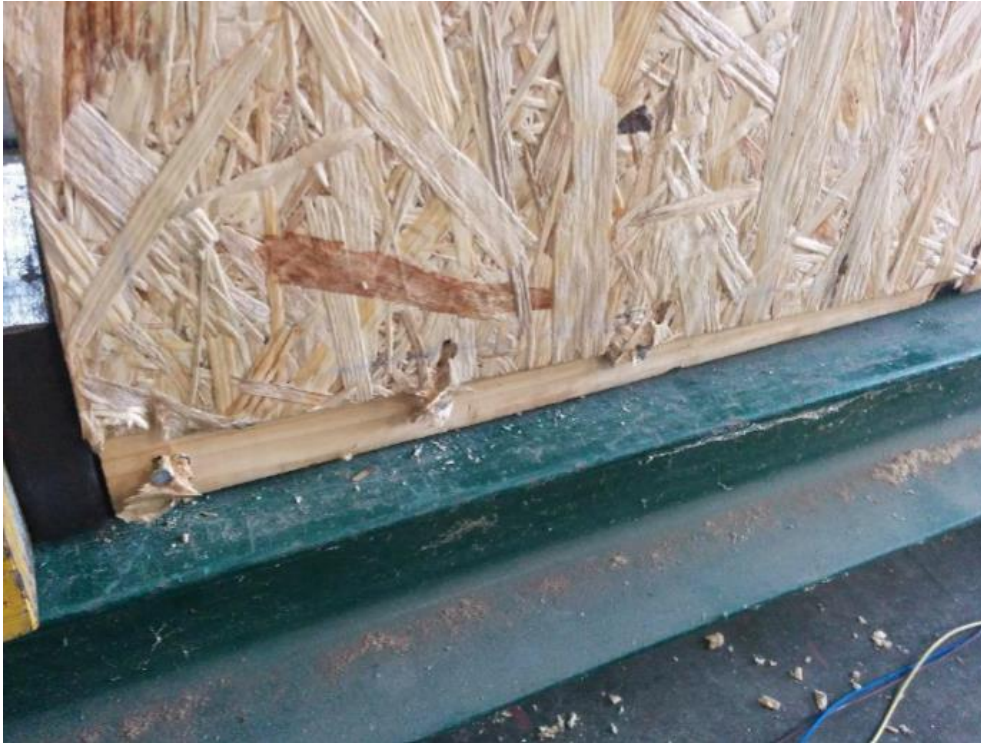
FIGURE B13: OSB BRACE SHEETING FAILURE (WET-DRY SAMPLES)

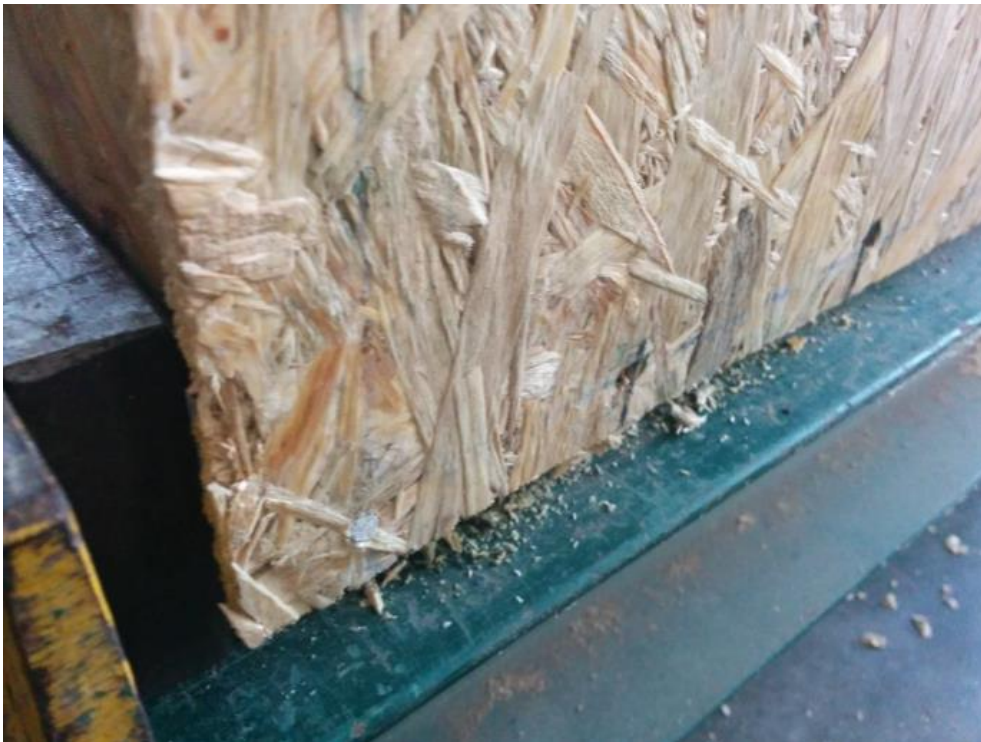
FIGURE B14: OSB BOTTOM PLATE FAILURE (DRY-DRY SAMPLES)

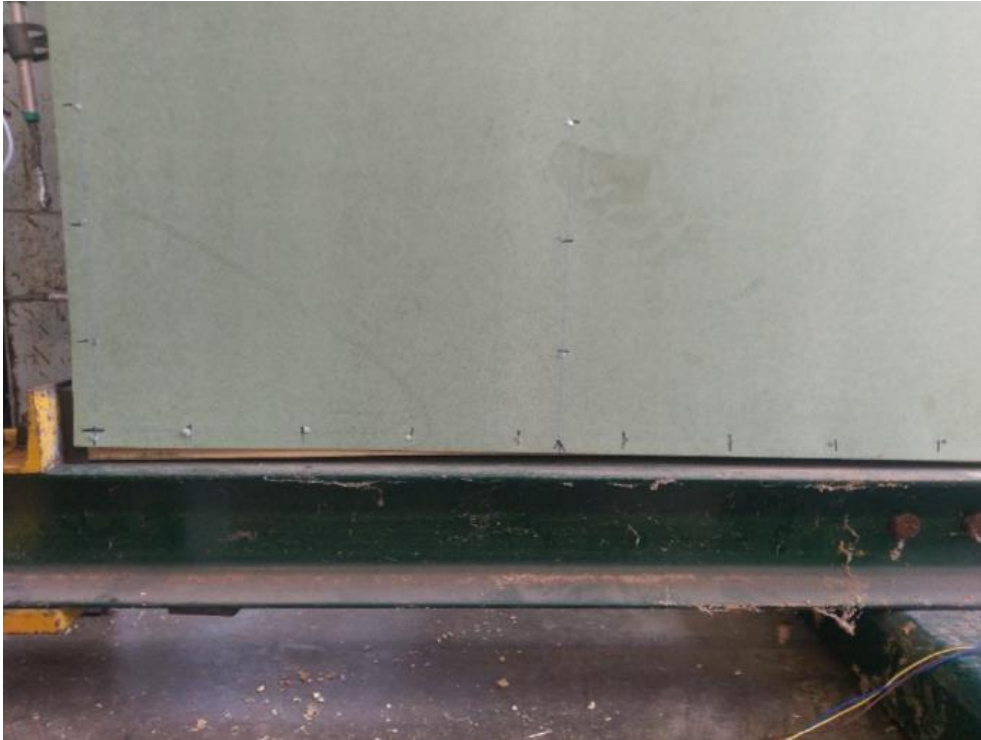
FIGURE B15: OSB BRACE SHEETING FAILURE (WET-DRY SAMPLES)

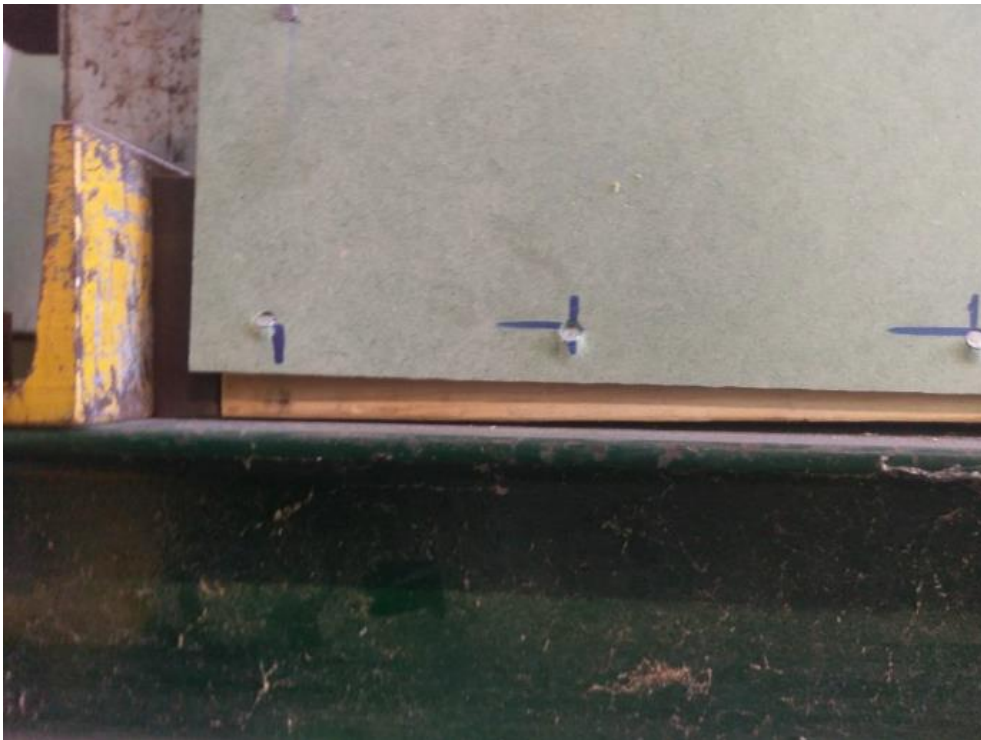
FIGURE B16: OSB BOTTOM PLATE FAILURE (DRY-DRY SAMPLES)

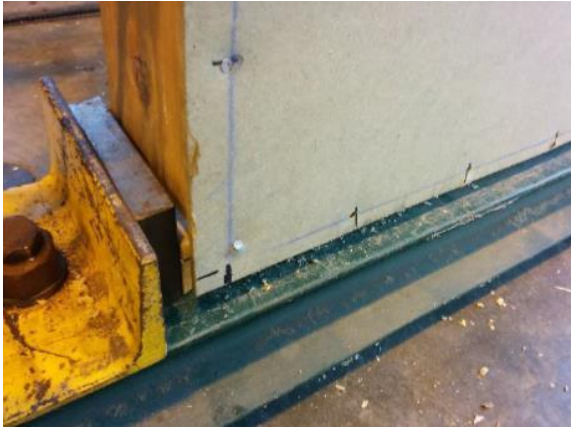
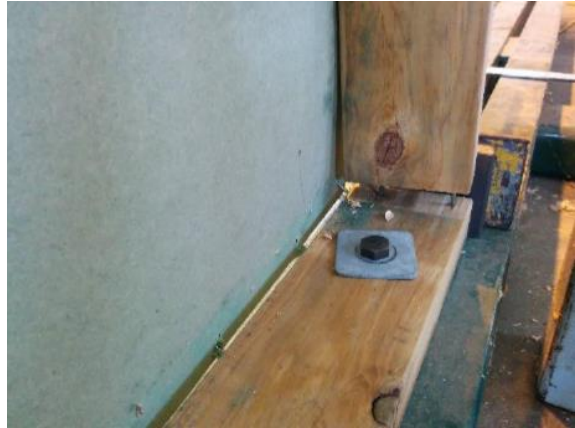
(A) HDF: NAIL FAILURE

(B) HDF: SHEET FAILURE

FIGURE B17: NAIL FAILURE ON HDF (WET-DRY SAMPLES)
