TESTING OF SIMULATED FLOOD EFFECT ON THE STRENGTH OF SELECTED BUILDING COMPONENTS

Tariq Maqsood¹, Martin Wehner¹, Mark Edwards¹, Simon Ingham²
and David Henderson²

¹ Geoscience Australia

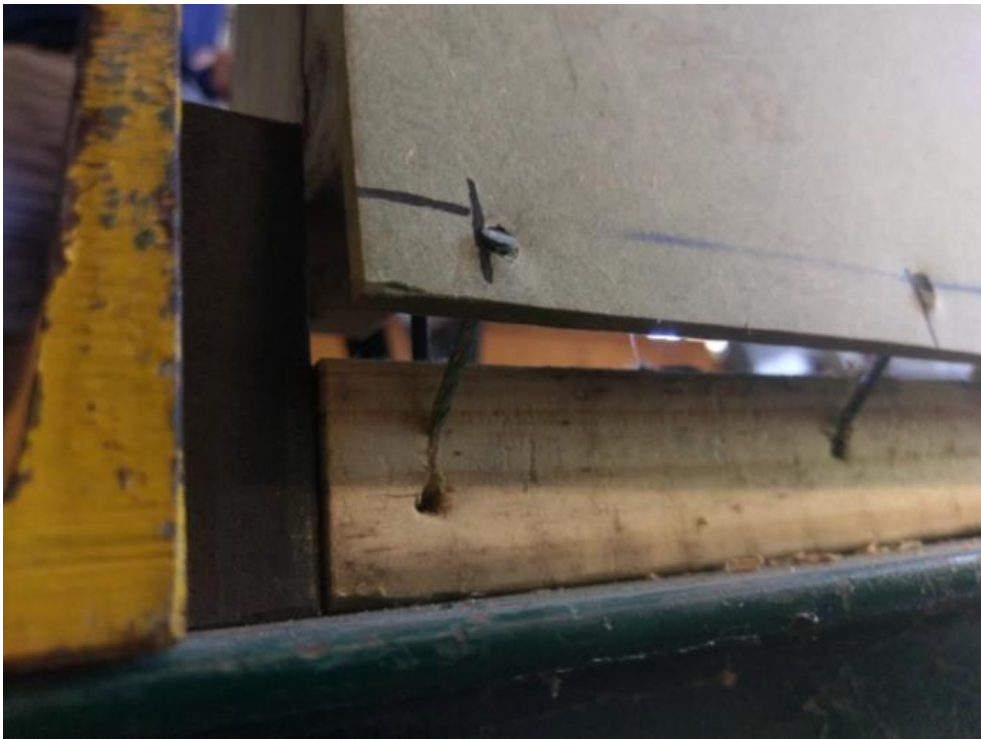
FIGURE B18: NAIL FAILURE ON HDF (WET-DRY SAMPLES)

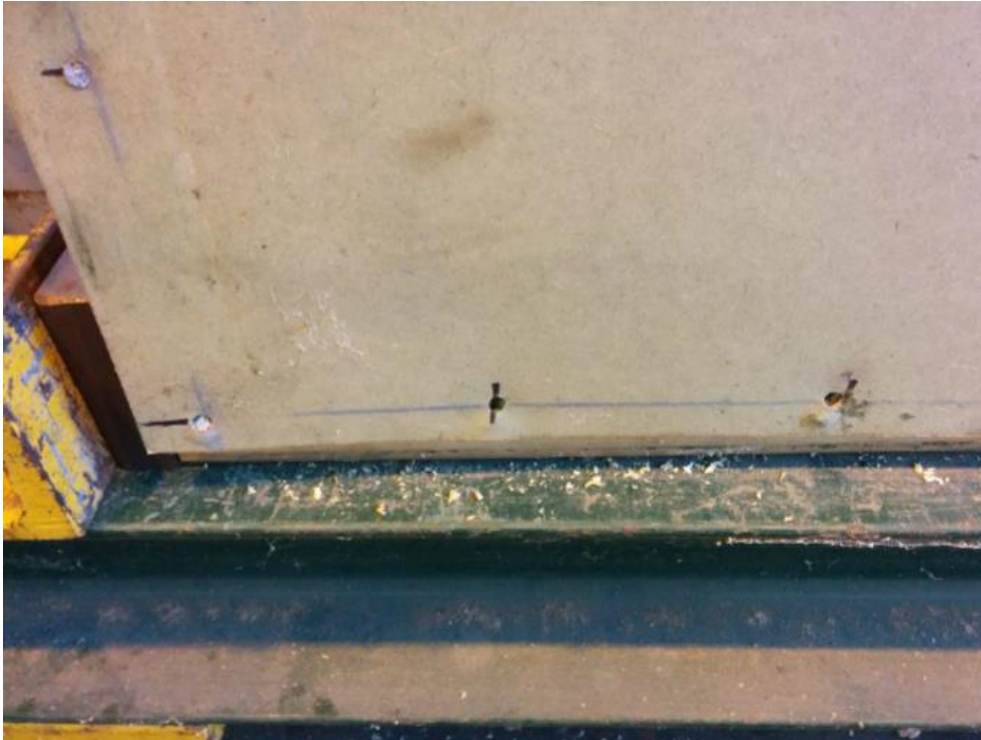
FIGURE B19: NAIL FAILURE ON HDF (WET-DRY SAMPLES)

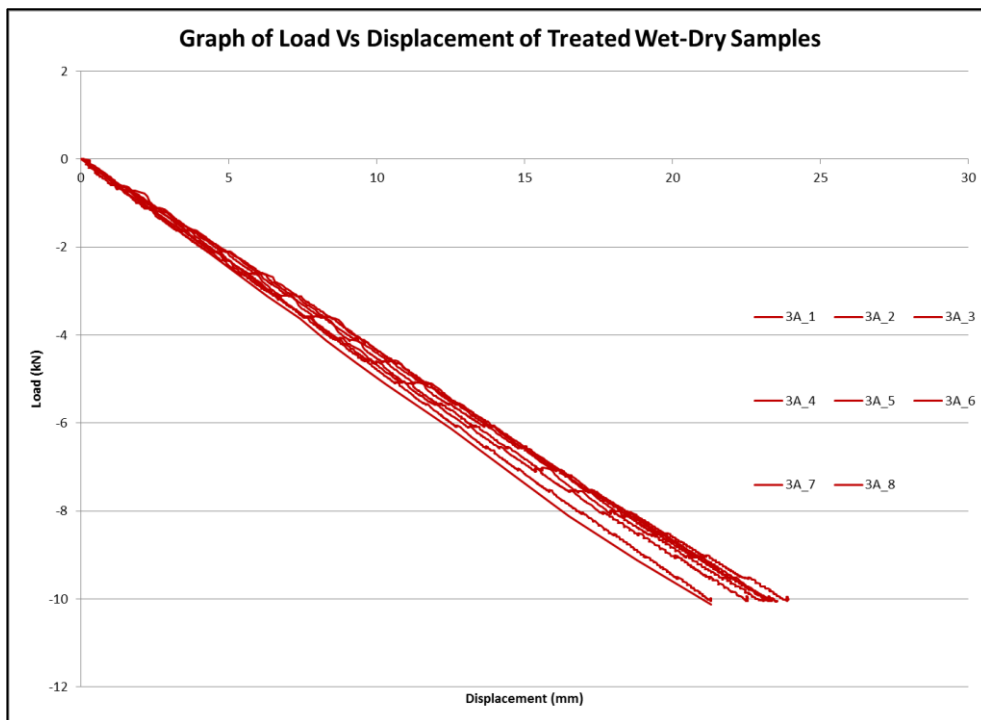
FIGURE C3: LOAD VS DISPLACEMENT GRAPHS OF H2 TREATED JOISTS (WET-DRY SAMPLES)

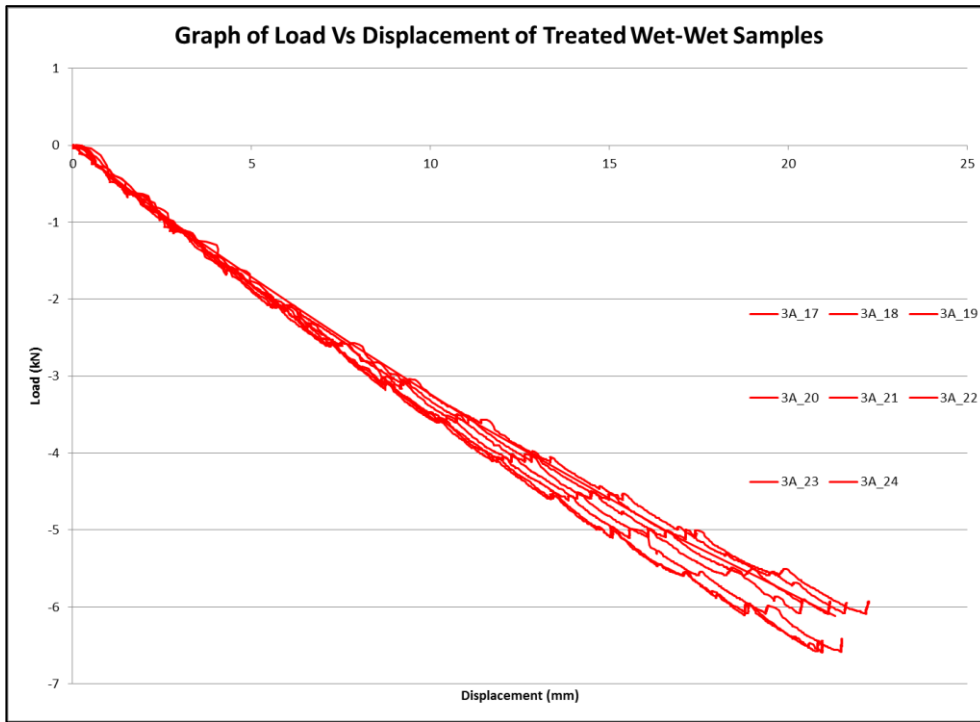
FIGURE C4: LOAD VS DISPLACEMENT GRAPHS OF H2 TREATED JOISTS (WET-WET SAMPLES)

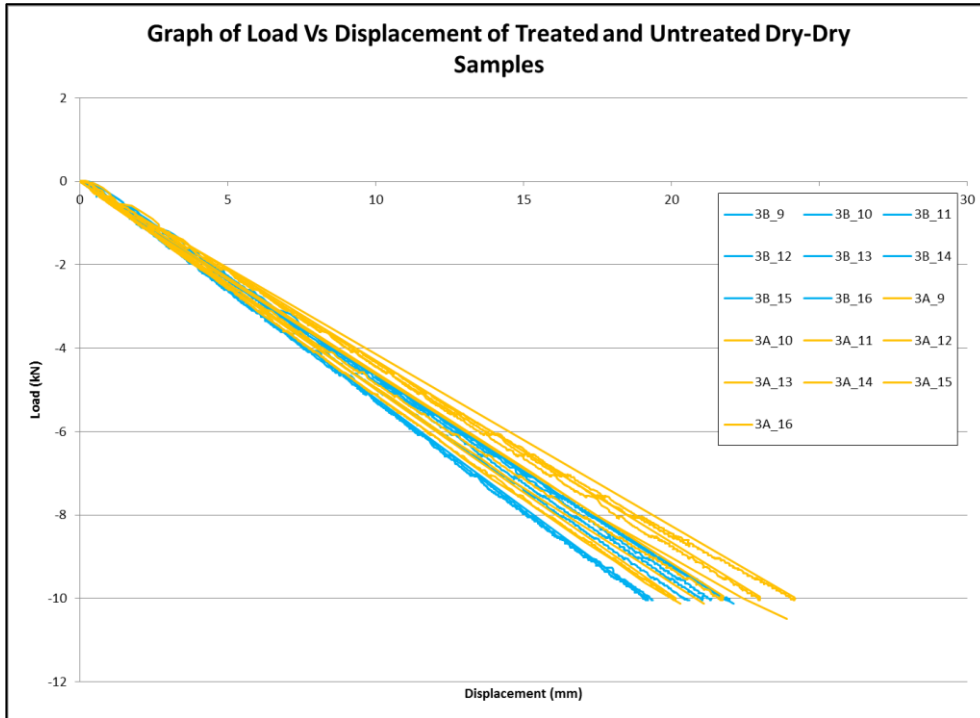
FIGURE C8: LOAD VS DISPLACEMENT GRAPHS OF H2 TREATED AND UNREATED JOISTS (DRY-DRY SAMPLES)

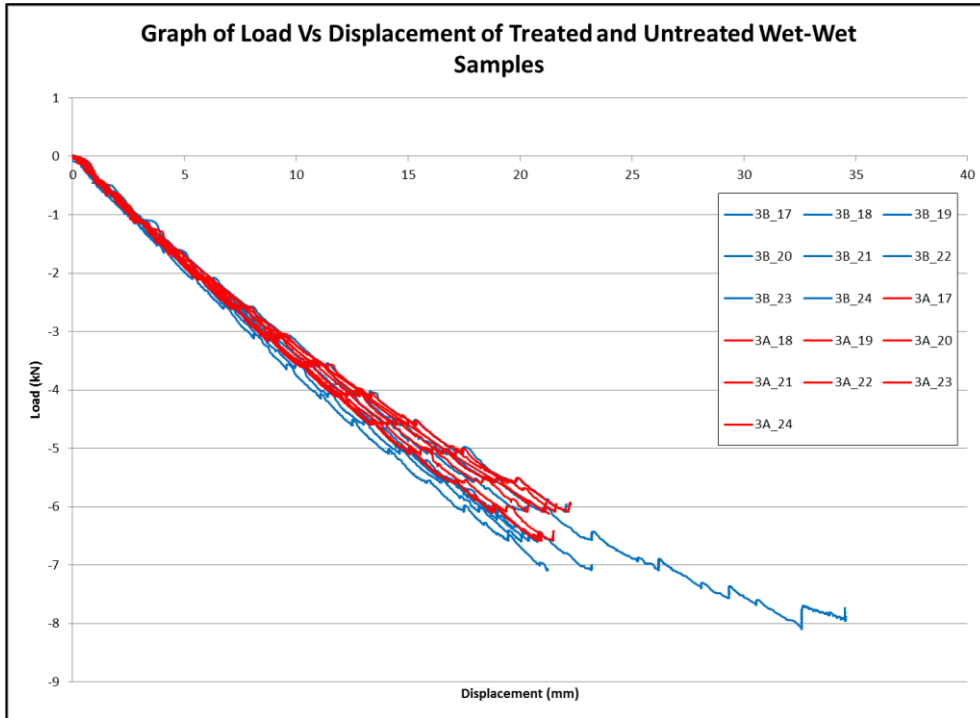
FIGURE C10: LOAD VS DISPLACEMENT GRAPHS OF H2 TREATED AND UNREATED JOISTS (WET-WET SAMPLES)

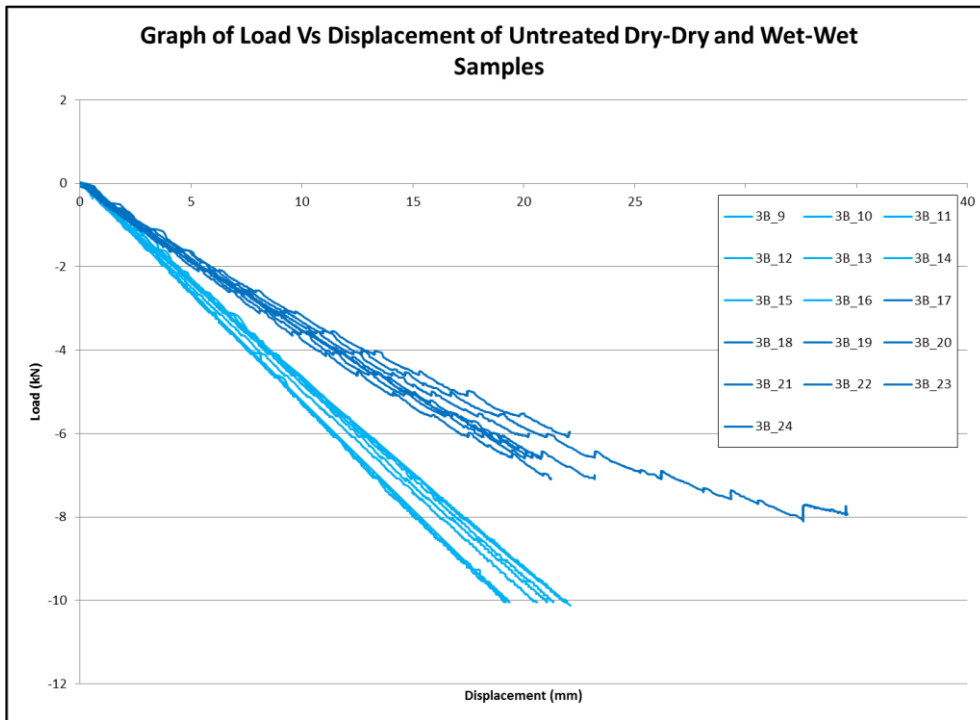
FIGURE C15: LOAD VS DISPLACEMENT GRAPHS OF UNTREATED JOISTS (DRY-DRY AND WET-WET SAMPLES)

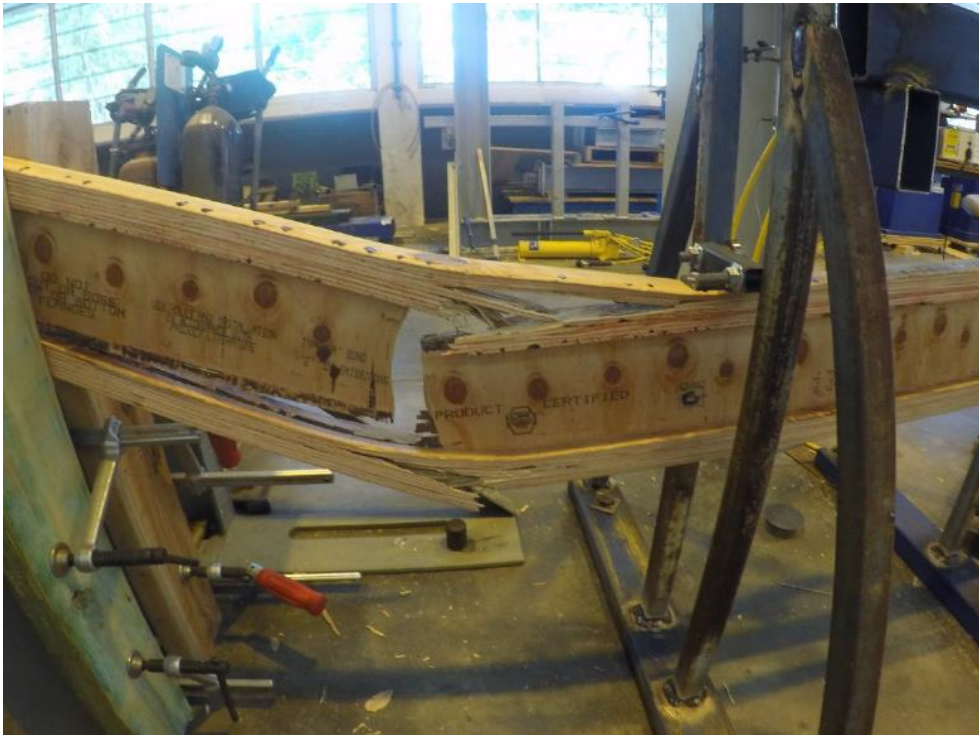
FIGURE C17: FAILURE OF H2 TREATED TIMBER T SECTIONS DRY-DRY SAMPLES: TOP AND BOTTOM RUPTURE AND CRACKED WEB

Figure C17 to Figure C28 show the typical failure in all the samples for Test Type 3.

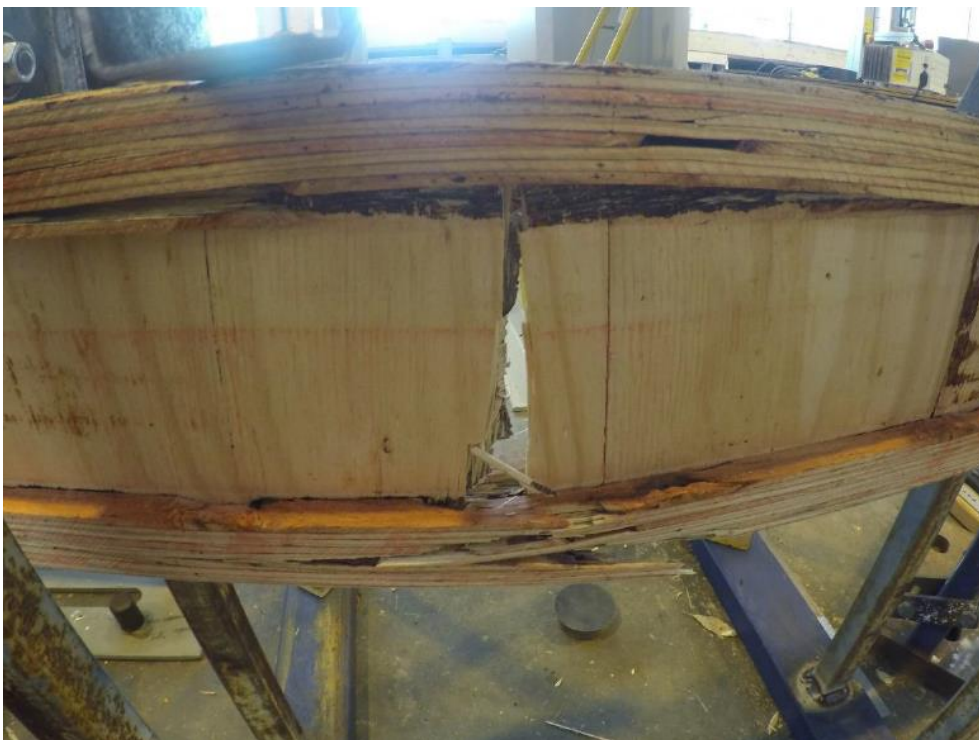
FIGURE C18: FAILURE OF H2 TREATED TIMBER T SECTIONS DRY-DRY SAMPLES: BOTTOM FLANGE RUPTURE AND WEB DISLODGED FROM FLANGES

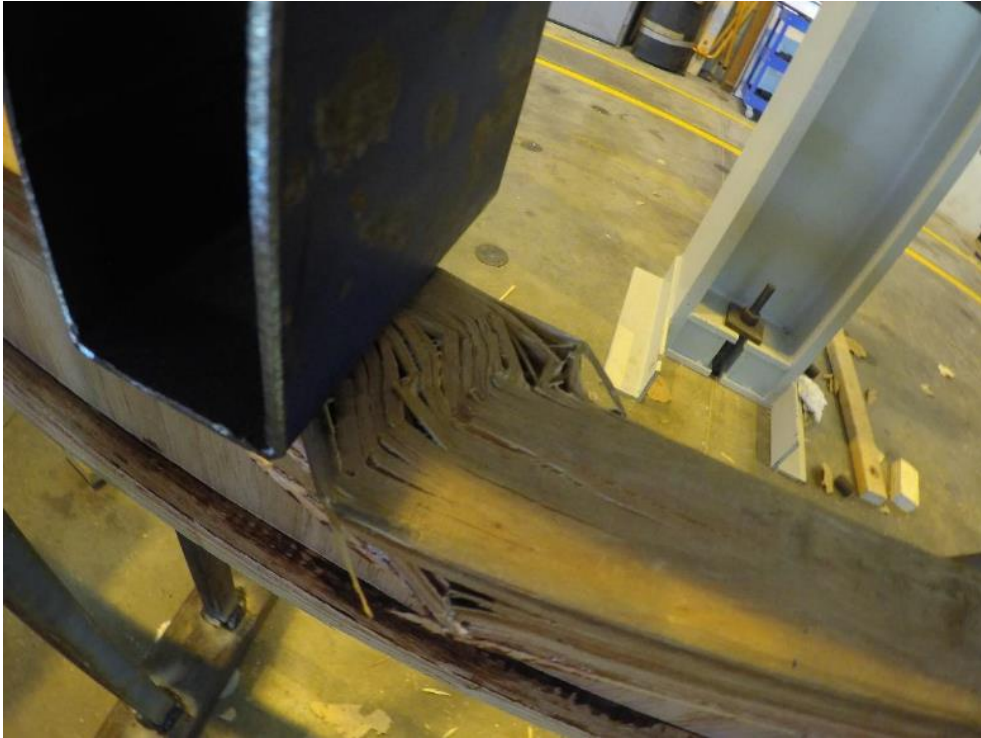
FIGURE C19: FAILURE OF H2 TREATED TIMBER T SECTIONS WET-DRY SAMPLES: TOP FLANGE COLLAPSE (LOCALISED BUCKLING) AT LOADING POINTS

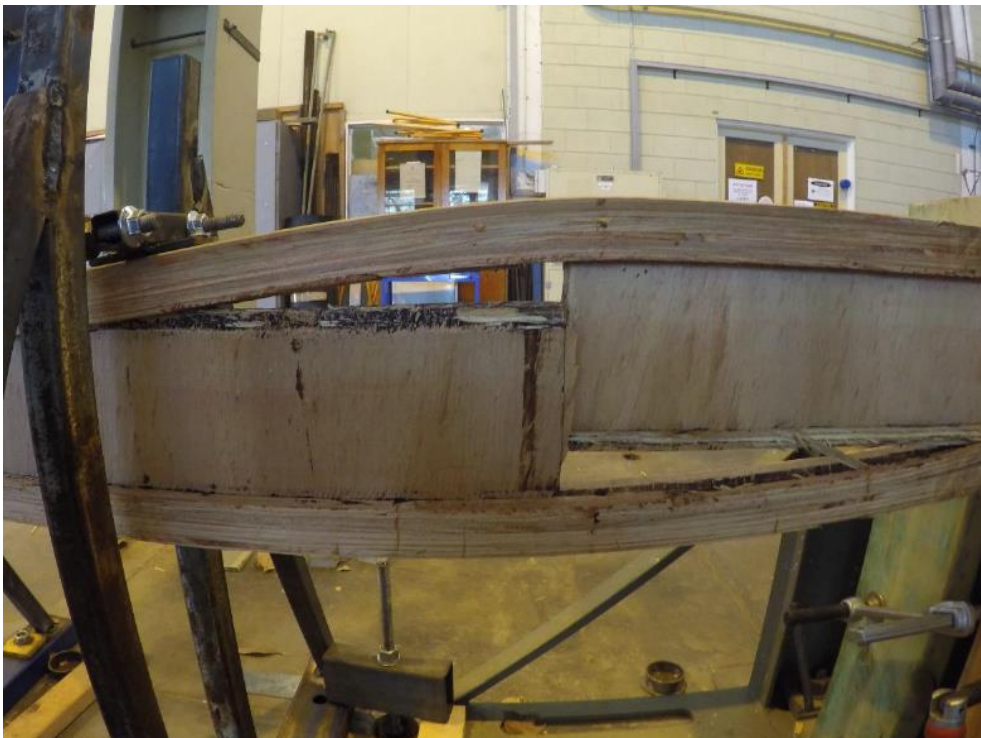
FIGURE C20: FAILURE OF H2 TREATED TIMBER T SECTIONS WET-DRY SAMPLES: BOTTOM FLANGE RUPTURE AND WEB DISLODGED FROM FLANGES

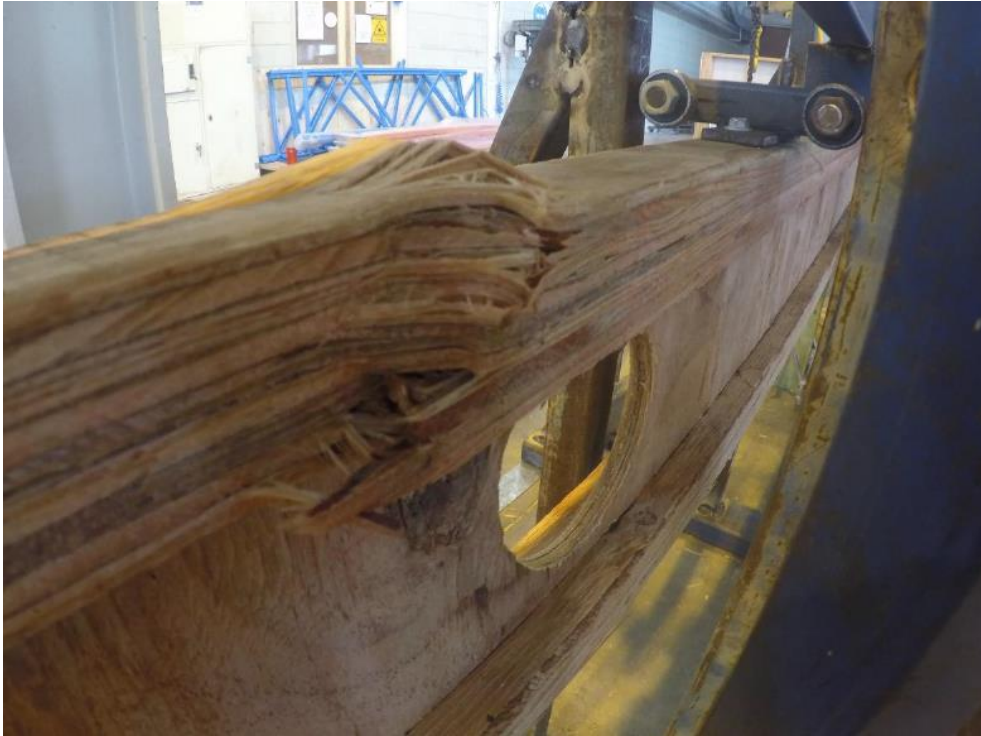
FIGURE C21: FAILURE OF H2 TREATED TIMBER T SECTIONS WET-WET SAMPLES: TOP FLANGE COLLAPSE (LOCALISED BUCKLING) AT LOADING POINTS

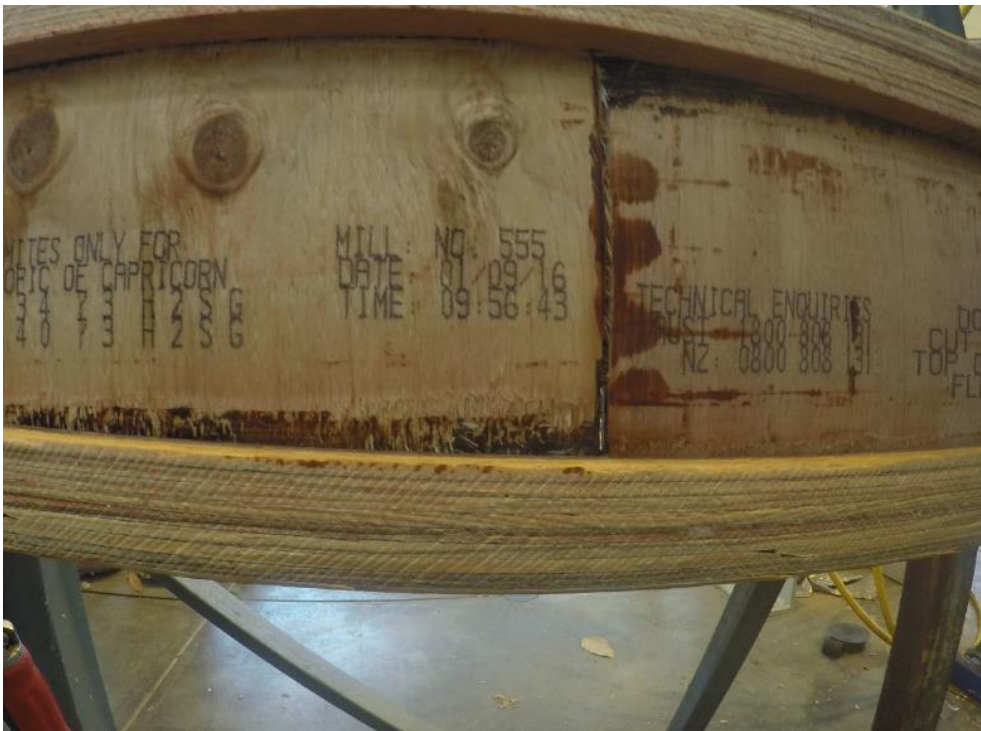
FIGURE C22: FAILURE OF H2 TREATED TIMBER T SECTIONS WET-WET SAMPLES: WEB DISLODGED FROM FLANGES

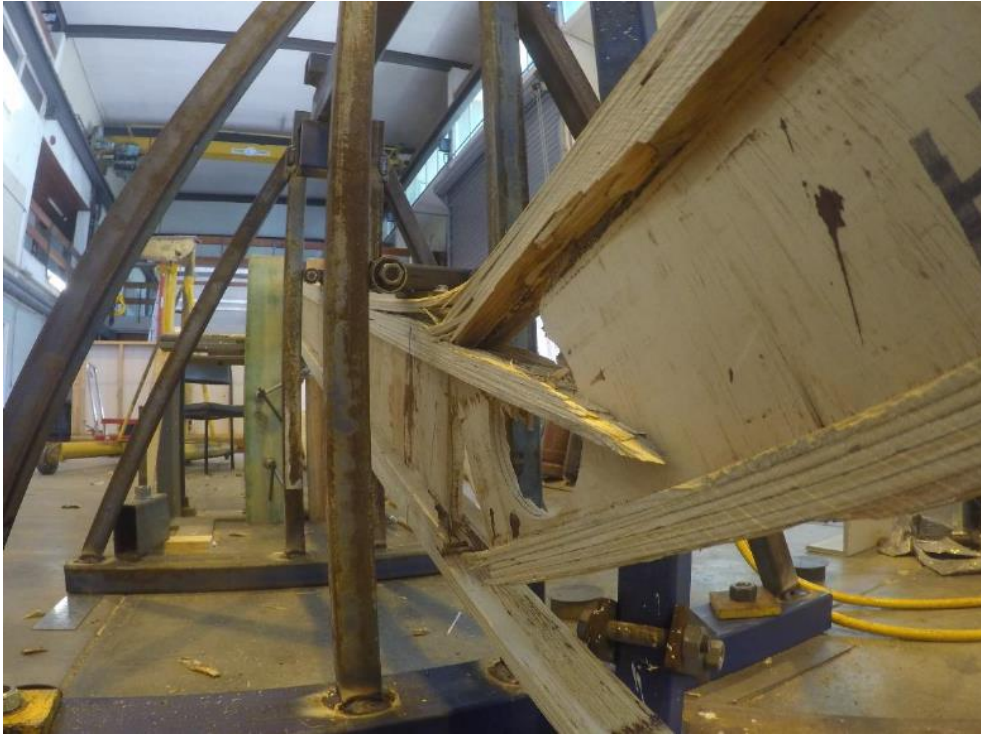
FIGURE C23: FAILURE OF UNTREATED TIMBER T SECTIONS DRY-DRY SAMPLES: TOP AND BOTTOM RUPTURE AND CRACKED WEB

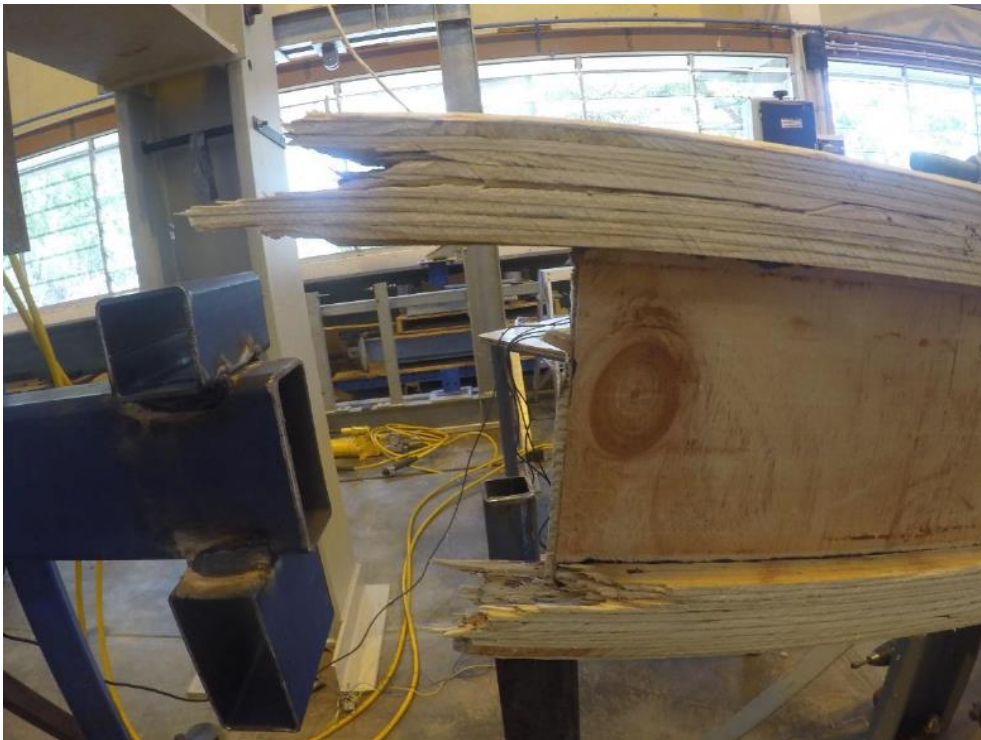
FIGURE C24: FAILURE OF UNTREATED TIMBER T SECTIONS DRY-DRY SAMPLES: TOP AND BOTTOM FLANGES CRACKED AT WEB JOINT

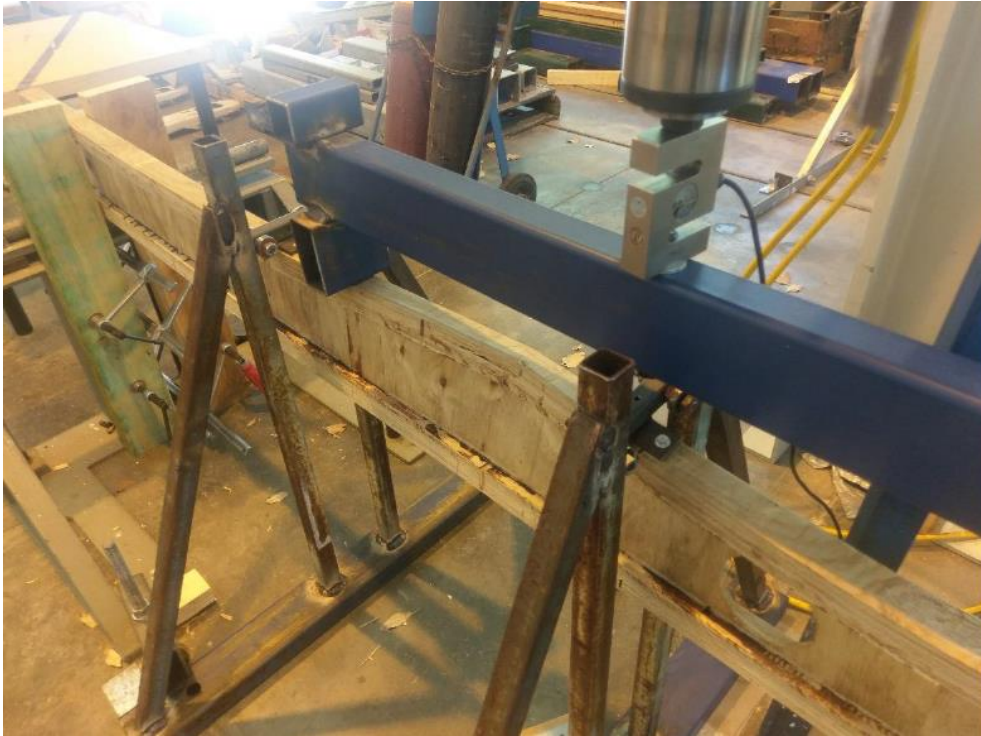
FIGURE C25: FAILURE OF UNTREATED TIMBER T SECTIONS WET-DRY SAMPLES: TOP FLANGE COLLAPSE (LOCALISED BUCKLING) AT LOADING POINTS

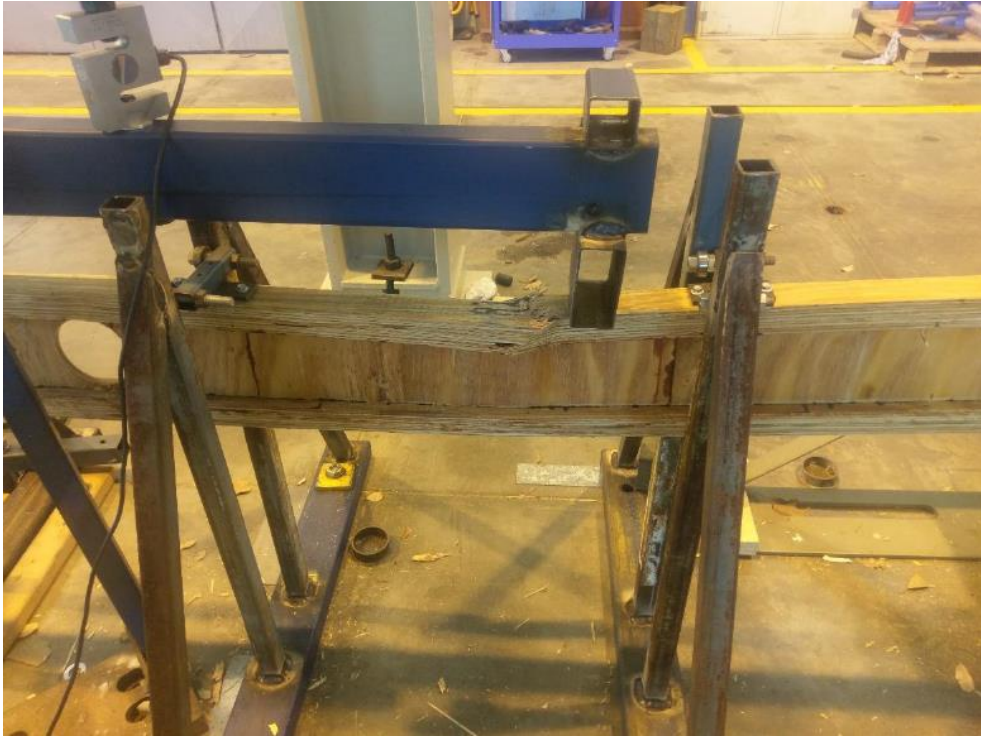
FIGURE C27: FAILURE OF UNTREATED TIMBER T SECTIONS WET-WET SAMPLES: TOP FLANGE COLLAPSE (LOCALISED BUCKLING) AT LOADING POINTS

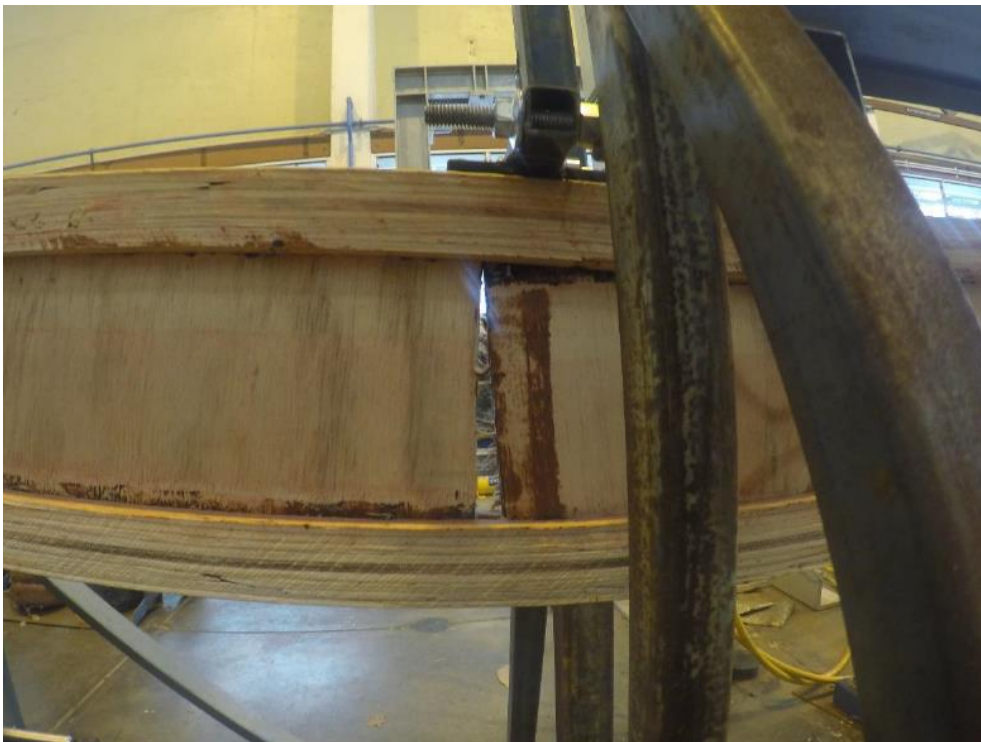
FIGURE C28: FAILURE OF UNTREATED TIMBER T SECTIONS WET-WET SAMPLES: TOP FLANG AND WEB COLLAPSE
