IMPROVING THE RESILIENCE OF EXISTING HOUSING TO SEVERE WIND EVENTS

Annual project report 2016-17

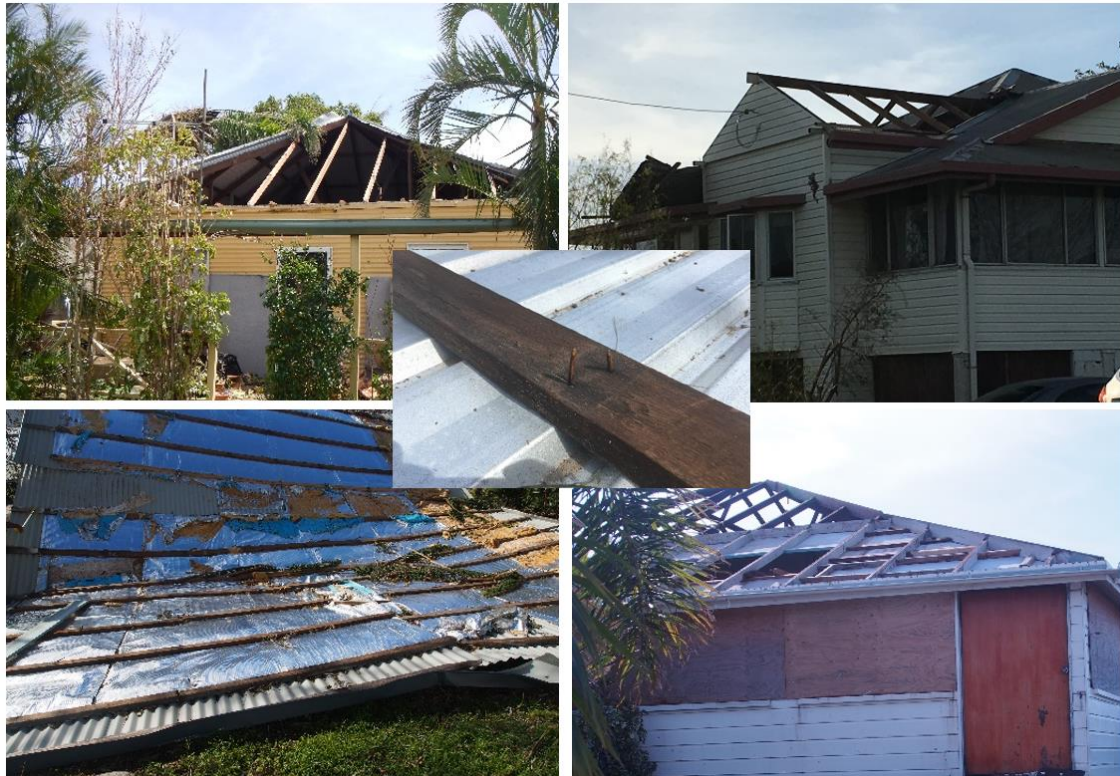
FIGURE 1. WIND-INDUCED FAILURES OF ROOF BATTENS TO RAFTERS ON PRE-80S CONSTRUCTION DURING TC DEBBIE. THERE WERE EXAMPLES OF NEW ROOF CLADDING SCREWED TO BATTENS BUT NO RETROFITTING OF UPGRADED BATTEN TO RAFTER CONNECTIONS (E.G. STRAPS OR SCREWS) WERE OBSERVED.

Batten to rafter or truss connections were the most commonly observed failure in the roofs of older buildings.

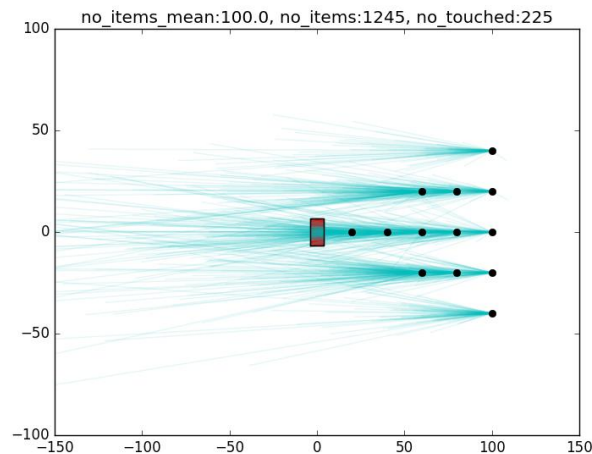
FIGURE 6. PLOT OF SIMULATED DEBRIS ITEM FLIGHT PATHS

- Changing the method of counting debris item impacts from those landing in the target house polygon to the number of debris item trajectories crossing the target house polygon. This facilitates the incorporation of non-rectangular house shapes by virtue of not having to artificially stretch the footprint to calibrate the number of impacts. The number of impacts has been scaled to the output of the previous code so that the output of the debris module is identical with the previous version. Figure 6 shows a simulation of the proposal with the target house represented by the red rectangle and the source houses represented by the black dots. Debris item flight paths are represented by the blue lines. When a blue line crosses the target house footprint it is counted as an impact.

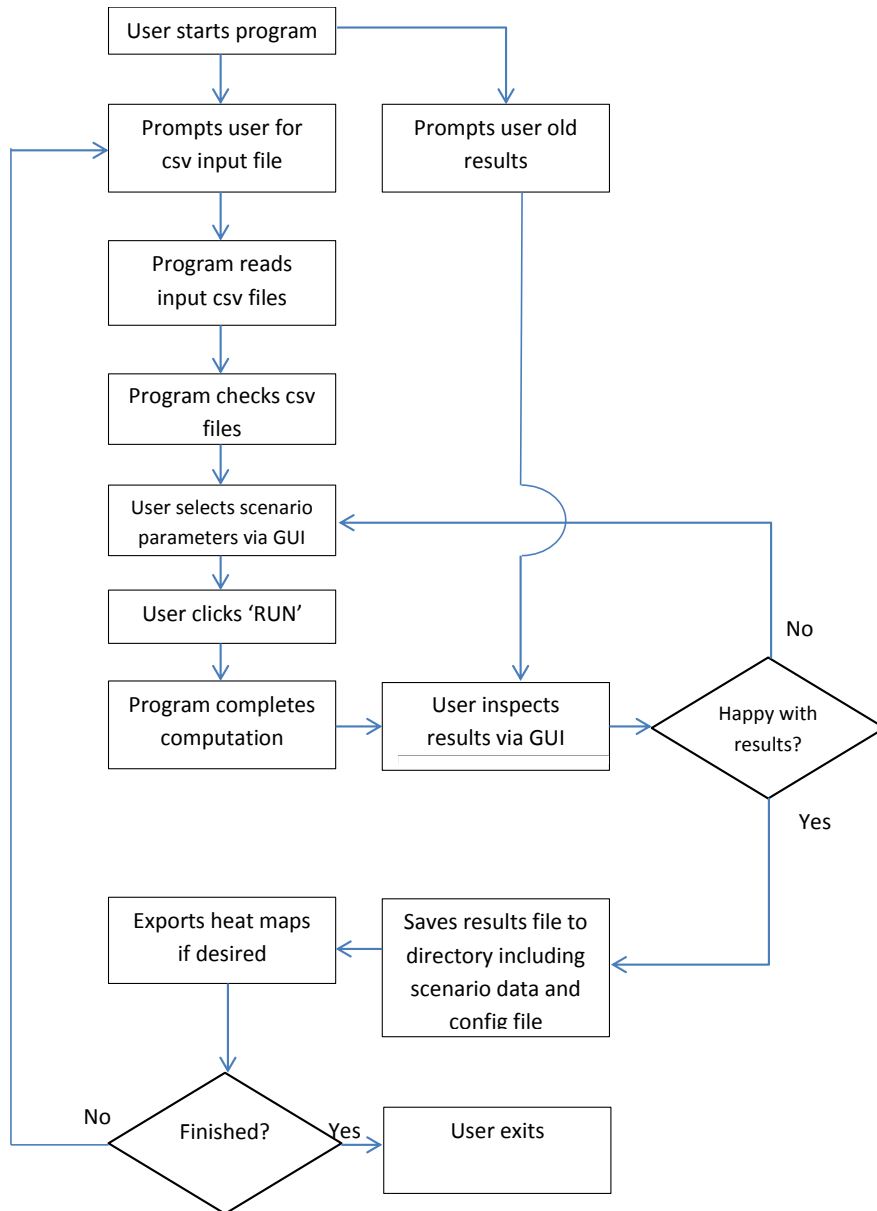
FIGURE 7. BASE USE-CASE FLOWCHART FOR VAWS

The flowchart describes the base use-case for VAWS, or how the user would interact with the program.

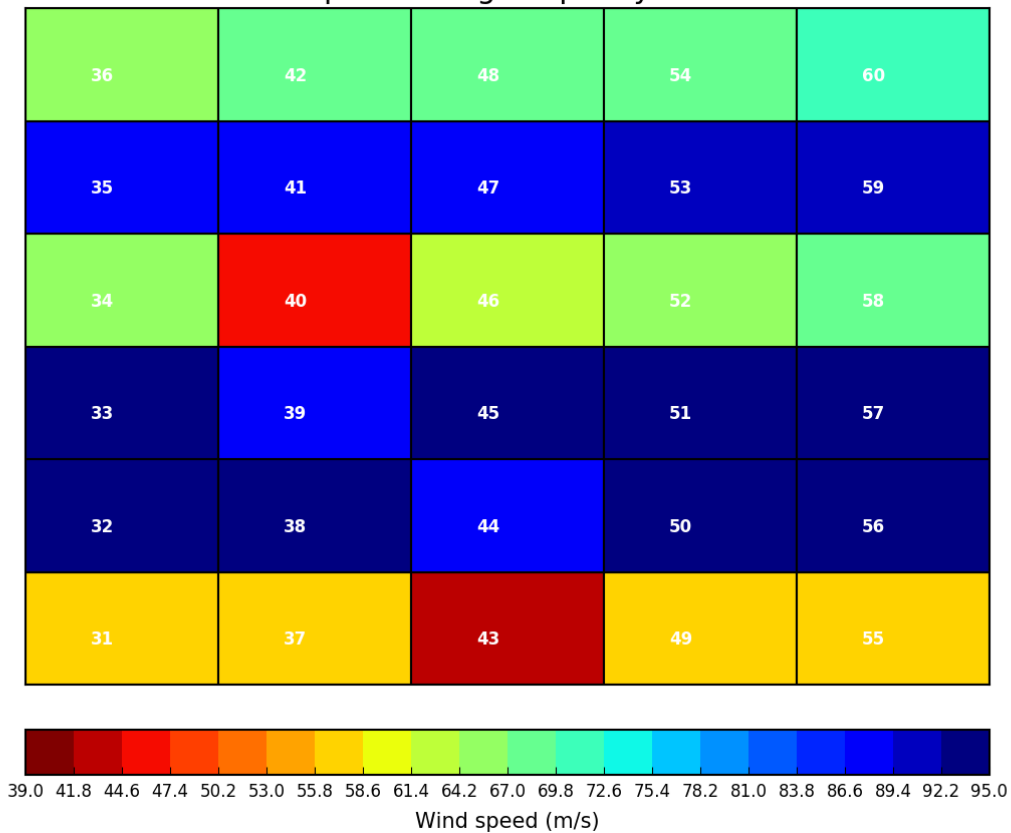
Heatmap of damage capacity for batten

FIGURE 10. PLAN VIEW HEATMAP OF FAILURE WIND SPEEDS FOR BATTEN CONNECTIONS MODELLED FOR TEST SCENARIO 3. THE CPE VALUES FOR THE ZONES ABOVE CONNECTIONS 36, 40 AND 43 WERE MODELLED ARTIFICIALLY HIGH (APPROXIMATELY 70 TIMES AS HIGH AS THE SURROUNDING CONNECTIONS). FAILURES IN BATTEN CONNECTIONS CAN BE SEEN TO INITIATE AT THE HIGHLY LOADED CONNECTIONS AND PROPAGATE AWAY AT SUBSEQUENT WIND SPEEDS

Designed to test whether the code correctly calculates which batten connections have failed and redistributes loads as expected. Sheeting connections modelled with artificially high strengths to ensure failures occur in batten connections. Fixed batten strengths modelled by zero standard deviation of connection strengths. Tests distribution from interior and gable batten connections.

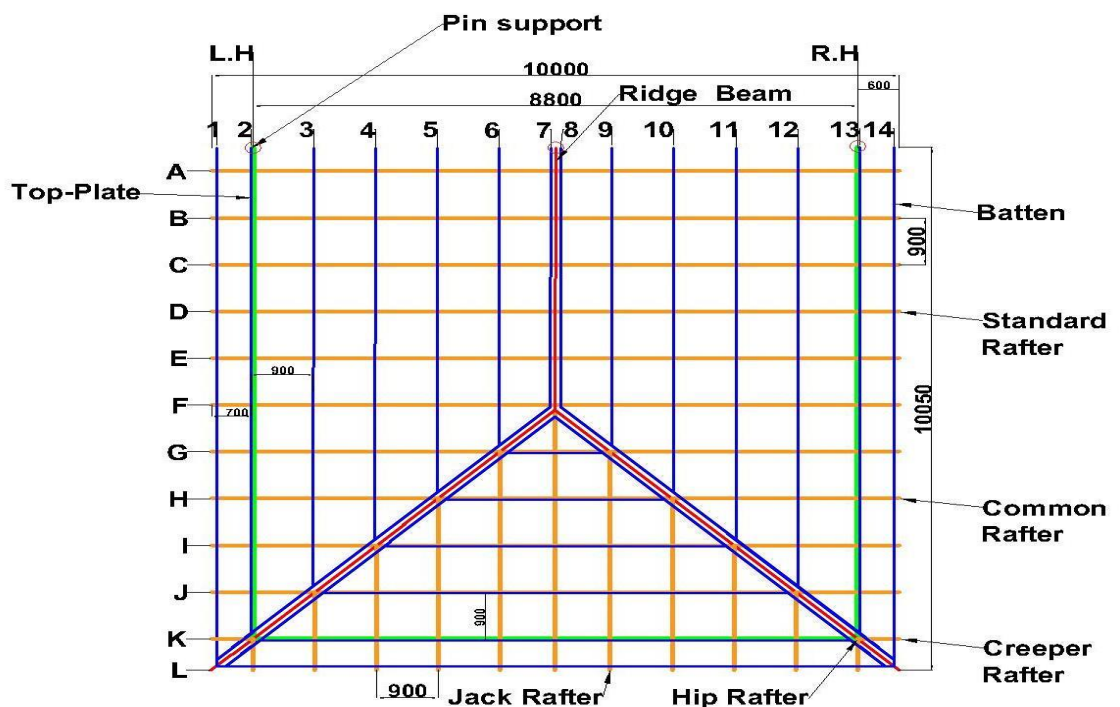
FIGURE 12: PLAN VIEW OF TYPE 1 FEM

- Type 1: Ideal connection model (applied load was 2 kN on roof cladding), See Figure 12 and 13
- The FEM model was developed for the general and hip-end region roof structure of pitched roof house. The model consists of eleven types of components: corrugated steel roof cladding, timber battens, rafters, ridge beam, collar tie, top plates, hip-rafter, ceiling joist, ceiling battens and ceiling.

- Collar ties were installed every second rafters in the general rafter region (i.e. Rafters B, D and F)
- The inter-component connection properties used were obtained from previous studies, individual connection tests and FEM.

- The modelling methodology was similar to the FEM of Satheeskumar et al. 2017.
- Pin supports were enforced on the bottom surface of top-plate at wall stud locations, end surface of top-plates, ridge beam and ceiling battens at gable end of roof.
